Reconnaissance of the 2017 Central Mexico Earthquake

Key Facts

- Hazard Type: Earthquake
- Date of the disaster: September 19th, 2017
- Location of the survey: Mexico City, Puebla, Morelos
- Date of the field survey: October 15th to 19th, 2017
- Survey tools: Microtremor
- Key findings: site effects, contribution of sinking to the amplification of damage, need for implementation of mandatory retrofitting of old structures and seismic revision of damaged structures

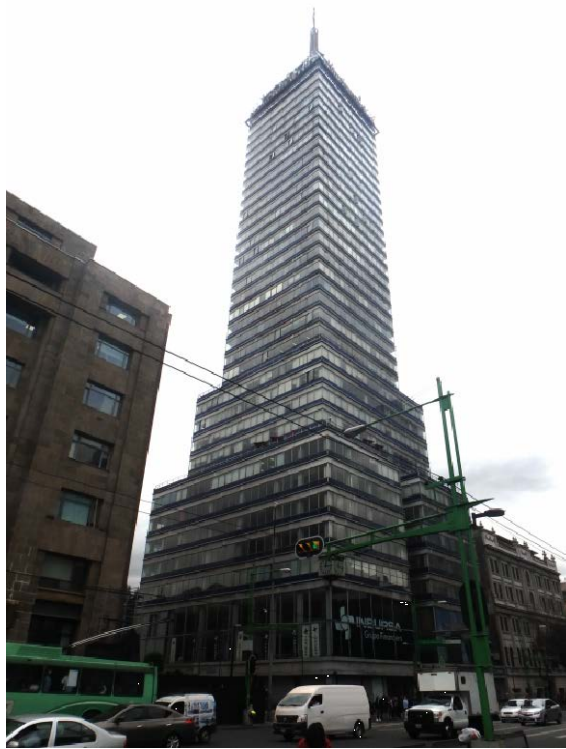
In the central district, one of the most distinguished structures was the Latin-American Tower, a 44-story building finished in 1956 (Figure 11). Its foundation consists of a combination of point bearing piles to a depth of 33 m and a reinforced concrete box at a depth of 13.5 m. The Latin-American Tower has survived the earthquakes of 1957 and 1985. During this earthquake, no damage was observed in the structure (D0).

Fig.11 Latin-American Tower, D0, Zone III

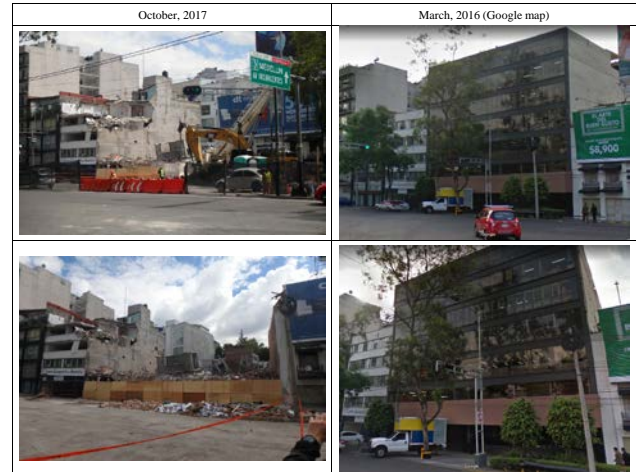
Figure 14 shows a damage to 7-story reinforced concrete structure (RC) building in Alvaro Obregon 286. It was surrounded by smaller buildings and collapsed immediately after the earthquake, causing damage to the buildings on the left and the back that had to be evacuated. This issue, known as pounding, was observed in many instances after this earthquake.

Fig.14 Alvaro Obregon 286, D5, Zone II

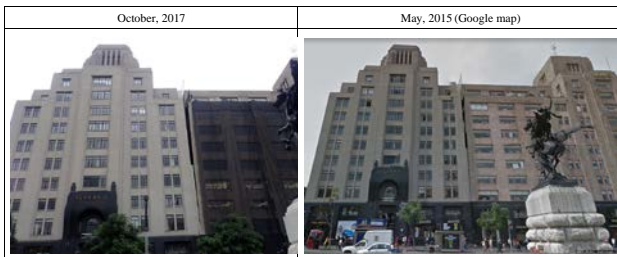
Figure 12 shows the buildings near the Latin-American Tower which exhibited 1° of tilting. Although a previous picture (Figure 12 right) shows that these buildings have tilted before, the base of the building shows recent differential settlement (Figure 13).

Fig.12 La Nacional and Sears, Centro District, D2, Zone III

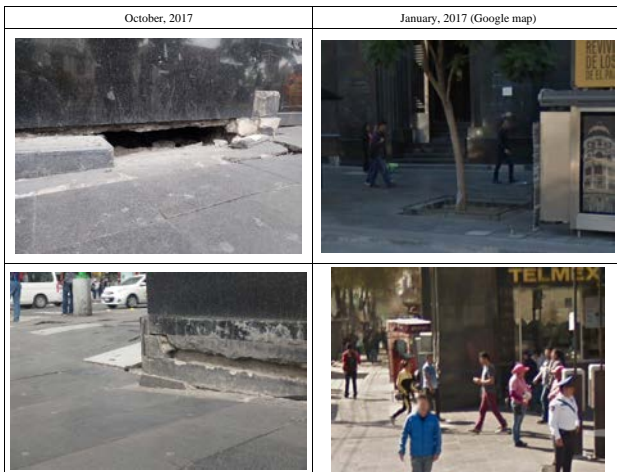
Fig.13 Corner of La Nacional, Centro District, D2, Zone III

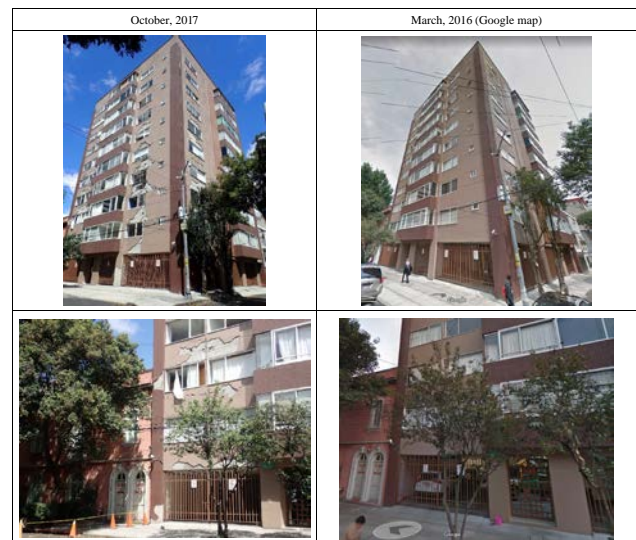
Figure 15 shows a 10-story building between Puebla Street and Cozumel Street, exhibited peeling of surface and collapse of a masonry concrete block. Built before 1985, it underwent minor repair after that earthquake but it was evacuated this time. Asymmetric damage was observed due to the corner location and the 2-story house on the right side.

Fig.15 Puebla and Cozumel Streets, D2, Zone II

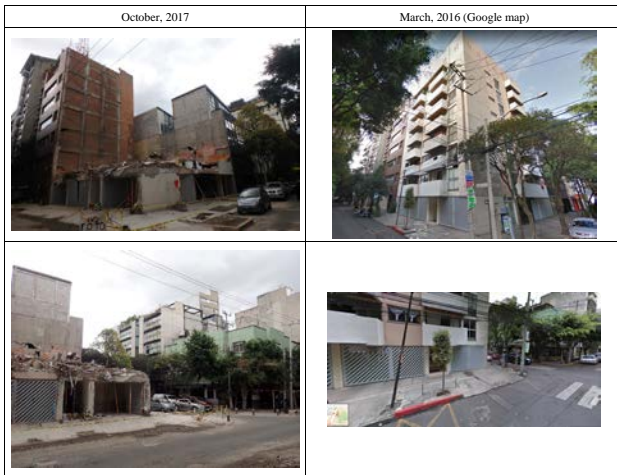
In this area, there were several collapses, such as the RC structure with masonry bricks in the corner of Amsterdam and Laredo Streets (Figure 16). This 9-

story building was located on the corner and had an 8-story building on the left side that suffered moderate damage (D2).

Fig.16 Amsterdam 15, D5, Zone II

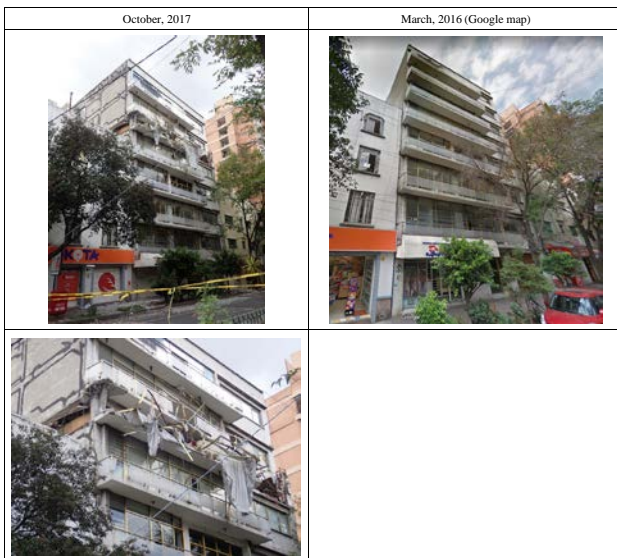
A particular case was the 8-story building shown in Figure 17. This building in Avenida Sonora had the collapse of the sixth floor. It was surrounded by lower buildings on both sides. A repair mark was observed on the side of the RC structure, which could indicate previous repairs in the building. A reduction in stiffness from the fifth floor to the sixth floor could have caused the loss of the latter.

Fig.17 Avenida Sonora 149, D5, Zone II

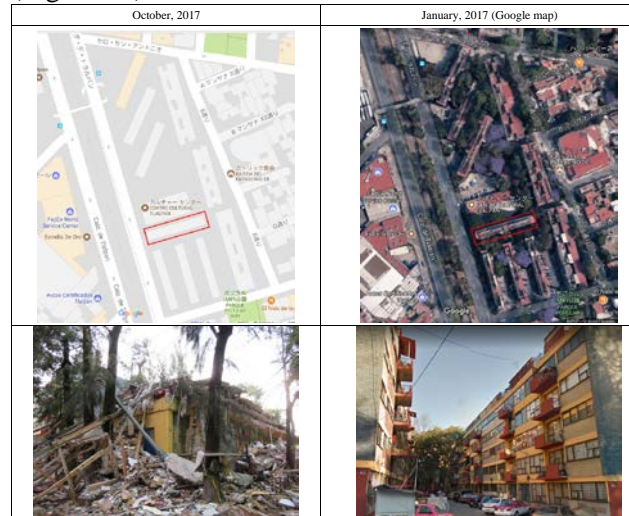
A residential building in Coyoacan collapsed after the shaking. The 5-story building was on a corner surrounded by trees and only the ground floor remained (Figure 18). The direction of this building was different from the surrounding buildings in the block, that were built at the same time, before the 1985 Michoacan Earthquake.

Fig.18 Residential building in Coyoacan, D5, Zone III

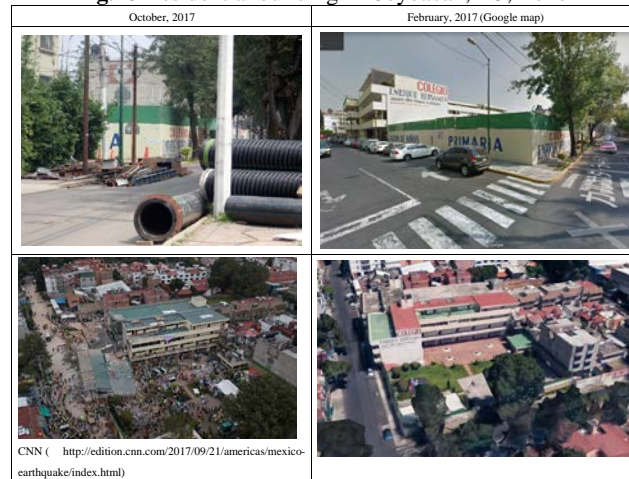
In the county of Tlalpan, several residential and commercial buildings were damaged in the district of Villa Coapa. One of the most relevant cases was the elementary school “Enrique Rebsamen”, in which one of the 4-story buildings collapsed completely (Figure 19).

Fig.19 School “Enrique Rebsamen”, D5, Zone III

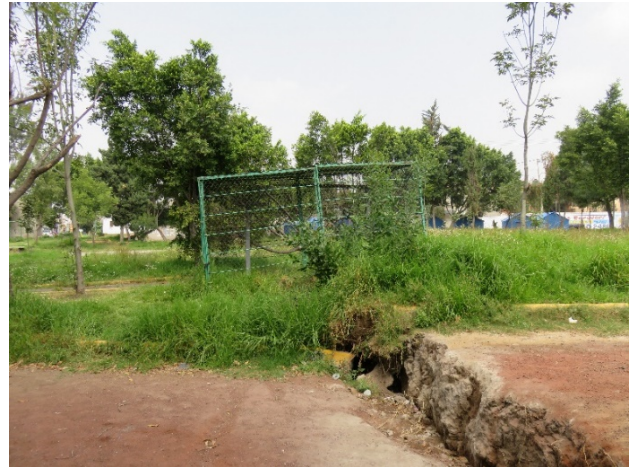
Site 1, in Fig. 23, is a park on the border between Tlahuac and Iztapalapa counties (Figure 24). In this area, the local government had previously built a subsidence monitoring station, that can be seen in the back, because the park had been settled for a while. However, a settlement of around 1 m was observed on the running track immediately after the earthquake, and on the date of the survey, the maximum settlement was 1.3 m.

Fig.24 Site 1. Settlement in a park

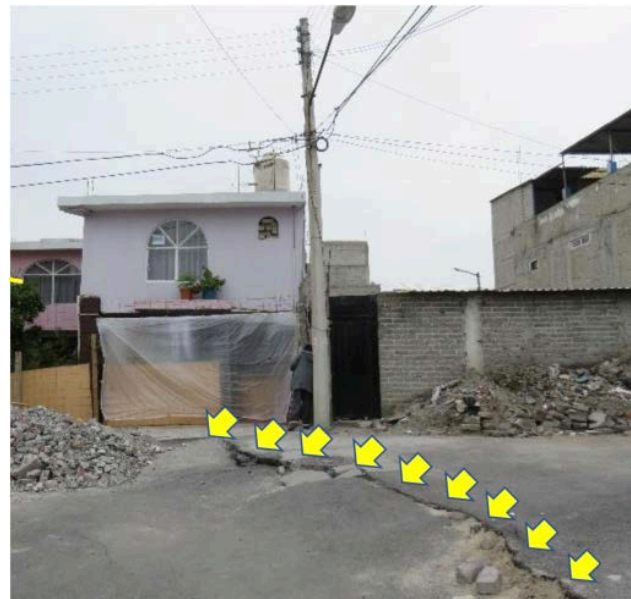
Site 2 was a house located in Oceano St. and Pingüino St., were the pavement displaced downwards in the transverse direction of the street (Figure 25). Inside the house, along the line of the outside

Fig.25 Site 2. House with a sinkhole

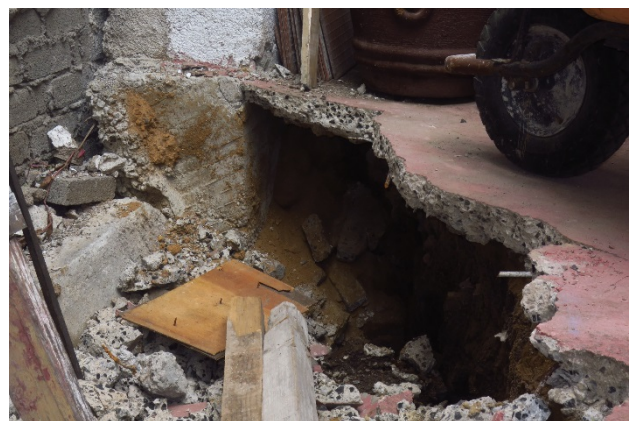
crack, an existing sinkhole expanded. The sinkhole opened the year earlier but the size significantly increased after the earthquake (Figure 26).

Fig.26 Site 2. Sinkhole inside of the house

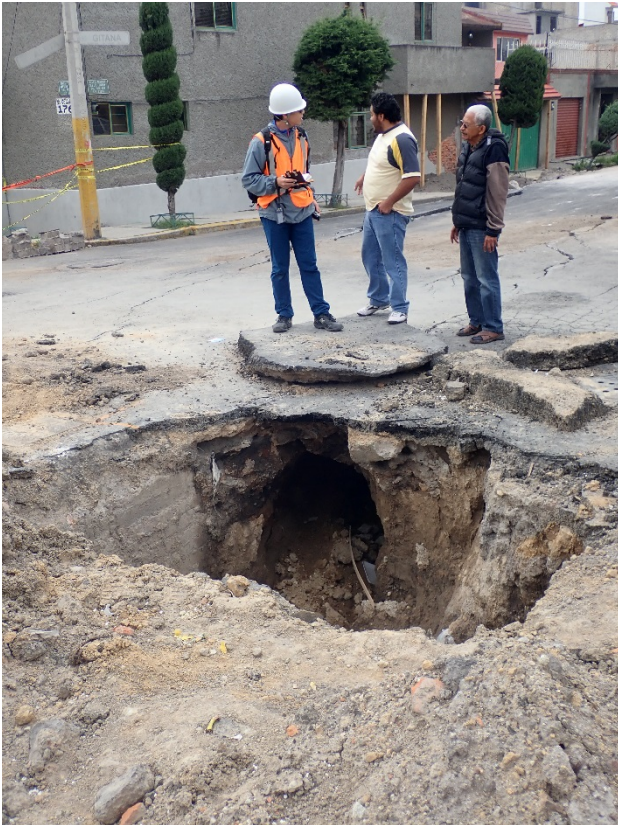
A similar phenomenon was seen in Site 3 (Figure 27), nearby Marist University, where a sinkhole expanded, exposing the pipelines under the street. The cavities inside might indicate that a process of internal erosion have been taken place for a long time, just as in other areas of Colonia del Mar.

Fig.27 Sinkhole nearby Marist University

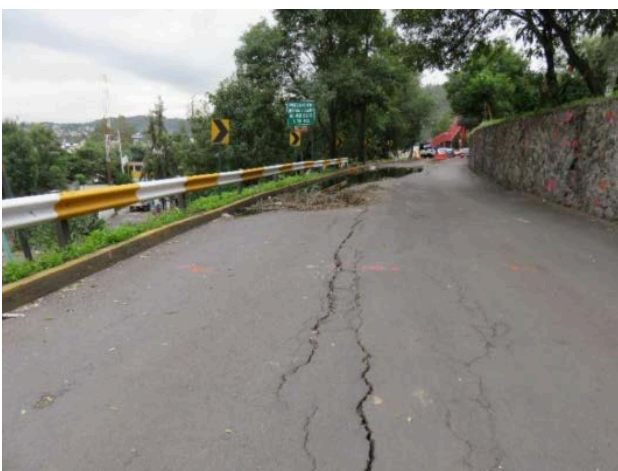
In the area of Xochimilco, one lane of the Tulyehualco-Xochimilco roadway had to be closed due to the appearance of longitudinal cracks and cavities of even 1 m depth (Figure 28).

Fig.28 Damage in the Tulyehualco-Xochimilco highway

Transit was restricted to one lane; however, it was learnt that in the working lane a sinkhole of about 0.7 m diameter and 5.3 m depth, opened six months before the earthquake and was filled weeks later. This indicates that this district, also part of the water extracting area, is prone to cracks and cavities.

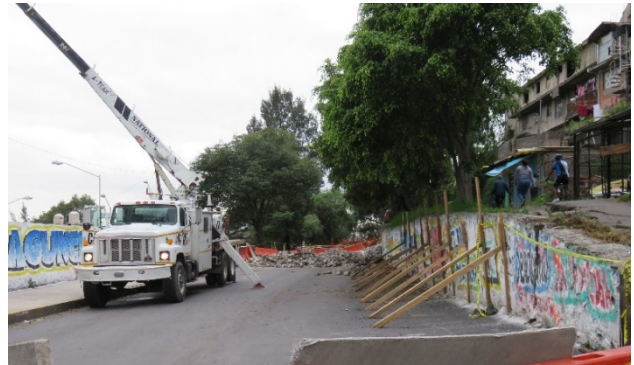
In this area of Xochimilco, houses are built on the slopes of the hill and after the earthquake, the retaining walls adjacent to the roadway leaned outwards (Figure 29). Besides, there were water outages and leakages in all the district; three weeks after the earthquake, the water service was not fully restored yet.

Fig.29 Inclination of retaining walls

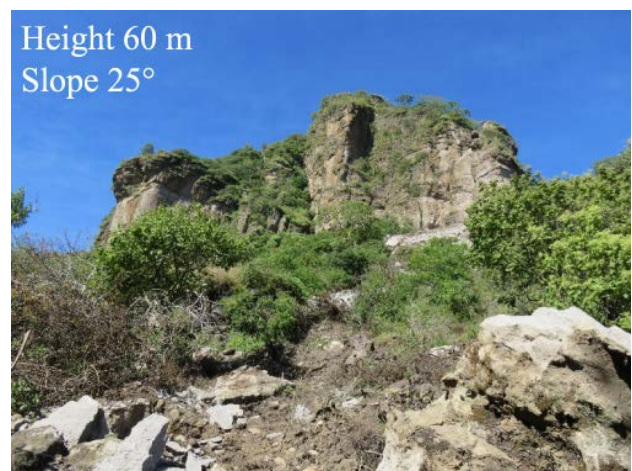
In the district of Piedra Grande, Tlayacapan, Morelos, the earthquake triggered a rock slide, that endangered more than 20 houses on the hill (Figure 30).

The rock mass (60 m height and 25° slope) exhibited fractures in the steeper areas. The fragments of tuff on the foot of the hill ranged from 30 to 50 cm diameter. Most of boulders (~1.5 m diameter) that slid were blocked by an older rock mass from a previous rockslide and just one hit a house in construction and perforated the wall as displayed in Figure 31. As told by the neighbors, the site has been threatened by the possible sliding of the rock mass for several years, but just after the earthquake people was told to evacuate

Fig.30 Rock mass in Tlayacapan, Morelos

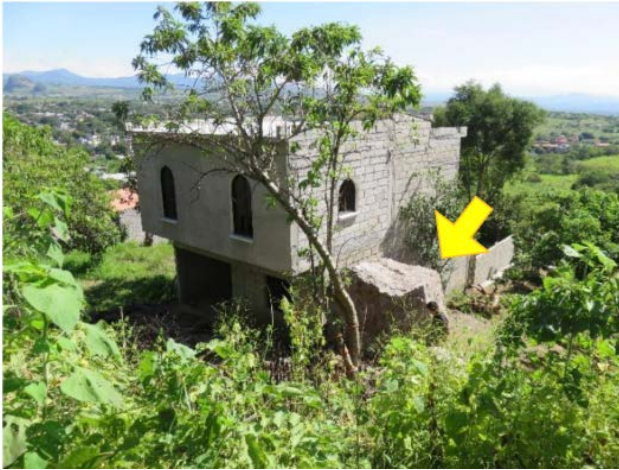
Fig.31 House wall destroyed by rock falling

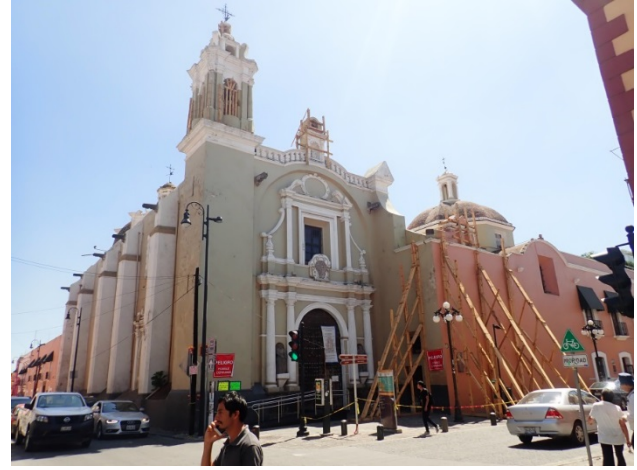
Fig.33 San Juan de Letrán, Puebla City

The church of San Juan de Letran had structural damage and was closed. The structure of masonry tilted and was supported by wooden beams (Figure 33).

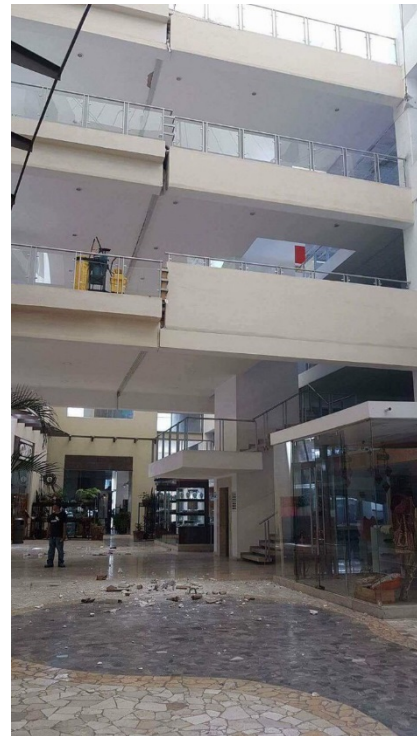
Besides the historical and religious buildings, new buildings experienced cosmetic damage and cracking. Structures such as the High Towers in Lomas de Angelopolis were built after the 1999 Tehuacan Earthquake and exhibited damage in the roof and the façade (Figure 34).

Fig.34 Plaza Sonata. Photo by Pilar García Téllez.

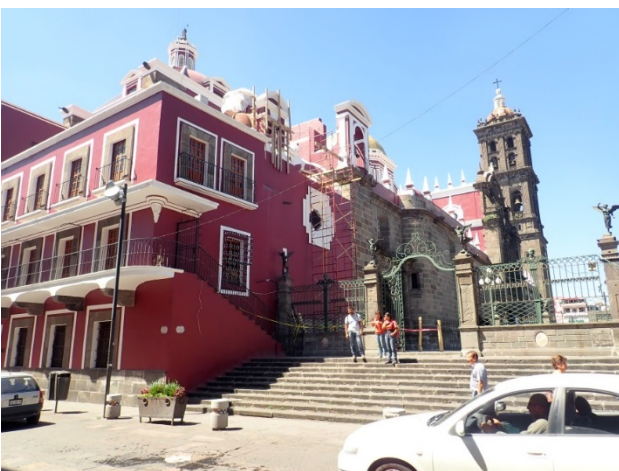
This time, the damage concentrated in the central part and historical buildings, where 34 properties had structural issues. There were cracks and cosmetic damage in the dome of the tabernacle at the Cathedral (Figure 32).

Fig.32 Cathedral in Puebla City
