Large ground deformations caused by the 2018 Hokkaido Eastern Iburi Earthquake

Key Facts

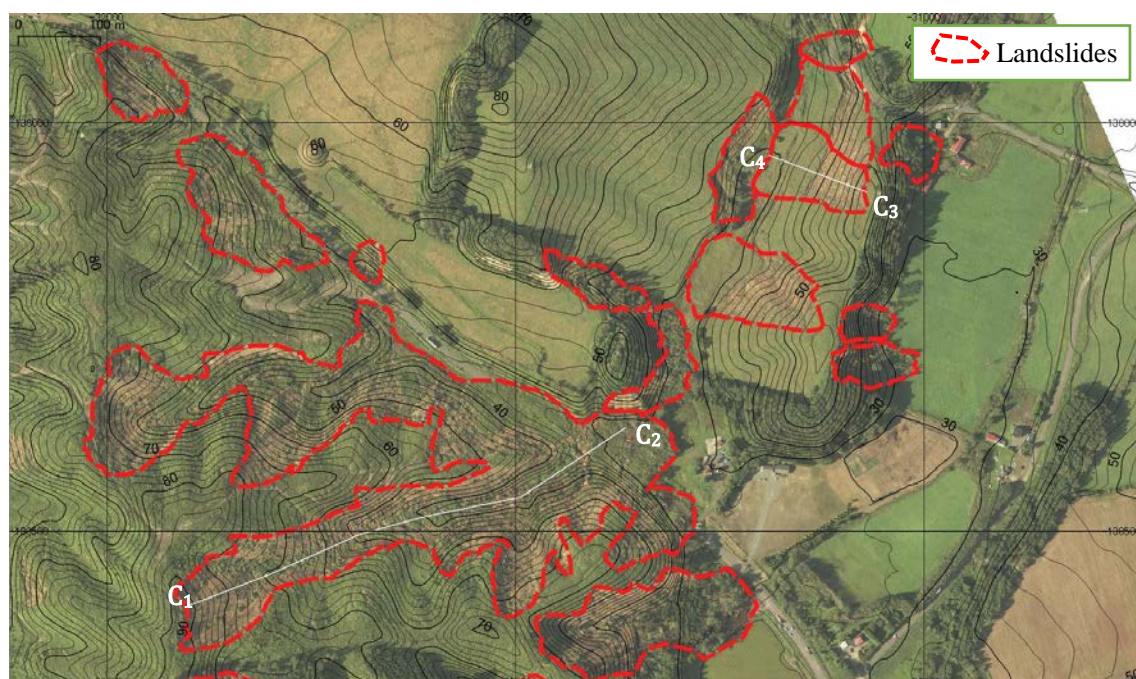
Fig. 1 Aerial photograph of Atsuma north area (Sept. 6, 2018, with the map square grid 500 m on each side on Zone 12 of the Japan rectangular plane, contour lines from the digital surface model from Geospatial Information Authority, Japan on October 1, 2016).

The central part of the prefectural road No. 10 connecting Hayakita area of Abira Town and Atsuma Town goes through hilly terrain with low altitudes of about 100 to 150 m at highest. Hill slopes along this road are typically very gentle as shown in Fig. 1. The digital terrain model (DTM), which was used to prepare Fig. 1, was made by the Geospatial Information Authority of Japan (GSI, hereafter) on Oct. 1, 2016 before the area was severely shaken by the earthquake. It is therefore to be noted that the contour lines do not describe any morphological change caused by this earthquake. An aerial photograph of this area, which was also taken by GSI on September 6, 2018, was georeferenced and laid over the DTM with the recognized landslide traces

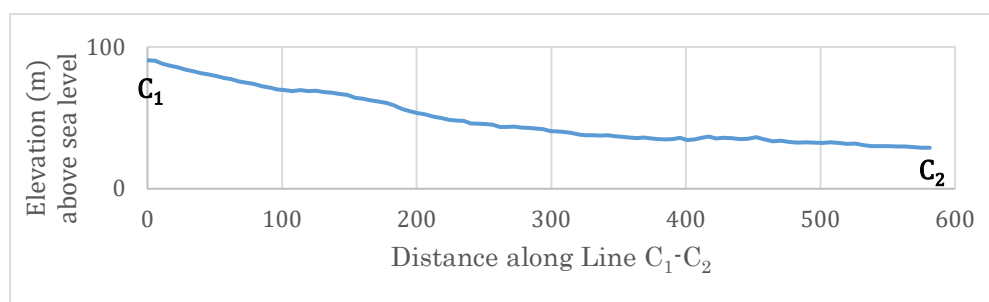
Fig. 2 Cross-section of the slope along Line C₁-C₂ in Fig. 1: The digital terrain model was prepared by the Geospatial Information Authority, Japan on October 1, 2016. Locations of C₁ and C₂ are (N42.7518°, E141.8603°) and (N42.7538°, E141.8668°), respectively.

marked with polygons of red broken lines. Landslide masses detached from hill slopes have traveled some ten to hundred meters long on gentle slopes and along existing shallow valleys. The cross-section C₁-C₂ in Fig. 1 along a shallow valley bottom is shown in Fig. 2. This cross-section shows that the landslide mass that have blocked the prefectural road No. 10 traveled along this extremely gentle valley with the average inclination of about 0.106, indicating that the mobilized frictional coefficient could have been as large as or smaller than this value, 0.106, with its toe part pressed against the opposite hill side. However, the scenario for the movement of this landslide mass is not that simple in that several soil masses detached from different locations on both walls of this valley have accumulated along the valley, and the toe part of the landslide mass may largely be from the nearest valley wall.

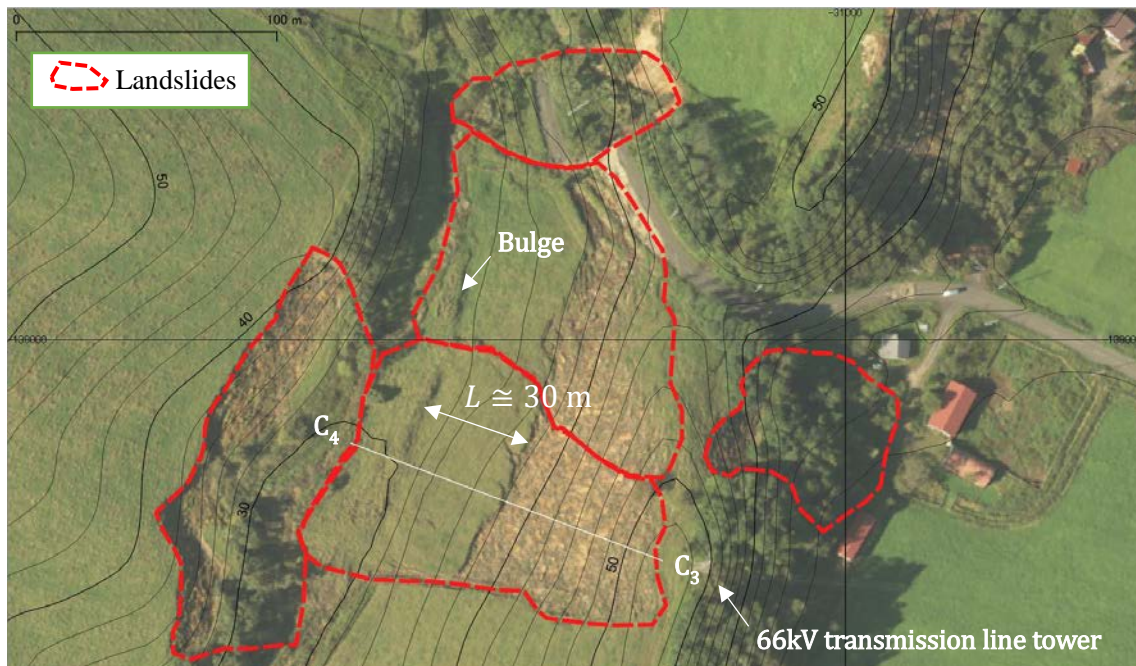
Fig. 3 Coherent landslide mass compressed against the other side wall of valley

To examine the mobilized frictional coefficient in a more careful manner, the movement of a single planar and coherent landslide mass that has slid along Line C3-C4 (Figs. 1 and 3) is discussed herein. This planar landslide mass, after sliding on the very gentle slope with the average inclination of about 0.2 (Fig. 4), hit the opposite wall of the shallow valley and stopped forming a transverse bulge as illustrated in Fig. 5. This bulge is assumed to have developed where two-dimensional wedges of passive soil failure

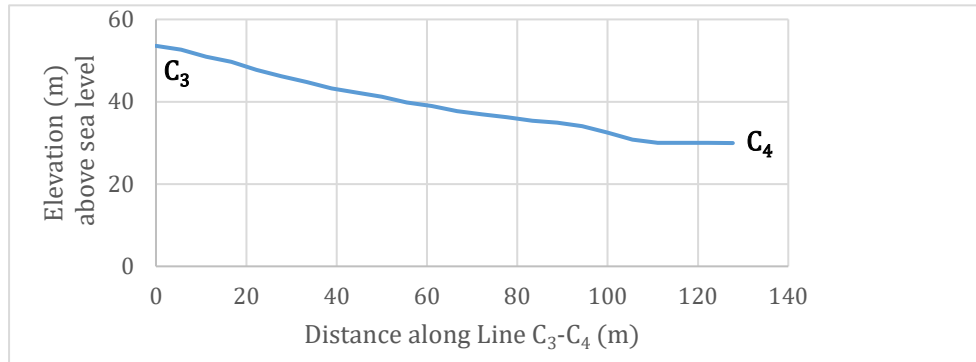
Fig. 4 Cross-section of the slope along Line C3-C4 in Fig. 1: The digital terrain model was prepared by the Geospatial Information Authority, Japan on October 1, 2016. Locations of C3 and C4 are (N42.75636°, E 141.8704°) and (N 42.7568°, E 141.8690°), respectively.

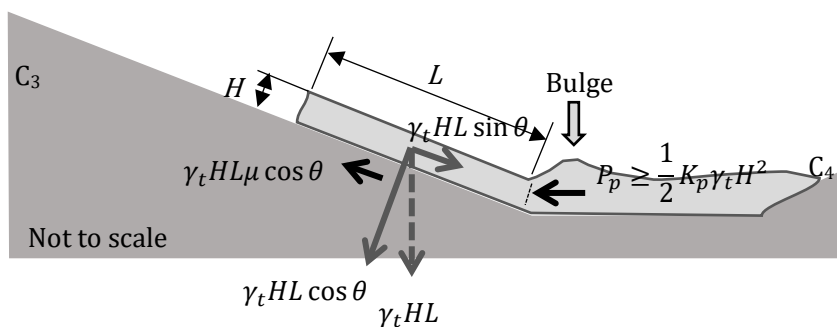
Fig. 5 Cross-section of landslide mass that has stopped moving being compressed against the other side wall of valley (not to scale)

formed one after another at the boundary between the toe part pressed against the opposite valley wall and the slowing tail part with the uniform thickness H as illustrated in Fig. 5. This tail part was gradually shortening until its final length of L was reached.

$$\begin{aligned} \mu &\leq \theta - \frac{1}{2} K_p \frac{H}{L} \\ &= 0.2 - \frac{5.83 \times 1.5}{2 \times 30} \cong 0.054 \end{aligned} \quad (3)$$

There are still much to examine to be sure, but this value suggests that the sliding surface beneath the landslide mass must have been very slippery like a banana peel. This landslide mass seems to have detached from the very top end of the slope just next to a 66kV transmission line tower. Though the both sides of this hill ridge have slid as shown in Fig. 3, the tower escaped from being taken away, though its foundations were exposed a little (Fig. 6).

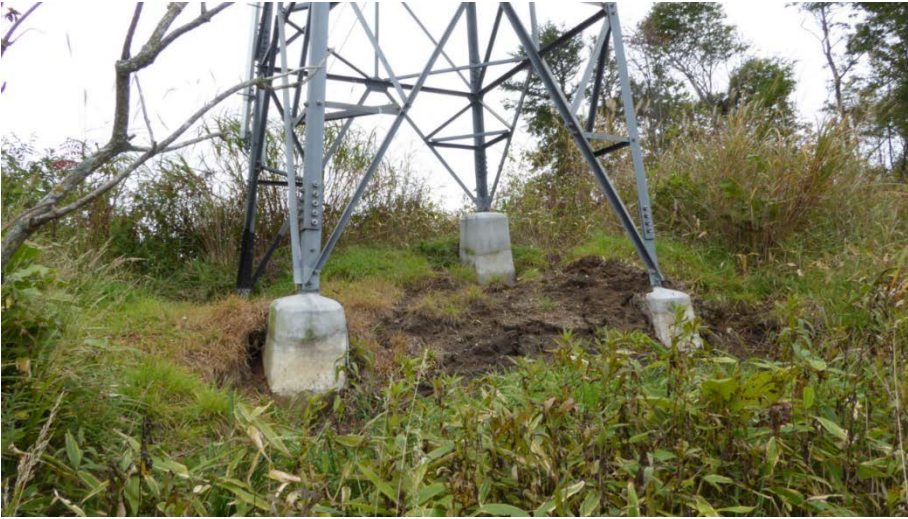
Fig. 6 Slightly exposed foundations of a 66kV transmission line tower
(Photo taken at N42.7563, E141.8704 near Point C₃ on Oct. 10, 2018 by Kazuo Konagai)

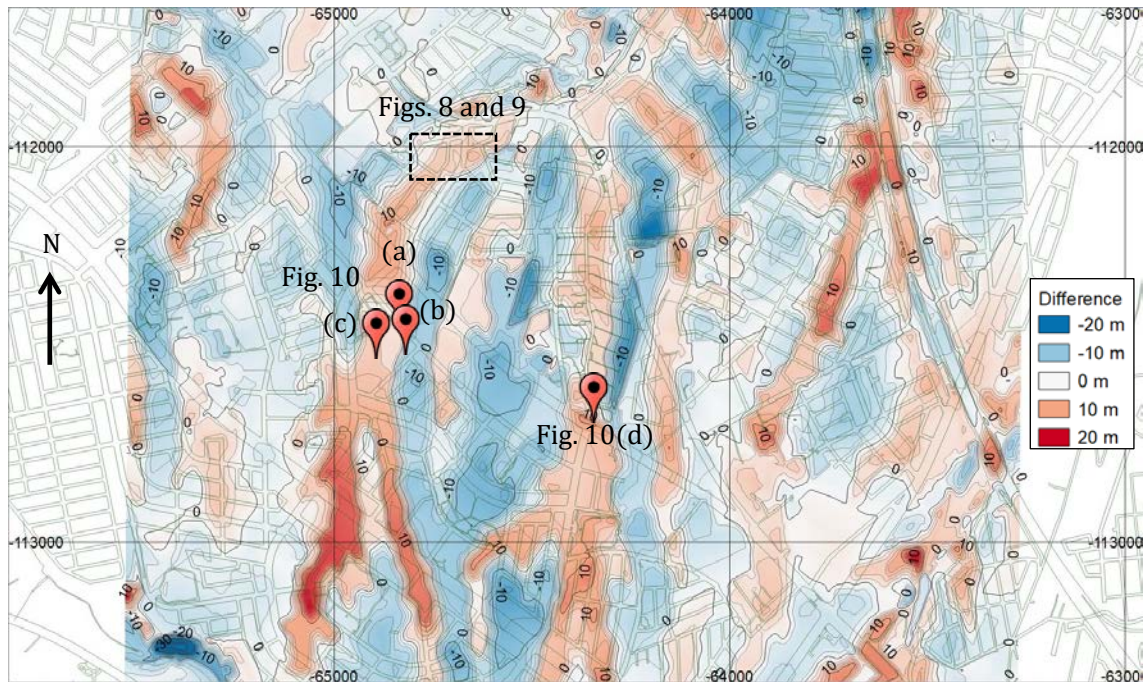
along old streams that underlie modern-era roads and were cutting the terrace of volcanic ash and clay 10 to 20 m down to lower elevations. These small valleys were filled with soils cut from the nearby terraces in the residential development from 1978 to 1980. Fig. 7 shows the change in elevation of the residential area. To make this map, a 1:25,000 scale terrain map of 1919 was first digitized, and then subtracted from the digital terrain model of Oct. 1, 2016. The severest swath of damage to houses associated with remarkable road subsidence was seen in the boxed area in Fig. 7. A pair of aerial photographs for this area shown in Fig. 8 were taken on September 13, 2018 by the GSI⁸⁾. These photographs put side by side can be perceived as a single image in terms of depth by cross-eye viewing. Immediately east next to the park shown in the upper parts of these photos, water is seen stopped indicating that this is a part of the swath of ground subsidence (Fig. 9). The lower (eastern) parts of the photos show that muddy mixture covers a large portion of streets.

Fig. 7 Change in elevation due to cut-and-fill: A 1:25,000 scale terrain map of 1919 was digitized, and subtracted from the digital terrain model of Oct. 1, 2016 (Zone 12 of the Japan rectangular plane). Damage to houses and ground subsidence were extremely serious in the broken-line boxed area.

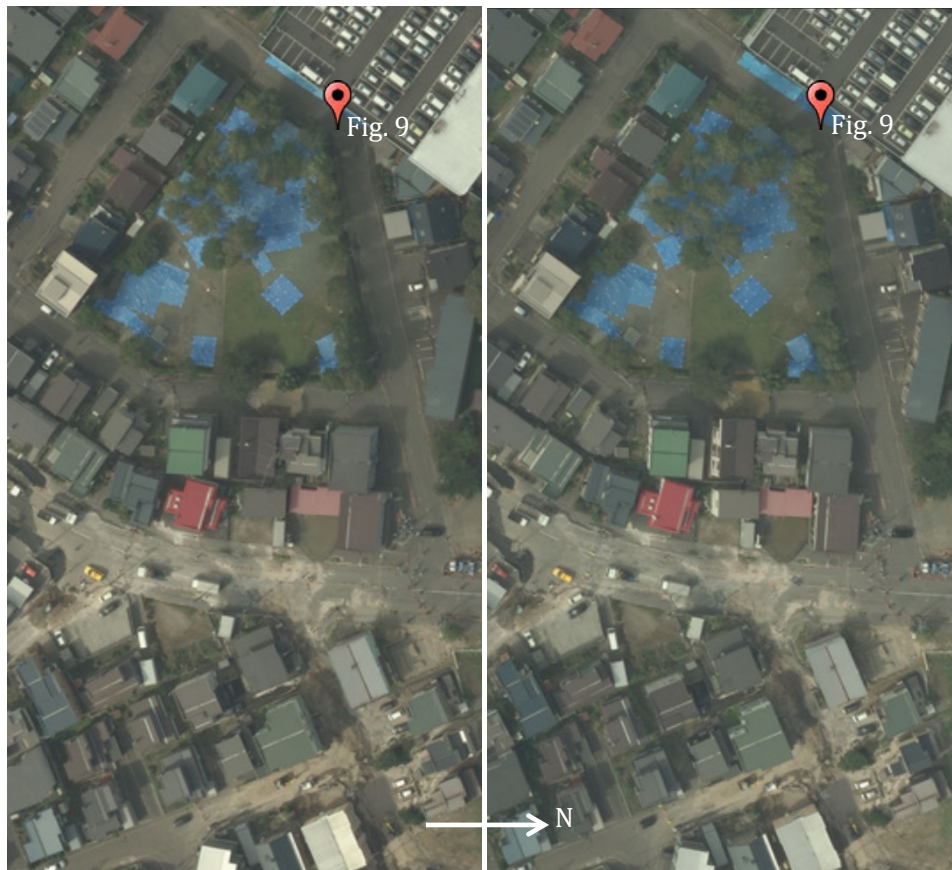
Fig. 8 A pair of aerial photographs of ground depression, Kiyota area, Sapporo: Photos were taken on September 13, 2018 by the Geospatial Information Agency, Japan.

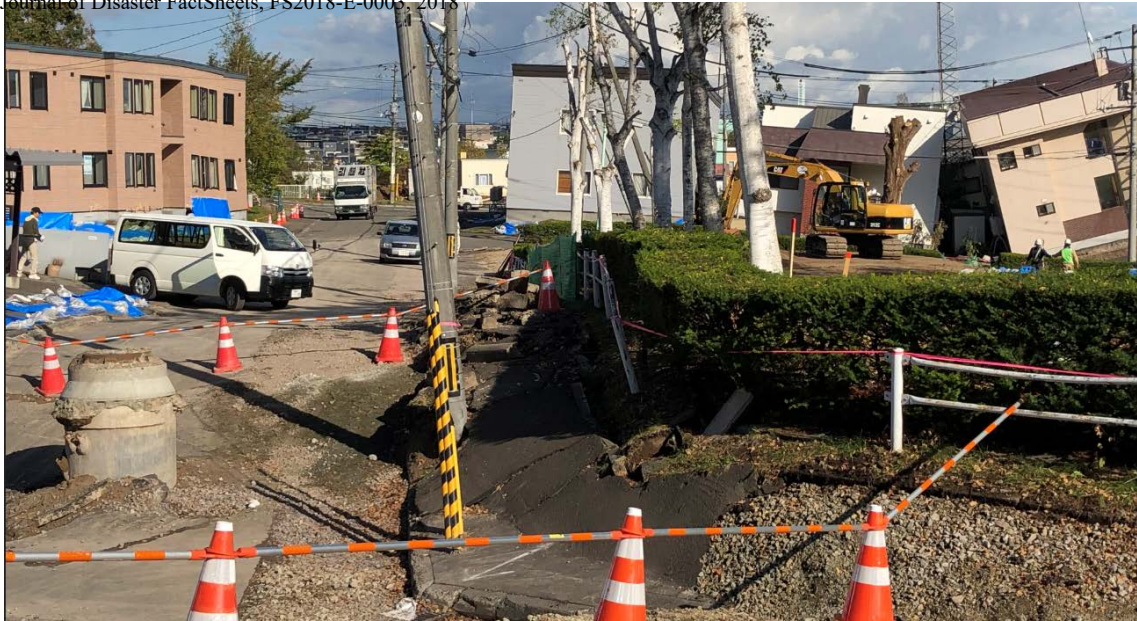
Fig. 9 Swath of ground subsidence in the boxed area in Fig. 7 (Photo taken on Oct. 8, 2018 at N42.9890°, E141.4555° by Daiki Kodama)

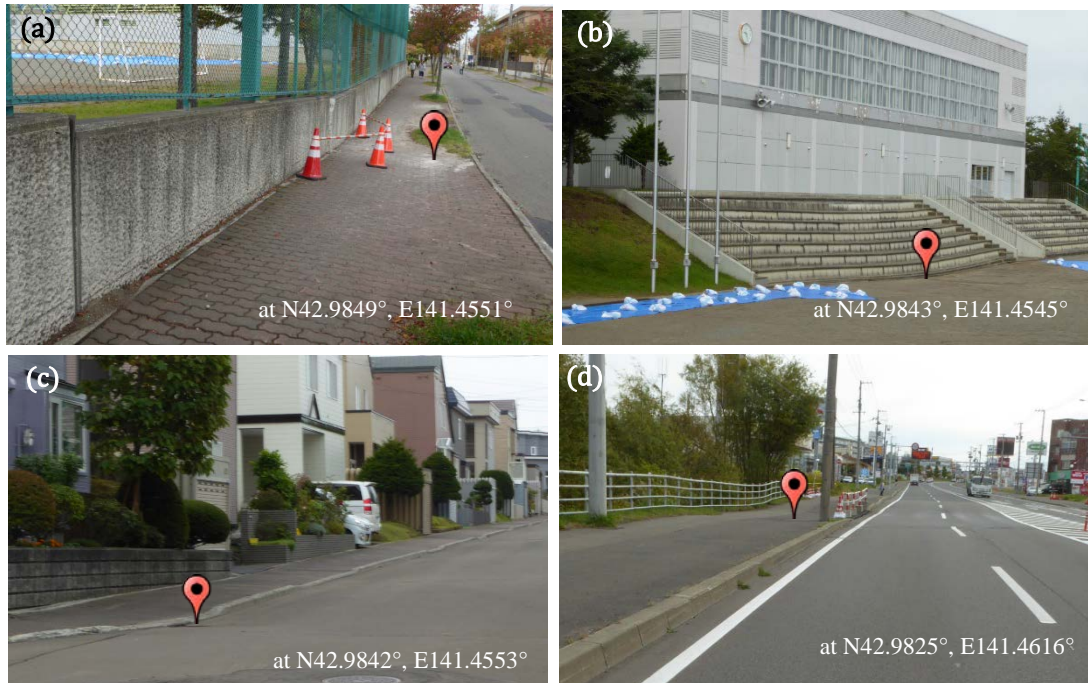
The swath continued further up along the old valleys as shown in Fig. 10 though the subsidence was getting less serious. Curiously enough, these swaths of ground subsidence are much narrower than widths of these old valleys. The swaths may have appeared above channels/ cavities that have developed underground through the filling of earthen material.

Fig. 10 Sunken roads in Sapporo's Kiyota Ward (Photos taken on Oct. 10, 2018 by Kazuo Konagai)

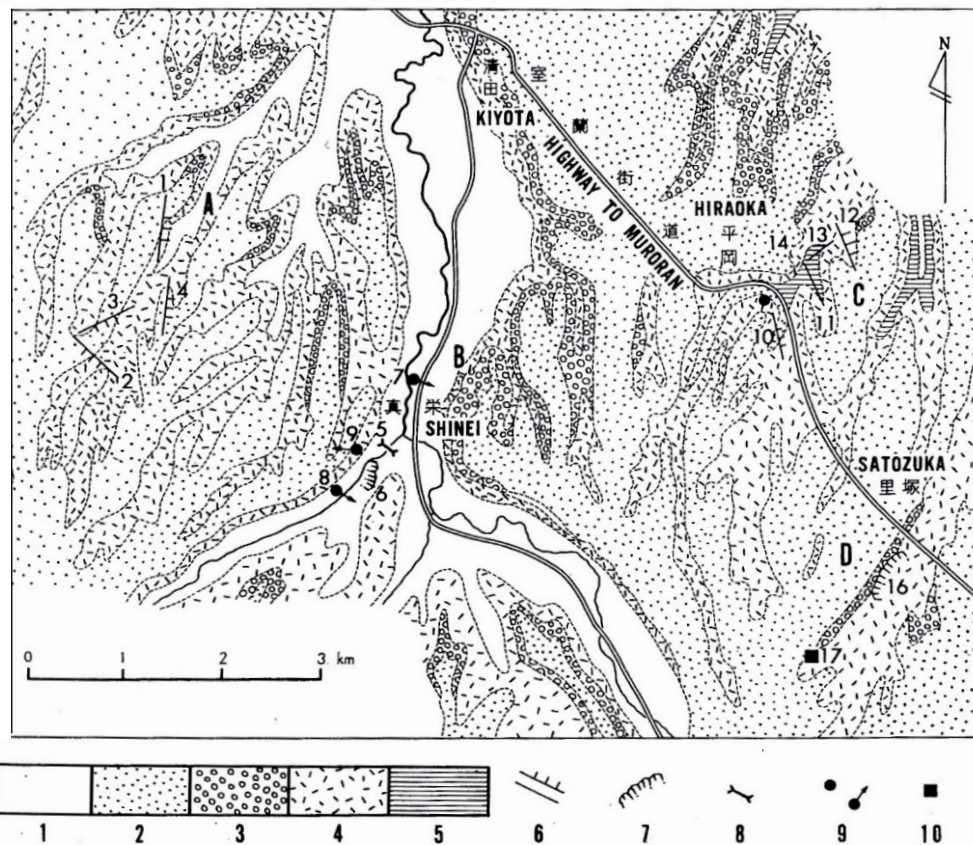
Tokachi, the thorough cut-and-fill work of the area had not yet started, and the surface geological map shown in the general damage report of this earthquake (Fig. 11)¹⁰⁾ says that there were pumice-

rich pyroclastic flow deposits and welded tuff exposed on the bottom of these valleys, which are now beneath filling earthen material. It is not clear yet how these soils (and maybe underground conduits

Fig. 11 Locations of geotechnical disasters in Kiyota ward in the 1968 Tokachi-Oki Earthquake: The figure above is from the General Report on the Tokachi-Oki Earthquake of 1968⁷⁾. When this earthquake occurred, cut-and-fill works had not yet started. This figure suggests that the landfills along valleys in this area underlay Shikotsu pumice flow deposits.
