# Preliminary Report of the Damage by the 2021 Off Fukushima Prefecture Earthquake Mj7.3, Japan

- Hazard Type : Earthquake
- Date of the disaster : February 13<sup>th</sup>, 2021
- Location of the survey : Fukushima and Miyagi prefectures, Japan
- Date of the field survey : February 15<sup>th</sup> and 16<sup>th</sup>, 2021
- Survey tools : Digital Camera
- Key findings:
  - (1) Minor damage due to soil liquefaction and ground deformation were found in Yamamoto Town and Soma Port.
  - (2) Damage, such as road pavement cracks, cracks around abutment and suspected liquefaction in Soma Overpass Bridge and Soma East Bridge are reported.
  - (3) Cracks and spalling due to shear deformation in horizontal beams of the frame piers of the Shinkansen viaduct near to Shiroishi Zao station were found.
  - (4) Damage to buildings was not severe compared to the measured strong ground motions.

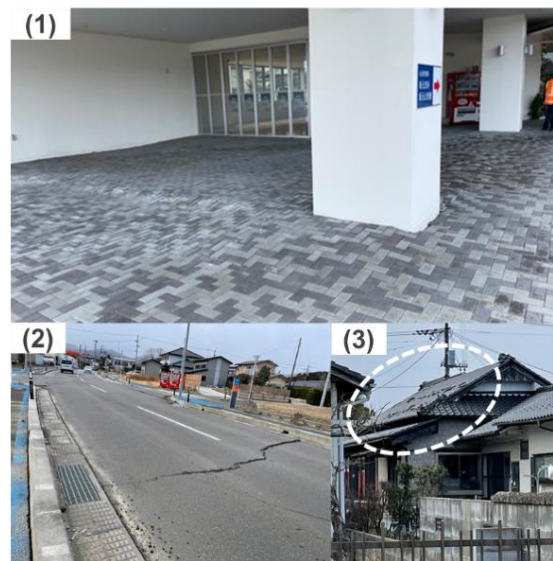
The 2021 earthquake caused minor geotechnical damage in a residential area in Yamamoto Town, Miyagi Prefecture. After the tsunami in the 2011 Tohoku earthquake, new residential houses and Sakamoto Branch Office of Yamamoto Town were constructed on the reclaimed land that was once paddy fields. Photo 1 shows aerial photos of the affected area taken in 2009 and 2021, respectively. Photos 2 (1) shows the damage observed around the Sakamoto

Branch Office. It was observed that the block pavement around the building foundation was deformed. This was due to the settlement of the reclaimed soil, and no deformation was observed at the building that is considered to have a good foundation. In addition, the road pavement at the north of the building had cracks about 5cm-wide running in the transverse direction of the road (Photo 2 (2)).

The area to the northwest of the branch office is a residential area that has existed since before the 2011 Tohoku earthquake. In this area, the 2021 earthquake caused roof tiles of several houses to fall off and block walls to lean in some places (Photos 2 (3)). However, there was no ground deformation-induced damage as in the new residential area, reclaimed after the 2011 earthquake. This clear distinction may be attributed to a difference in dynamic soil response characteristics of the reclaimed and the old districts.

**Photo 2** Various damage identified in Sakamoto residential area.

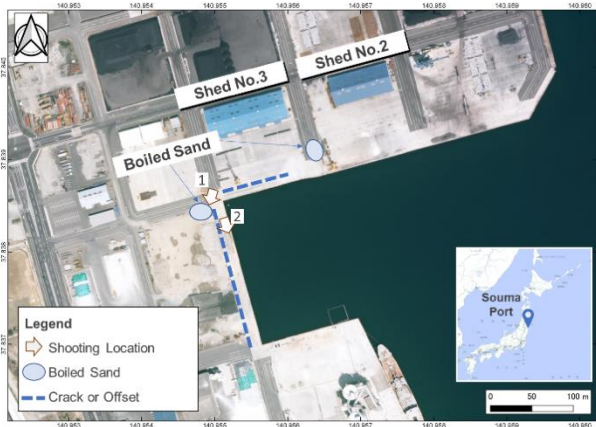
Fig.6 Observed damage map of Soma Port

Photo 3 and Fig.6 show the damaged site of No.2 quay at Soma Port in Fukushima Prefecture. As shown in Photos 3 (1) and (2), the 2021 earthquake caused liquefaction in the ground behind the quay wall and 10 to 20m long cracks with about 15cm opening parallel to the quay. The quay wall's concrete blocks were slightly inclined toward the sea, resulting in about 15 cm step. The 2011 Tohoku earthquake and subsequent tsunami of about 10 meters in height caused significant damage to Soma Port<sup>3)</sup>. However, the damage to port facilities caused by the 2021 earthquake was relatively minor and did not significantly disrupt port functions.

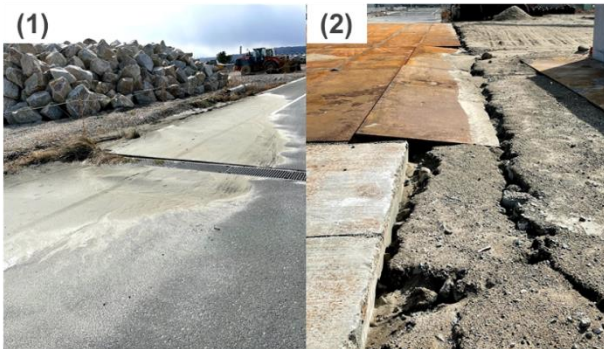
Photo 3 Liquefaction-induced damage in Soma Port

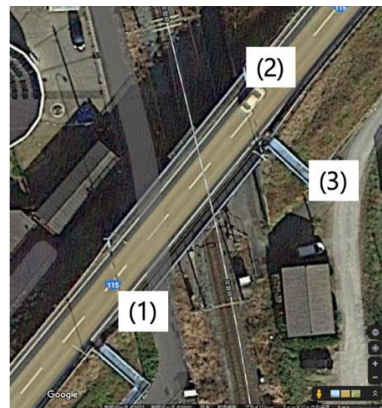
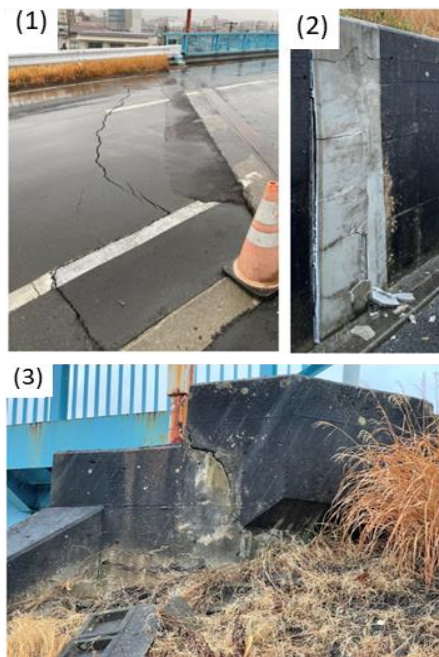
Soma Overpass Bridge is located at the south of the Soma Station (37°47'58.4"N, 140°55'36.1"E), crossing the Joban Line from southwest to northeast direction. It is a single span steel girder concrete deck bridge with five I shape girders, bridge fall prevention system. It is supported by two abutments supporting the girders with steel bearing. Expansion joints are installed in both sides of the girder to connect with the approaching road. Small step difference can be observed around the joints on both sides, as shown in Photo 4.

Road pavement cracks can be seen near the southwest joint in the abutment side, but not seen around the pavement of the bridges' northeast side. On both sides of the northwest abutment, cracks and damage was found. It can be assumed that the bridge moved toward northwest direction and pressed the northwest abutment, and pulled the southwest abutment, as can be seen in Photo 4.

Photo 4 Damage of Soma Overpass Bridge.

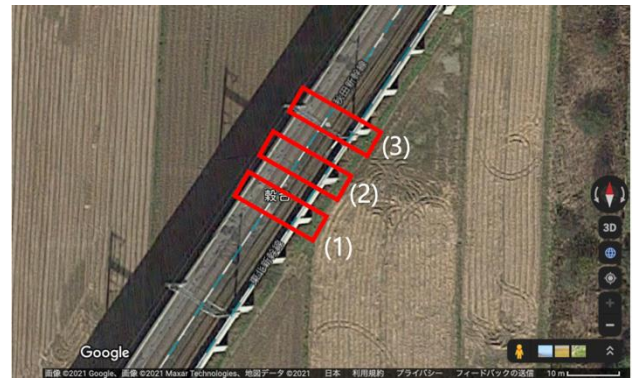
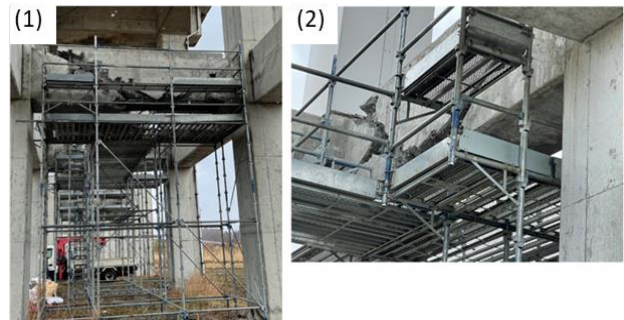
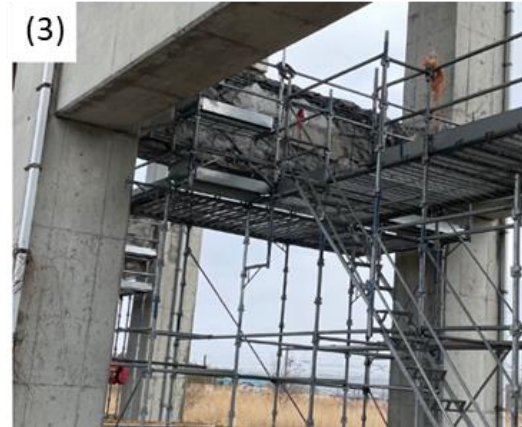
Typical shear damage can be seen in the horizontal middle beam in the frame of transvers direction of the continued two-direction frames as shown in Photo 6. Cover concrete spalling and steel bars exposition can be seen in Photo 6 (3). Similarly, other horizontal beams of near by frame piers also developed shear cracks, even without spalling of cover concrete.

Photo 6 Damage of Shinkansen Viaduct.

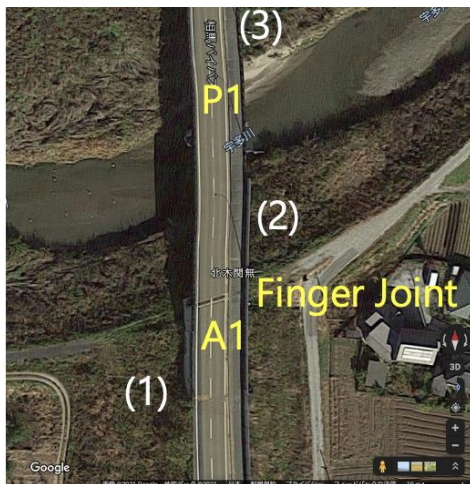
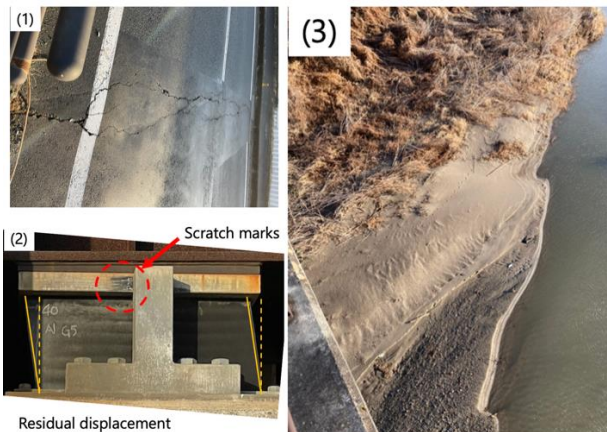
The locations of damage are marked in Photo 5. It can be seen that most of the damage outlooks are concentrated in the south side of the bridge around abutment A1. The residual shear deformation is observed at the bearing of the girder No. 5 at abutment A1. The damage is also marked by chalk. Road pavement cracks in south of A1 are clear with step difference.

Obvious vibration can be felt on standing by when heavy trucks are passing by. Under the P1 and A1, there are suspicious sands piles which may be caused by liquefaction.

From a brief observation, bearings are standing straight without tilting except those in A1. And the scratch marks caused by the two horizontal direction shaking of earthquake were observed in all of them. As been reported in the past, the movement of abutment due to liquefaction or nonlinear deformation of grounds may be the reason of the residual displacement on bearings of abutment and the pavement cracks on approaching road.

Photo 5 Damage of Soma East Bridge.

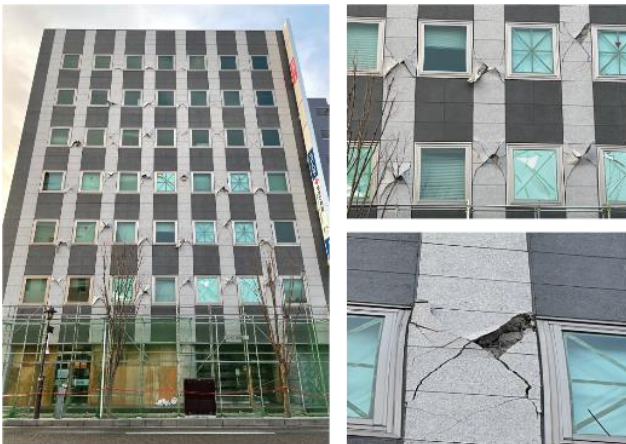
Several high-rise buildings in Koriyama City suffered relatively severe damage. Photo7 shows a reinforced concrete (RC) office building. The glass of windows on the first floor of the building was broken. Walls between the windows on the second floor and above had severe shear damage, and X-shaped cracks were clearly visible. The building shown in Photo 8 is approximately 500 m west of the building in Photo 7, also an office building of RC structure. The building has cracks at the joints of the components and at the corners of the windows inside the facade, and the tiles on the surface have fallen off, but they do not affect normal use.

**Photo 7** An office building in Koriyama City.  
(north elevation, east-west direction)

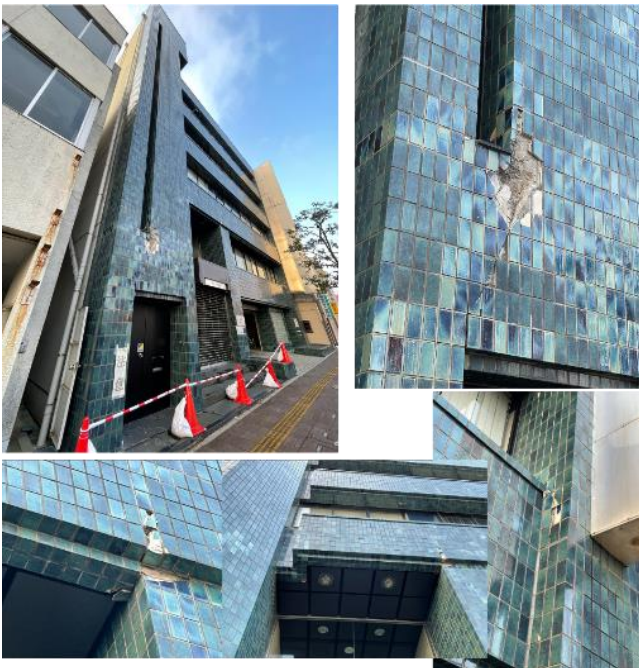
**Photo 8** An office building in Koriyama City.  
(north elevation, east-west direction)

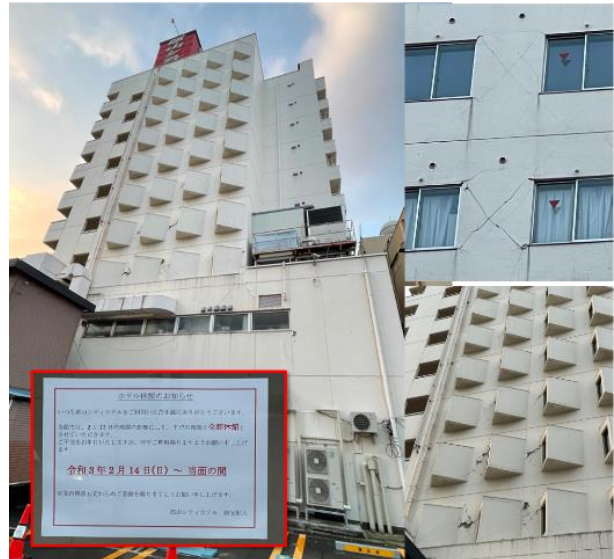
Photo 9 shows a hotel in the city. It is out of business due to the severe damage. Externally, an X-shaped shear crack can be seen on the wall between the windows. Photo 10 shows a library. It is out of service

**Photo 9** A hotel in Koriyama City.  
(west elevation, south-north direction)

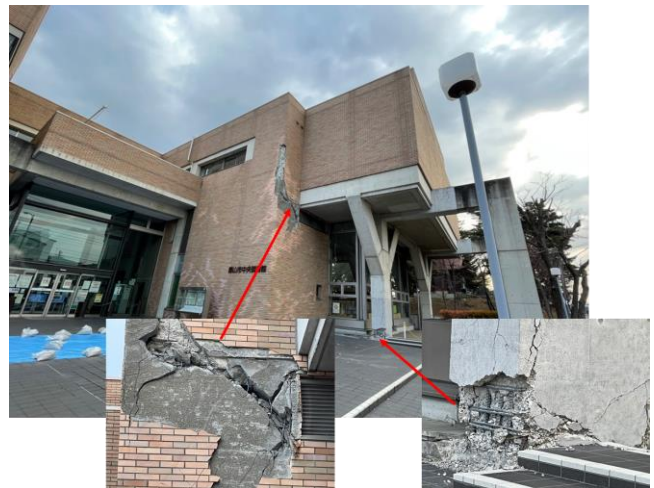
due to severe damage. The damage is mainly concentrated at the entrance of the building. The concrete at the foot of the reinforced concrete column supporting the superstructure was crushed, and the reinforcement was exposed and seated. The large vibration of the entrance structure caused large damage to the wall connected to it.

**Photo 10** A library in Koriyama City.  
(south elevation, east-west direction)

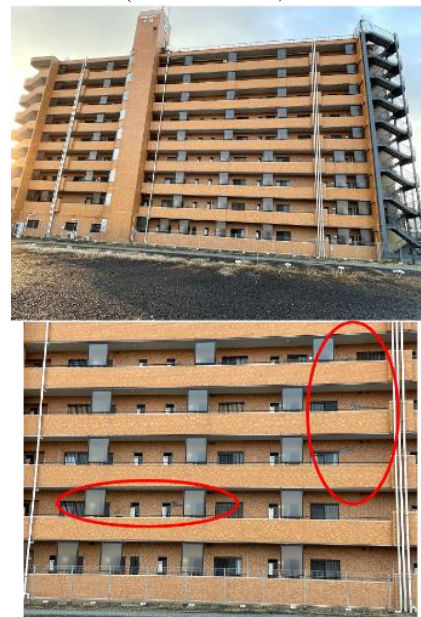
Photo 11 shows a steel-reinforced concrete (SRC) residential building. The building was significantly damaged during the Great East Japan Earthquake in 2011<sup>6)</sup>, and its strength was increased after seismic repair<sup>6)</sup>. However, a certain degree of damage was caused in this earthquake. As shown in the Photo, significant cracks were produced in the non-structural wall under the veranda on the north elevation.

**Photo 11** A residential building with SRC structure in Koriyama City.  
(north elevation, east-west direction)

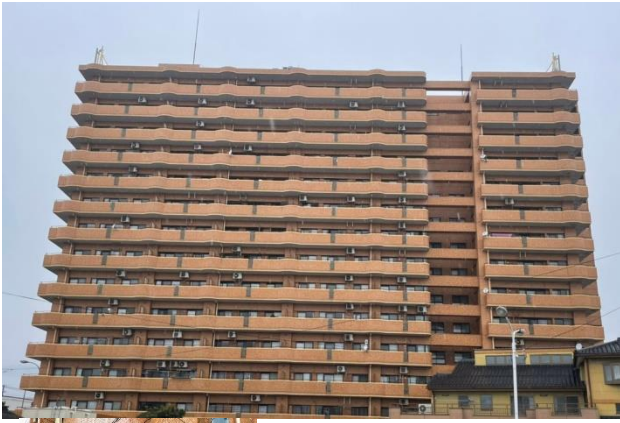
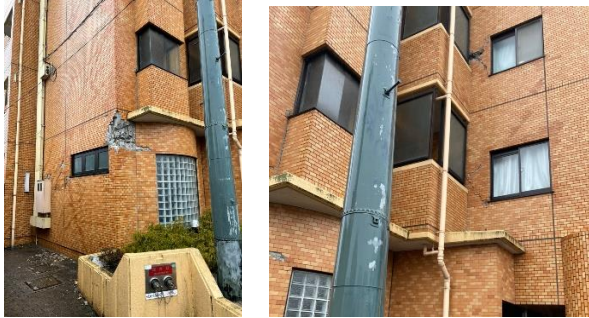
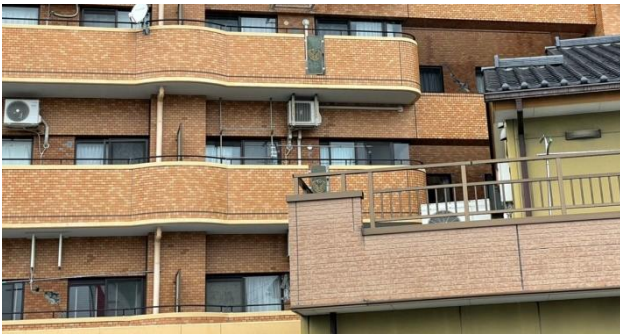
**Photo 12** A residential building with SRC structure in Fukushima City. (south elevation, east-west orientation)

According to the field survey, there appeared to be minor damage to buildings in Fukushima City. The building shown in Photo 12 and the building in Photo 11 are both SRC residential buildings, and the damage was similar such as the wall between the windows produced obvious cracks and concrete spalling. Also, the corner column on the 1st floor had large deformation near the column head.

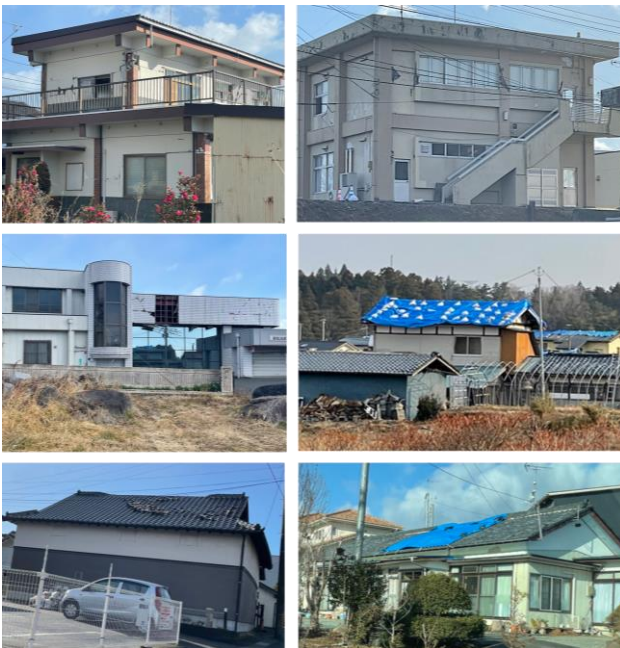
**Photo 13** Representative damage to house in Shinchi Town.

During the on-site survey we found that Shinchi Town, Soma District is a place with high concentration of housing damage. Photo 13 shows some of the representative photos of house damage. The two photos in the upper section show two RC buildings with cracks in the walls at the second story. The damage to the buildings in the middle and lower sections in this photo was in the form of typical damage, i.e., roof tiles peeling off. Also, as shown in Photo 14, the air conditioning system and the ceiling of the office building of Shinchi Town were damaged to some extent but did not affect normal use

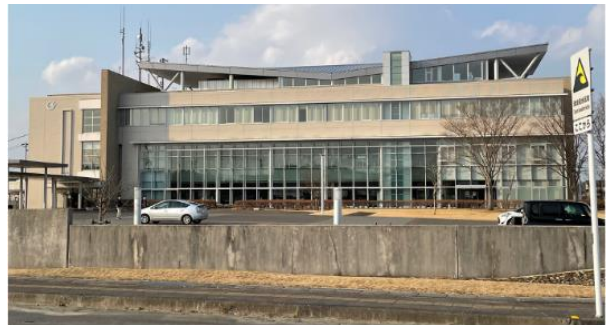
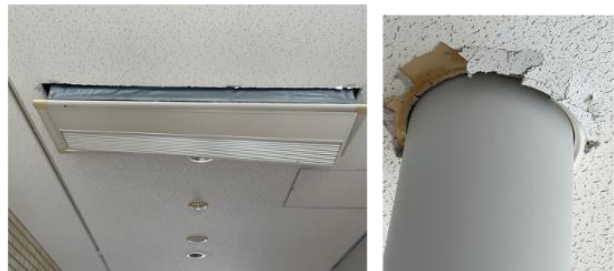
**Photo 14** Damage to the interior of office building of Shinchi Town.

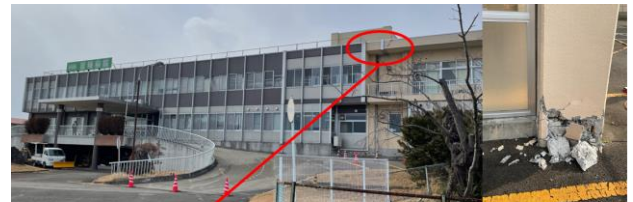
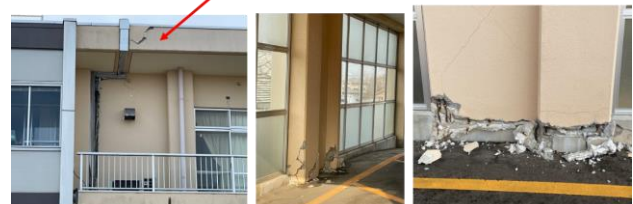
**Photo 15** Damage to Miyagi Hospital..

No extensive building damage was found near Yamamoto town at where the maximum acceleration of this earthquake was recorded. However, severe damage occurred to the buildings of Miyagi Hospital. As shown in Photo 15, the main part of the hospital building did not suffer significant damage. However, the branch building next to it was severely damaged, and the column feet were severely bent. Also, the water supply system of the hospital was damaged. In addition, as shown in Photo 16, the surrounding ground of the Disaster Prevention and Communication Center in Yamamoto Town was deformed. Though there was no damage to the building, the inside library was out of service due to severe scattering.

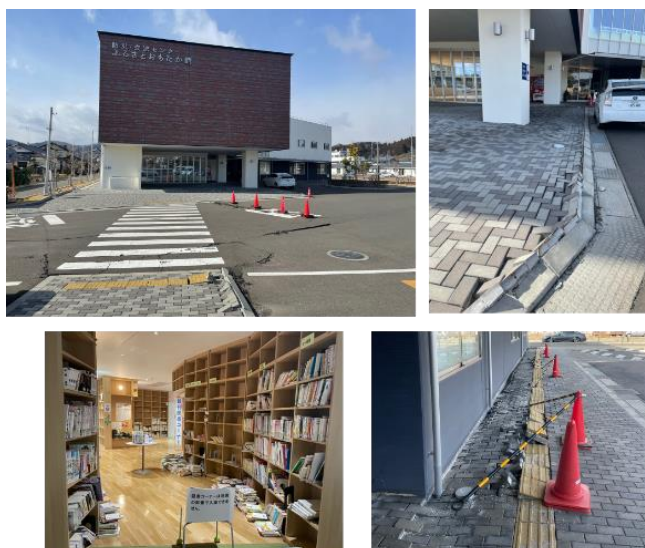
**Photo 16** Damage to Disaster Prevention Communication Center in Yamamoto Town
