Geotechnical Preliminary Report of The M_j 7.3 Fukushima Earthquake on March 16, 2022

Key Facts

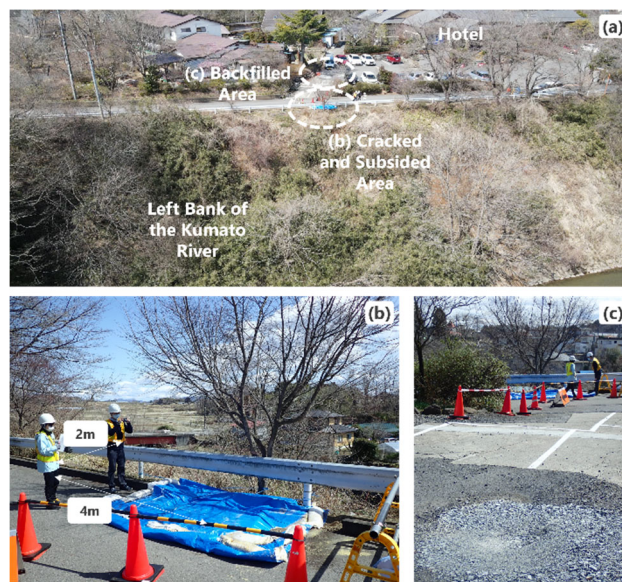
Fig.2 shows the damage on the shoulder of a local road next to a hotel facility, which stands over the Kumato River. Cracks or a cavity had developed over an area of 2m by 4m and were covered with blue sheets. Upslope of the ground settlement, there were traces of repaired works in the parking lot's pavement of the hotel. In addition, fresh soil could be seen in a hollow area on the downslope side. These suggest that the earthquake may have induced loosening of the cavity in the ground. Nevertheless, the UAV survey identified no significant deformation in the nearby bridge abutment or concrete revetment along the river.

Fig.2 Cracked and subsided area in Yabuki Town of Fukushima Prefecture (a) Whole view, (b) Subsided area of 2m by 4m, (c) Backfilled area in the parking lot

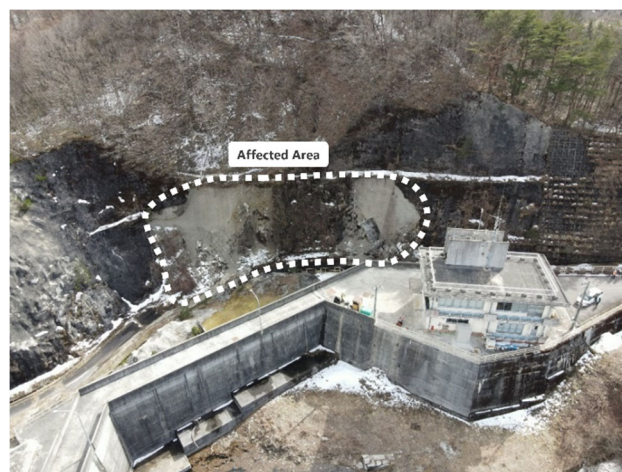
A small-scale slope failure occurred on the steep

slope along the Dake Walking Trail on the southern part of Dake Dam, as shown in Fig.3. The slope angle was about 60 degrees. The shotcrete facing the slope fell onto the path exposing the partially weathered mudstone behind. The geological map of AIST⁵⁾ shows that the local surficial geology of the adjacent area is classified as granite formed during the Cretaceous Period. Granite can lose its stiffness due to weathering because it contains compositional minerals with different coefficients of thermal expansion⁵⁾. Therefore, the shear resistance of the weathered mudstone was possibly exceeded by the sliding force during the earthquake event, causing shallow failure on the slope.

Fig.3 Small slope failure on the steep slope along the Dake Walking Trail

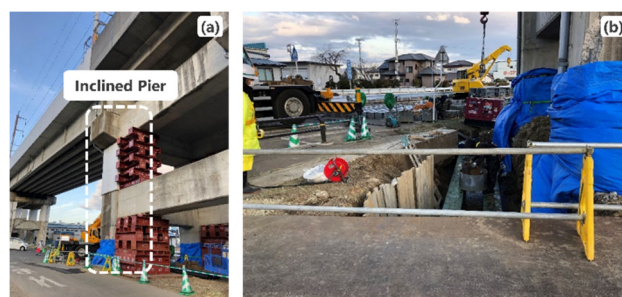
One Tohoku Shinkansen viaduct pier at 15km northeast of Fukushima Station suffered from tilting after the earthquake. The pier inclined towards the direction of the Shiroishizao Station. The lower part of the viaduct showed a typical shear failure; the failure of the cover concrete and buckling of the axial reinforcement bars, based on the preliminary report from the East Japan Railway Company⁷⁾. The direct cause of the shear failure can be attributed to the insufficient

shear strength of the pier because no land subsidence was observed around the pier. As shown in **Fig.4**, restoration works have been in progress to realign the harmed pier when our team arrived

Fig.4 Inclined pier of Tohoku Shinkansen viaduct in Kunimi Town

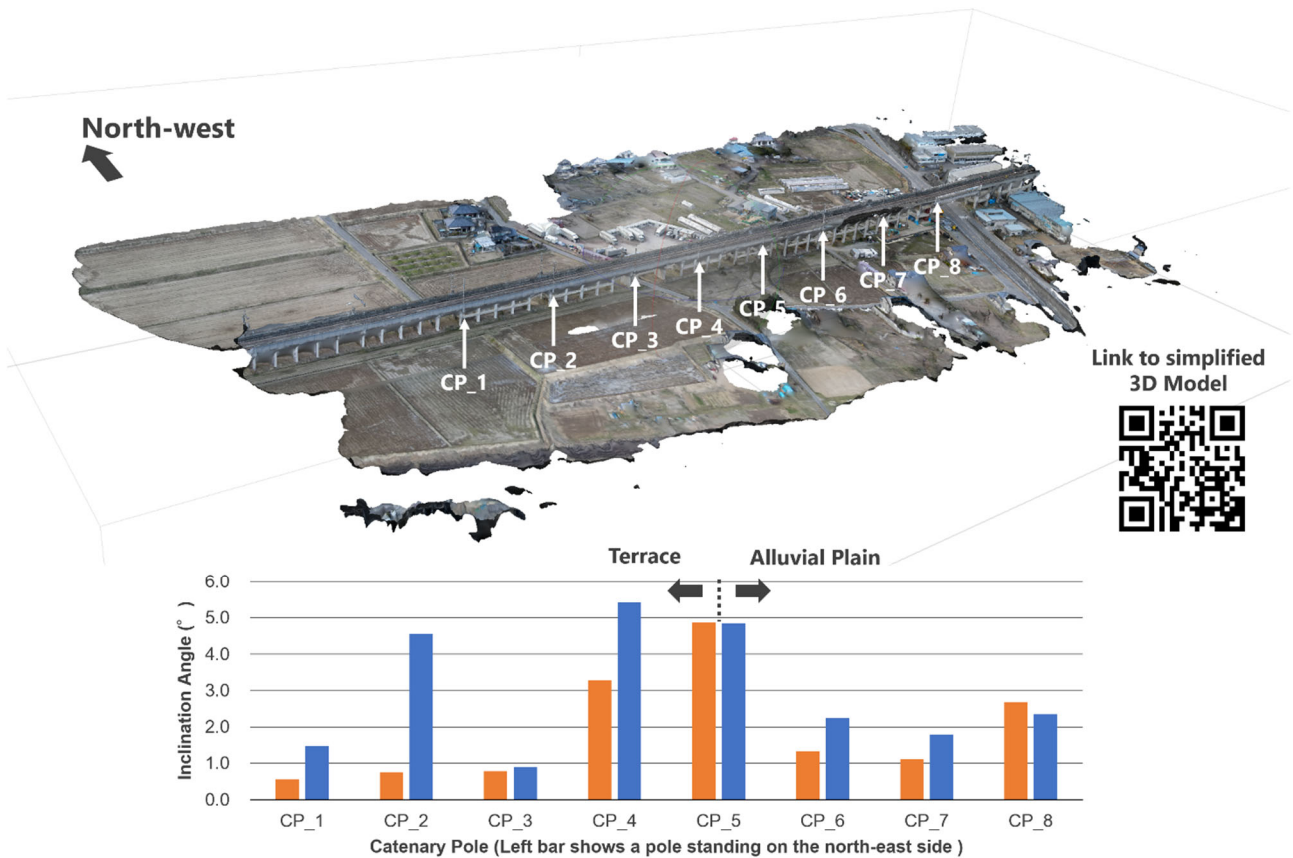
Fig.6 shows the absolute inclination angle of the catenary poles near the site, based on a 3D model created from the sequential images of the UAV⁹⁾. The pole above the inclined pier was named CP_8. The suffix number decreases as the pole is located west-southward. CP_5 is almost above the boundary between a lower terrace and the alluvial plain of the Takigawa River. **Fig.6** indicates that the angle of the poles near the boundary is larger than one in other areas. Although other factors such as pier length or steel lining may affect the pole behavior, the difference in the inclination angle implies the local topography changing the damage characteristics.

Fig.6 Absolute inclination of the catenary poles in the adjacent area. The decimated 3D model is available⁹⁾

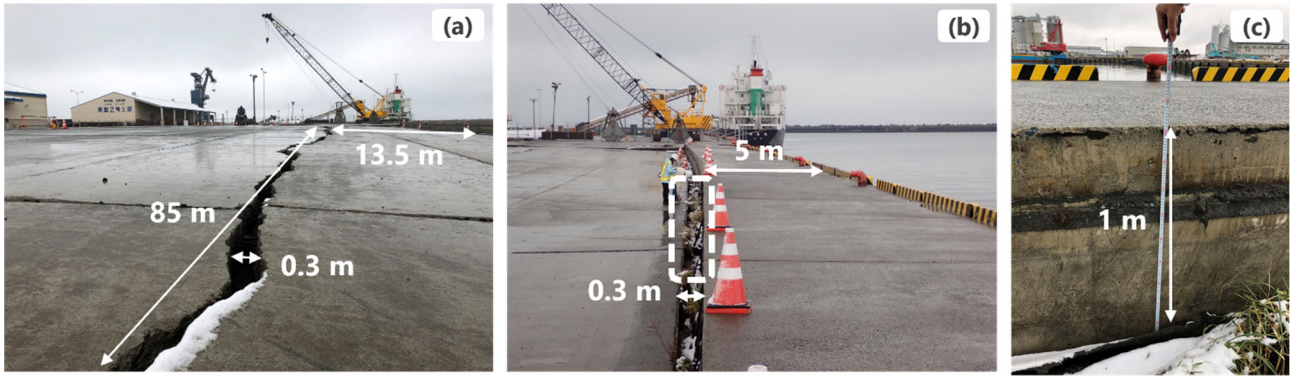
At Soma Port, ground settlement of approximately 0.5 m to 1 m was recorded at Quay No. 2, as shown in **Fig.7**. The 5m-thick quay wall concrete block has moved towards the sea by about 20 cm to 30 cm. A small amount of boiled sand was observed in the gap between the quay wall and the settled ground in the southeastern corner, in which liquefaction also happened in the 2021 Fukushima Earthquake. A simple sieve analysis was carried out with the sand ejecta to obtain the particle gradation curve. **Fig.8** indicated that D_{50} of the sample is 0.15 mm, and the curve was within the range particularly prone to liquefaction based on the guideline from MLIT¹⁰⁾. A similar deformation pattern was observed at Matsukawaura New Fishing Port, located southeast of Soma Port. In addition, extensive cracks with a length of 85m-100m and an opening size of about 30cm, parallel to the quay wall, occurred at about 14m from the quay wall. The resulting damage was similar to that caused by the 2021 Fukushima Earthquake¹¹⁾.

Fig.7 Cracks between the quay wall blocks

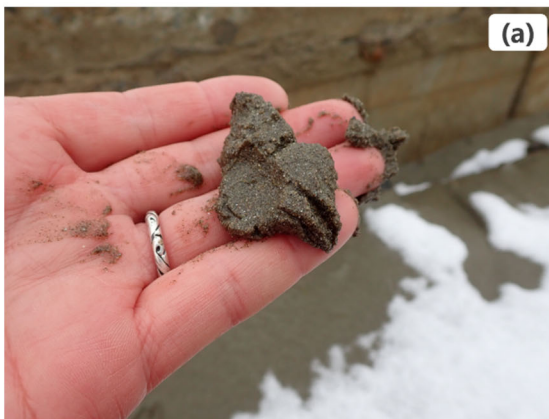
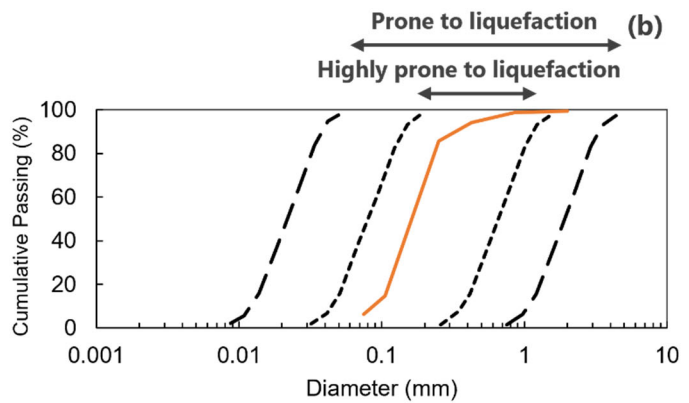
Fig.8 (a) Sand ejecta taken from a quay wall block, (b) Particle distribution curve and the diameter range of sand prone to liquefaction

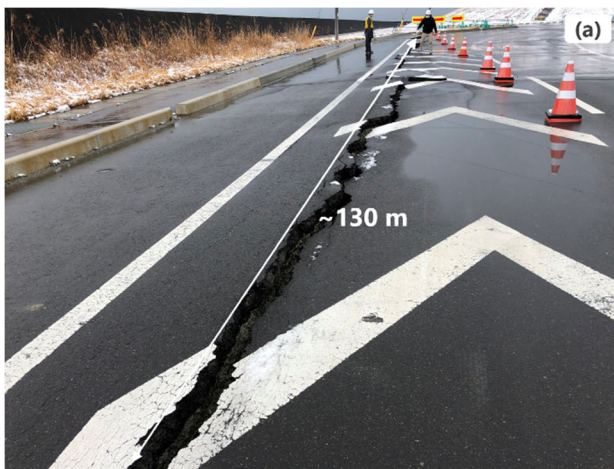
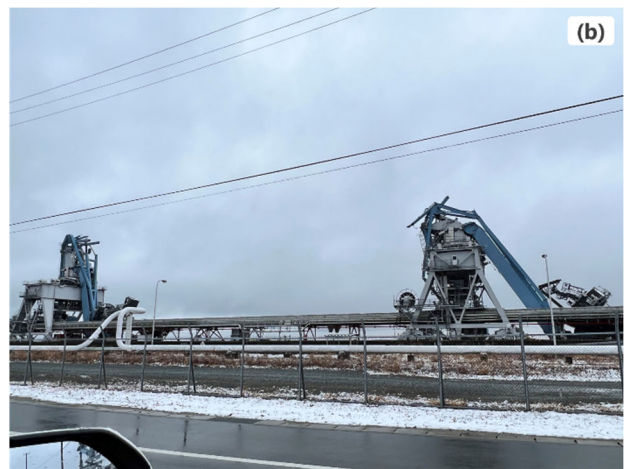
At Quay No. 5, a 130m-long crack was recorded on the carriageway (**Fig.9(a)**). There were small steps on the cracked road due to settlement. A slight displacement between seawall panels was also identified. Another implication of the earthquake was the destruction of two of the four coal unloading machines

installed at Quay No. 5, as shown in **Fig.9(b)**. This destruction has halted the operation of the Shinchi Thermal Power Station, severely affecting the electricity supply in the service area of Tokyo Electric Power Company (TEPCO) on March 22nd, 2022.

Fig.9 (a) a 130m-long crack on the carriageway in Quay No. 5, (b) Coal unloading machine with ruptured transverse beam

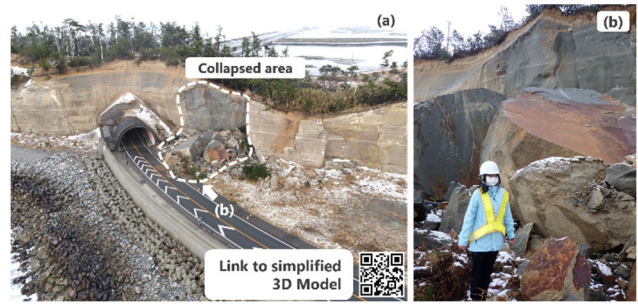
Rock slope failure was triggered by the earthquake at the northern side of the tunnel portal of Unoomisaki Tunnel along the 2-lane carriageway of Matsukawaura Bridge, as demonstrated in Fig.10. From the 1:50,000 Geological Map of the Soma-Nakamura District, this region is composed of greenish-gray mudstone (D2) of the Pliocene Dainenji Formation¹²⁾. With the observation of some several cm thickness

sandstone layers, the bedding plane orientation in this area is almost horizontal. The slope is prone to rockfall failure because it is divided by multiple vertical joint sets. Rockfalls could have taken place following the vertical joints that are orange-brown and show significant signs of chemical weathering brought by seepage. The rock boulders were as large as 5 m wide. Collapsed electricity poles, rock and surface soil debris, and pine trees on top of the cliff blocked a small part of the carriageway (Fig.10 (a)). The extent of the rockfall was estimated to be about 15 m in breadth.

Fig.10 Rock failure at the northern side of the tunnel portal of Unnomisaki Tunnel (a) Whole view, (b) Fallen rock

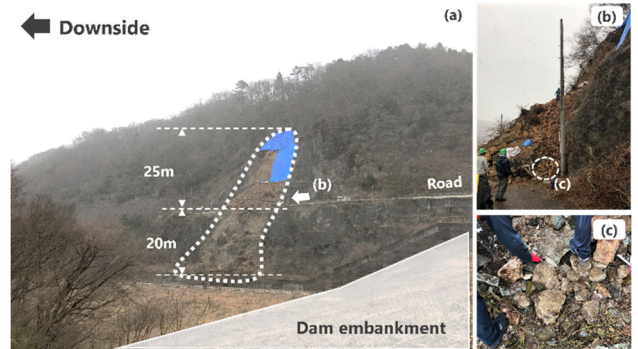
A massive landslide was inspected along the road leading from the top-left water dam and the dam office (Fig.11). The landslide debris of shotcrete, rock, mud, and trees entirely blocked the 4m-wide road. The debris mass continued to run out downslope to the top part of the spillway structure overlooking the Masuda River. The average slope inclination was between 50 degrees and 60 degrees. The crest of the scarp area was located about 25 m high from the road level. The width and depth of the landslide were about 20 m and 1 m, respectively. The failed section was of the largest height compared to the adjacent slope reinforced by shotcrete. The collapsed soil mass mainly comprises brown, slightly weathered gravels.

Fig.11 Steep landslide at the downside of Tarumizu Dam (a) Whole view, (b) debris crossing the road, (c) partially weather rock in the debris

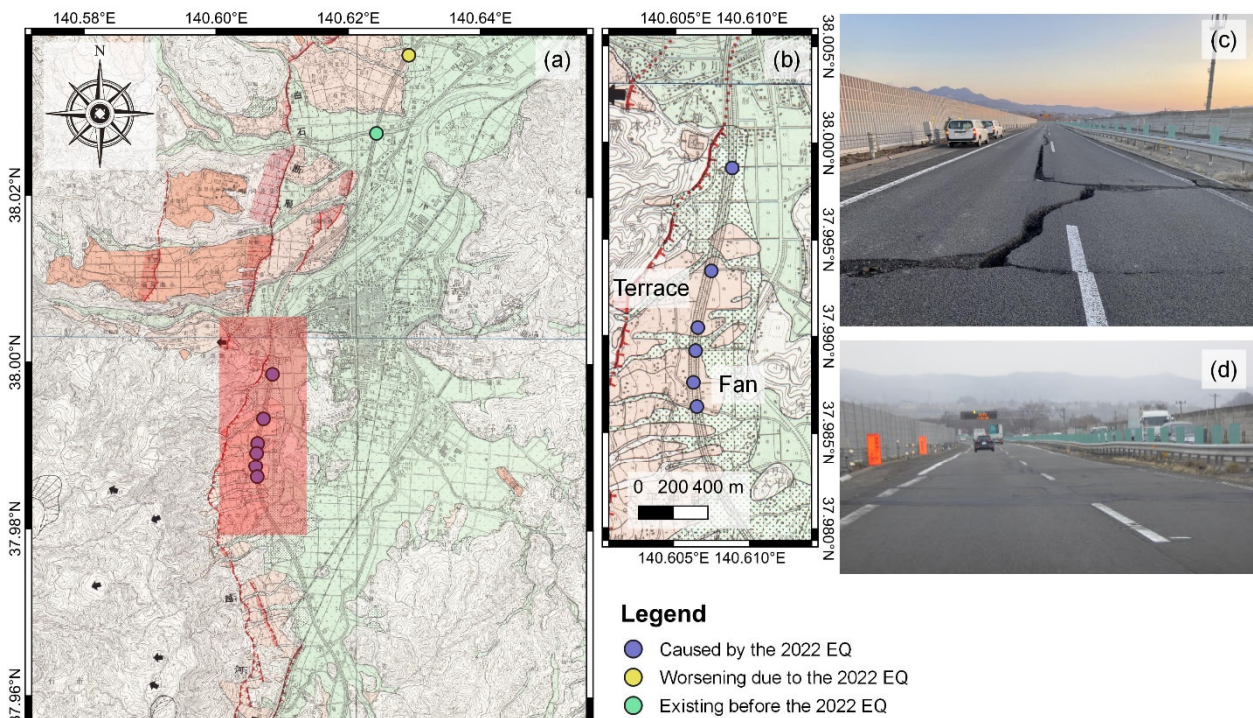
Fig.12 Cracks distribution appeared in the section from Kunimi to Shiraiishi of Tohoku Expressway (a) Whole Map, (b) enlarged map, (c) captured cracks by NEXCO¹⁵⁾ soon after the earthquake, (d) repaired pavement on April 23rd

The Tohoku Expressway was affected by moderate ground cracking and settlement associated with the 2022 Fukushima Earthquake (**Fig.12**). Many bumps were present during a brief survey driving north on the Tohoku Expressway. An approximately 50 m long retaining wall seems to have been damaged as it was under immediate recovery works.

By comparing the observations from the reconnaissance survey against Google Street View as of August 2021, a preliminary analysis of the distribution of ground cracking was carried out. As presented in **Fig.12**, cracks induced by this 2022 earthquake were identified at localities marked by blue dots. Yellow dots indicate cracking locations that propagate after the ground shaking, while gray dots are locations with existing cracks. The new cracks occurred mainly in the vicinity of the boundary between the box culvert and embankment regions. They are also concentrated on the western side of Shiroishi City, for instance, near Box Culvert Kunimi 65, 66, 67, 69, 71, and 75.

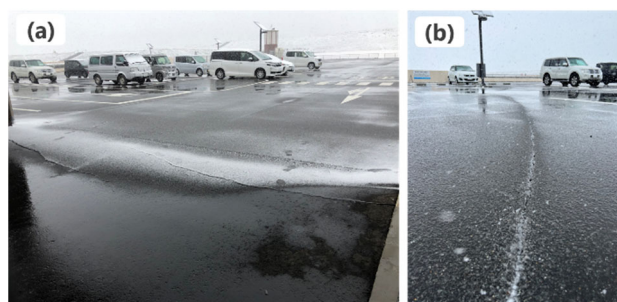
Slight ground surface damages were observed in the vicinity of Arahama Fishing Port. For example, a crack was found at the bottom of an electric pole near a hotel (**Fig.13**). In addition, some cracks and ejecta in the Torinoumi Park close to the sea wall have been identified by a resident, as shown in **Fig.14(a)**. Wakamatsu¹⁵⁾ found a similar pattern of sand ejecta and ground fissure after the 2021 earthquake at the same location (**Fig.14(b)**) and indicated that the liquefied area is located near a shoreline in the latest reclaimed area of the port.

Fig.13 Cracks on the pavement of the parking lot of a hotel

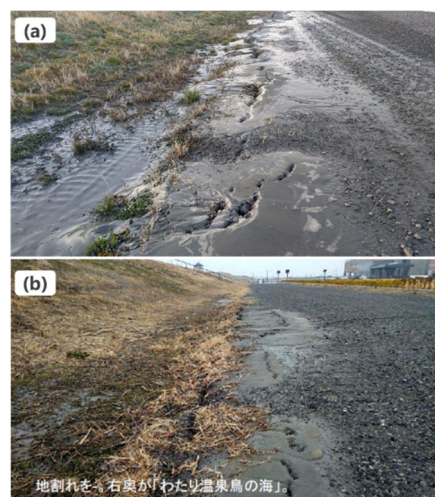
Fig.14(a) Sand ejecta after the 2022 earthquake captured by Mr. aito, a local resident, **(b)** sand ejecta after the 2021 earthquake at the same location¹⁵⁾

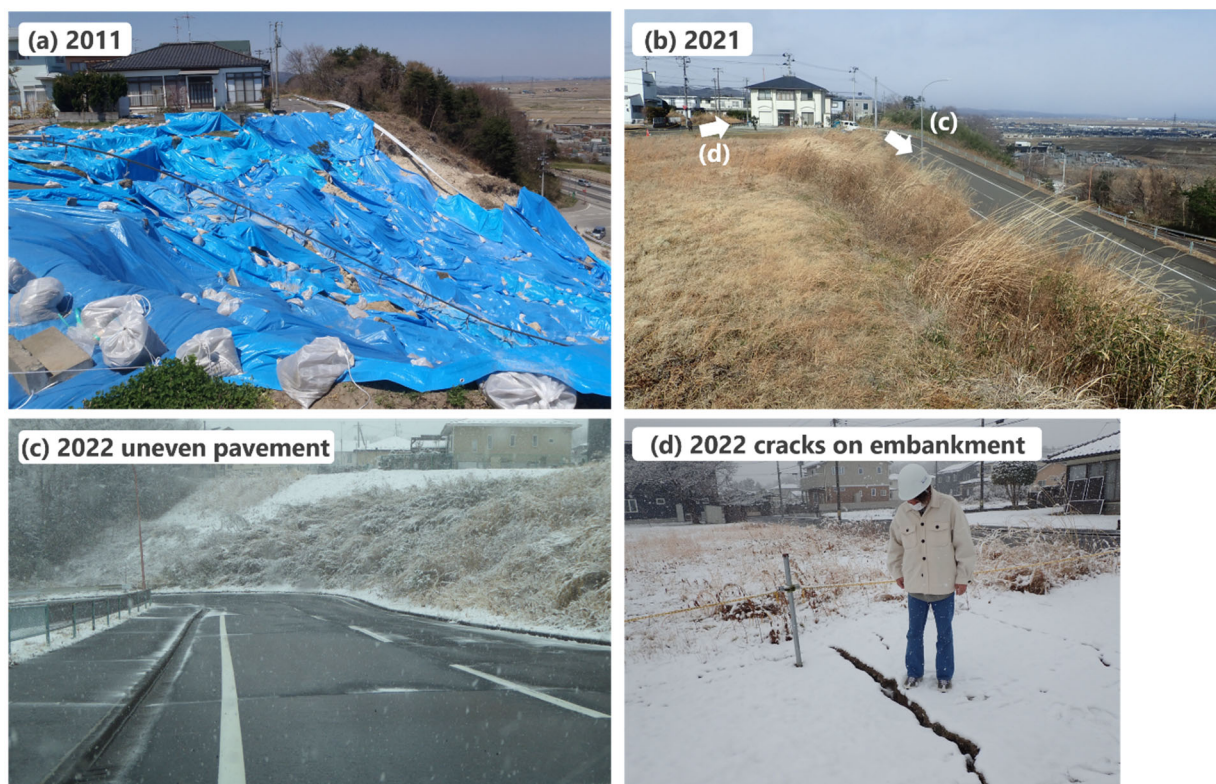
The damage conditions in the residential embankment area of Taiyo Newtown in Yamamoto Town were examined as significant ground deformation in the 2011 Tohoku Earthquake. While cracks of 10 cm to 20 cm in width could be identified on a slope along the road connecting to the National Route 6 (**Fig.15**), less critical geotechnical damage was brought by the 2022 earthquake than by the 2011 earthquake.

Fig.15 Ground deformation of the slope of Taiyo Newtown (a) after the 2011 earthquake, (b) after the 2022 earthquake, (c) uneven deformation, (d) cracks on the embankment

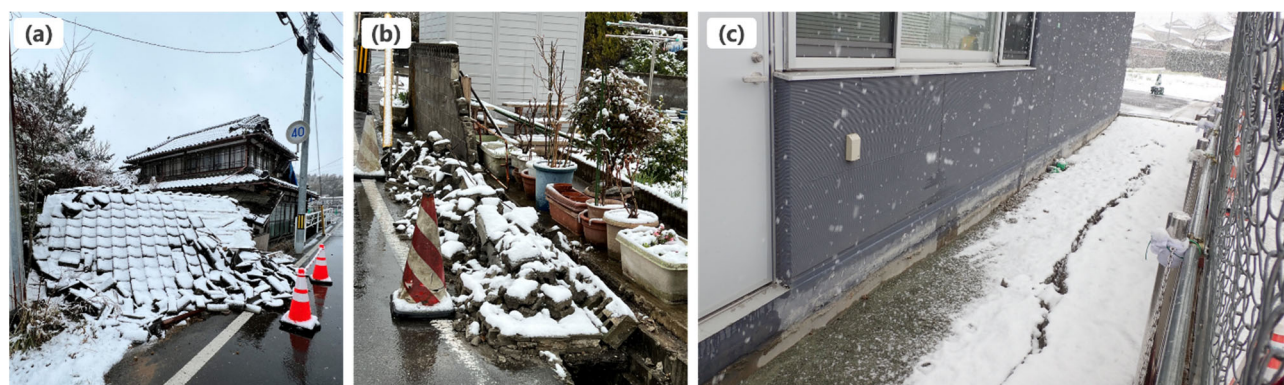
The inspection was made around the Disaster Prevention and Communication Center of Yamamoto Town. Cracks and ground settlement could be observed in the surrounding area of the Center (**Fig.16**). On the National Route 6 in the Sakamoto area, the ground settled mildly, and a crack of about 30 m long

Our previous survey¹¹⁾ after the 2021 earthquake revealed building structures in the area that suffered from damages were those constructed before the 2011 earthquake, while the ground was damaged in the areas reclaimed after the 2011 earthquake. A similar pattern was observed after the 2022 earthquake (**Fig.16**).

Fig.16 (a) Collapsed house (old residential area), (b) collapsed concrete-block wall (old residential area), (c) ground crack in the vicinity of the Center (newly landfilled area)
