Reconnaissance Report on Bridge Damage caused by the January 1st, 2024, Noto Peninsula Earthquake, Japan

Key Facts

- Hazard Type: Earthquake
- Date of the disaster: January 1st, 2024
- Location of the survey: Anamizu City, Nanao City, Shika Town, Suzu City, Wajima City
- Date of the field survey: January 20th – 22nd, April 23rd - 25th, 2024
- Survey tools: Digital Camera, GPS
- Key findings: Damage to the piers was limited, with most of the bridge damage resulting from ground deformation behind the abutments. In some cases, settlement of the ground caused abutments to tilt, leading to damage to bearings at the bridge ends.

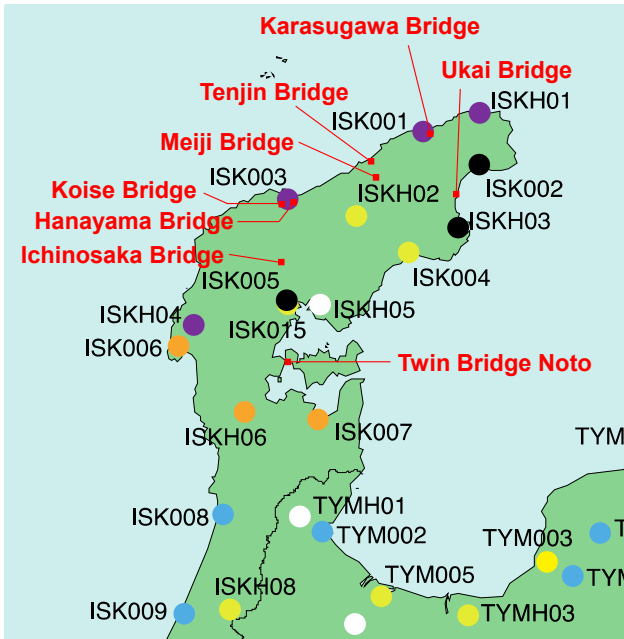
(a) Estimation of seismic response of RC road bridge piers in the 1970s.

Fig.1 Geographic location of target bridges and preliminary results of the numerical analysis by Takahashi²⁾

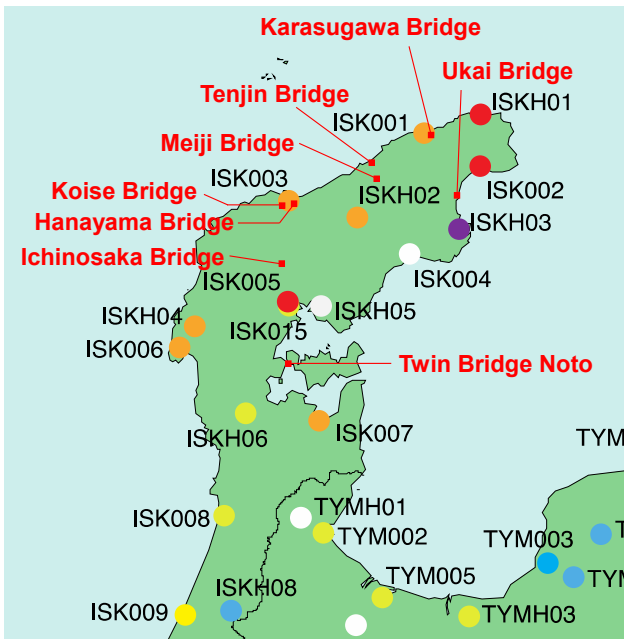
(b) Estimation of seismic response of RC road bridge piers in the 2000s.

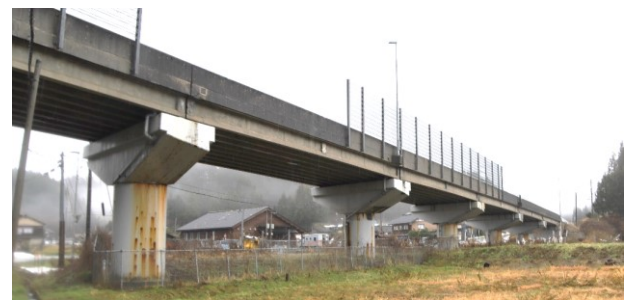
(a) Overall view

Ichinosaka Bridge, located on the Nanao-Wajima Line of Prefectural Route 1, has a longitudinal length of 175.2 meters and a traverse width of 7.5 meters, which was put into service in 1980. The bridge piers are being retrofitted with steel plate jacketing. No damage has been observed in the seismically retrofitted sections, which aligns with the results of Takahashi's numerical analysis²⁾. However, concrete spalling damage occurred at the pier overhang's root. This is considered to be due to the structural weakness shifting from the pier base to the root of the overhang as a result of the steel plate jacketing.

Photo. 1 Damage to bridge piers of Ichinosaka Bridge (37°17'41.9"N, 136°53'43.1"E)

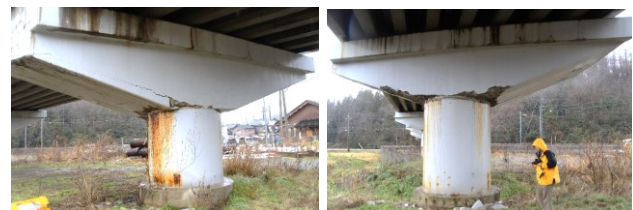
(b) Damage with concrete spalling at the root of the pier overhang

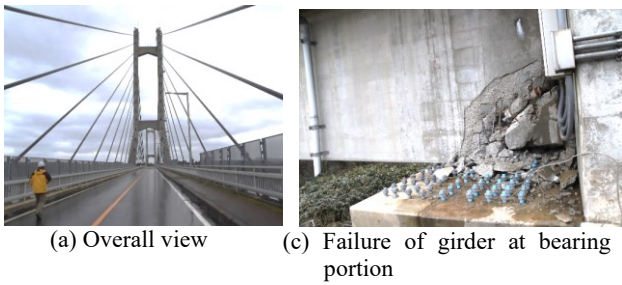
(a) Overall view (c) Failure of girder at bearing portion

Additionally, a collision between the abutment and the bridge girder on the Noto island side caused the girder to fail at the bearing portion. Bearing failure also occurred at the opposite end of the girder.

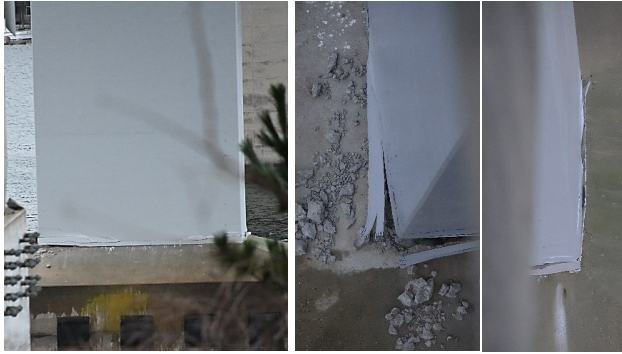
(b) Damage with carbon fiber rupture at the base of pier

Peninsula in Nanao City. The bridge has a longitudinal length of 620 meters, with the Noto island side featuring a continuous box girder bridge with two PC spans, while the Noto Peninsula side comprises a continuous cable-stayed bridge with three PC spans. At Twin Bridge Noto, carbon fiber rupture occurred at the base of the columns in the piers retrofitted with carbon fiber jacketing. It is noteworthy that deformation exceeding the ultimate displacement likely occurred despite the seismic retrofitting.

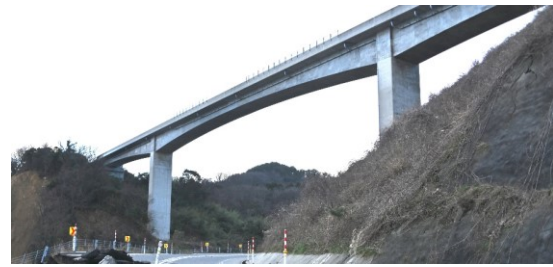
(a) Overall view

Photo. 3 Damage to Karasugawa Bridge
(37°29'55.7"N, 137°11'00.3"E)

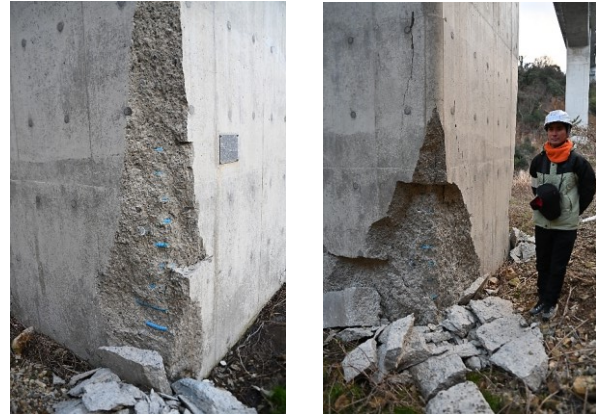
The Karasugawa Bridge, located on National Route 249 to the northern part of Suzu City, has a longitudinal length of 210 meters and a traverse width of 9.5 meters. It was put into service in 2011. Structural failures at the base of the piers have been observed, including spalling of concrete and exposure of rebar. The damage state of the Karasugawa Bridge's piers is consistent with numerical results, as seismic motions capable of generating responses with ductility ratios of 1.2 to 3.0 for RC road bridge piers in the 2000s were observed in the geographic location of the Karasugawa Bridge.

(b) Damage with spalling of concrete and exposure of rebar at the base of pier

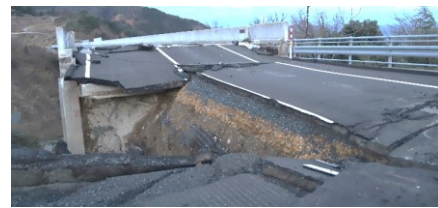
Additionally, ground failure behind the abutments was observed, causing the abutments to move forward and resulting in significant deformation of the bearings. Consequently, the failure of the attachments of the rubber bearings was observed.

(c) Ground failure behind abutment

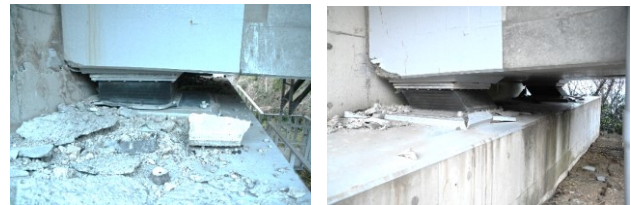
(d) Failure of attachments of rubber bearings

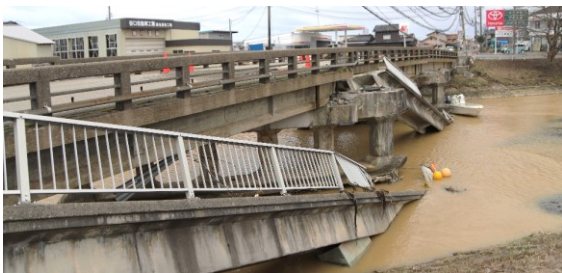
Ukai Bridge, located south of Suzu City and crossing the Ukai River, has a length of 54 meters and a width of 8.5 meters. It has been in service since 1960. The 2024 Noto Peninsula earthquake caused a collapse of the section designated for pedestrian traffic. Additionally, large cracks appeared on the road surface, and there was lateral displacement of the girders in the vehicular traffic section. Ground settlement behind the abutments caused steps to form in the approaches to the bridge. No significant damage to the piers was observed.

(a) Collapse of the section designated for pedestrian traffic

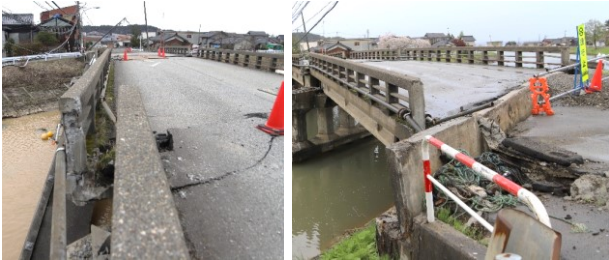
(b) Lateral displacement of vehicular traffic section (c) Step at approaches to bridge

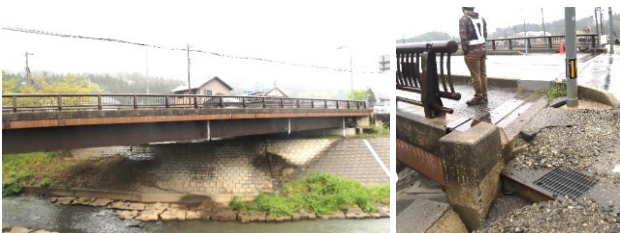
Koise Bridge, which crosses the Fugeshi River in Wajima City, has a longitudinal length of 14 meters and a traverse width of 4.5 meters. It was put into service in 1999. At the approach to Koise Bridge, steps at the approach parts to the bridge were observed due to the settlement of the ground behind the abutments. Additionally, damage to the bottom mounting and displacement stoppers of the rubber bearings was observed at the bridge girder ends.

(a) Overall view (b) Step at approaches to bridge

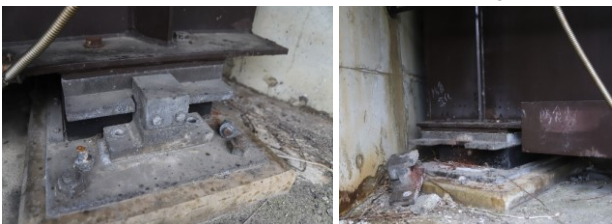
(c) Damage to attachment of rubber bearings

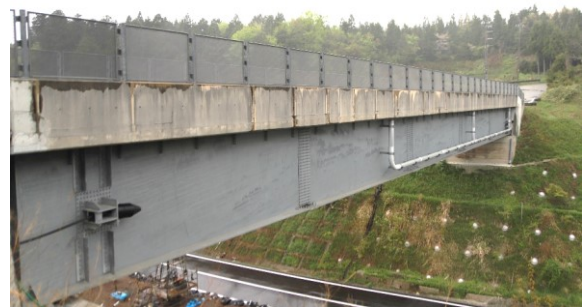
(a) Overall view

Photo. 6 Damage to Hanayama Bridge (37°23'10.0"N, 136°55'05.0"E)

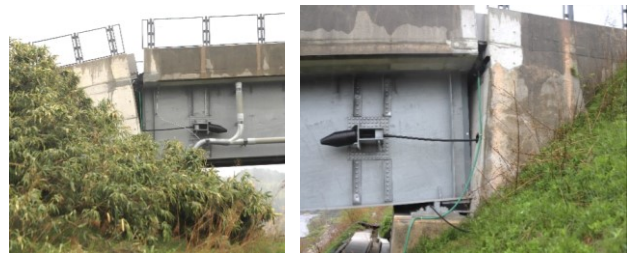
Due to the deformation of the surrounding ground, the bridge's abutment tilted significantly, causing damage to the rubber bearings at the ends of the bridge. Specifically, the mounting of the east side rubber bearing failed, and the west side rubber bearing ruptured.

(b) Tilting of bridge abutments

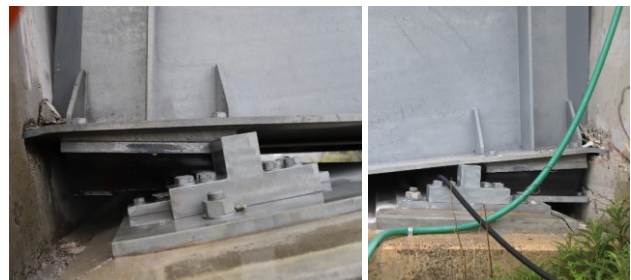
(c) Damage to rubber bearings
