**A RECONNAISSANCE REPORT  
ON  
THE 2007 SINGKARAK LAKE (SOLOK) EARTHQUAKE  
WITH  
AN EMPHASIS ON THE SEISMIC ACTIVITY OF SUMATRA FAULT  
FOLLOWING 2004 and 2005 GREAT OFF-SUMATRA EARTHQUAKES**

**Ömer AYDAN**

**Earthquake Disaster Investigation Sub-Committee  
Japan Society of Civil Engineers  
(Tokai University, Department of Marine Civil Engineering, Shizuoka)**

**August 2007**

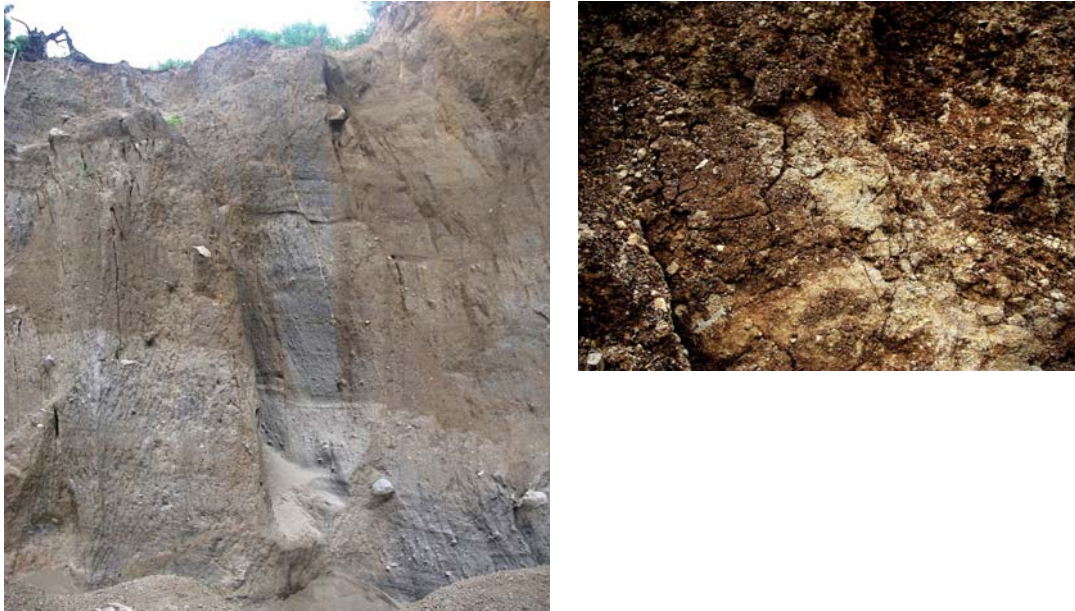
The author did some observations in a quarry just north of Singkarak Lake. Figure 3.3 shows views of the fractures in a quarry and a fault surface with striations. The fractures are almost steeply inclined. However, their dipping direction is about 85°SW. The striations are almost horizontal. Nevertheless, they have slight normal component. In other words, the sense of deformation implies slight trans-tension type movements. Figure 3.4 shows the inferred focal mechanism solution for the striations in the quarry proposed by Aydan (Aydan and Kim, 2002, Aydan 2007b). The strike of the fractures is slightly different from the general trend of the SFZ.

Figure 3.3. Views of the fractures and the striations in Batipuh quarry in the north of Singkarak Lake

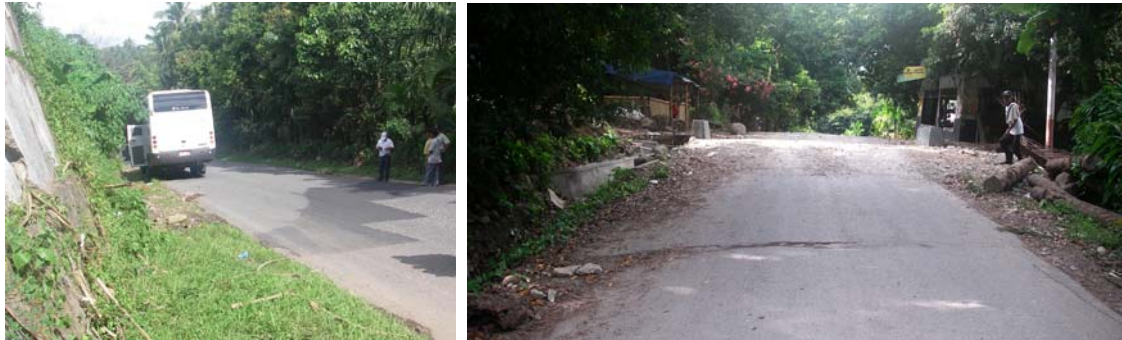
The hypocenter depth of the earthquake is about 30km and the projected epicenter is near the north end of Singkarak Lake. The author noticed two surface ruptures to the north of Singkarak Lake at localities called Batipuh and Sumpur. The strike of these surface ruptures were aligned in the direction of N30-50E. The global strike of Sumatra fault is N35W. The acute angle between the strikes of the Sumatra fault and surface ruptures ranges between 65-85. The two locations of surface ruptures are aligned along N40W direction. Therefore, we expect that surface ruptures are associated with the earthquake faulting and the surface ruptures belong to T-fractures of the fracture zones. Particularly, the surface rupture observed in the village of

Sumpur resembles to that observed between Kavaklı and Hisareyn caused by the 1999 Kocaeli earthquake (Aydan et al. 2000a). This fracture was followed by the author for about 500m and the subsidence of the ground up to 30cm were observed.

(a) Rupture of roadway in Batipuh (b) rupture of roadway in Sumpur  
Figure 4.3. Surface ruptures

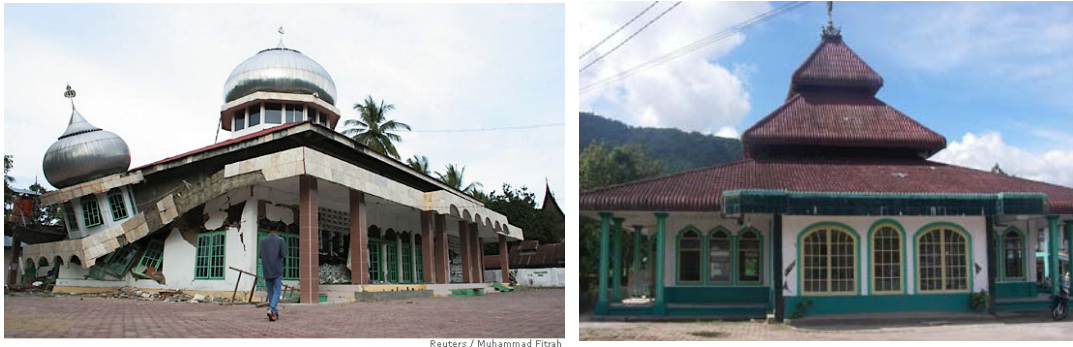
Mosques are semi-reinforced concrete structures. Although reinforced columns and beams are utilized, they are quite small in cross section (15x15 to 20x20cm) and they have 4-6 smooth steel bars with a diameter ranging between 8 and 12mm. The walls are either hollow cement blocks or bricks. The roof of mosques are generally light. The earthquake caused the failure of outer columns and load-bearing walls at corners and subsequent collapse of roofs (Figure 5.1).

Figure 5.1 Damage to mosques

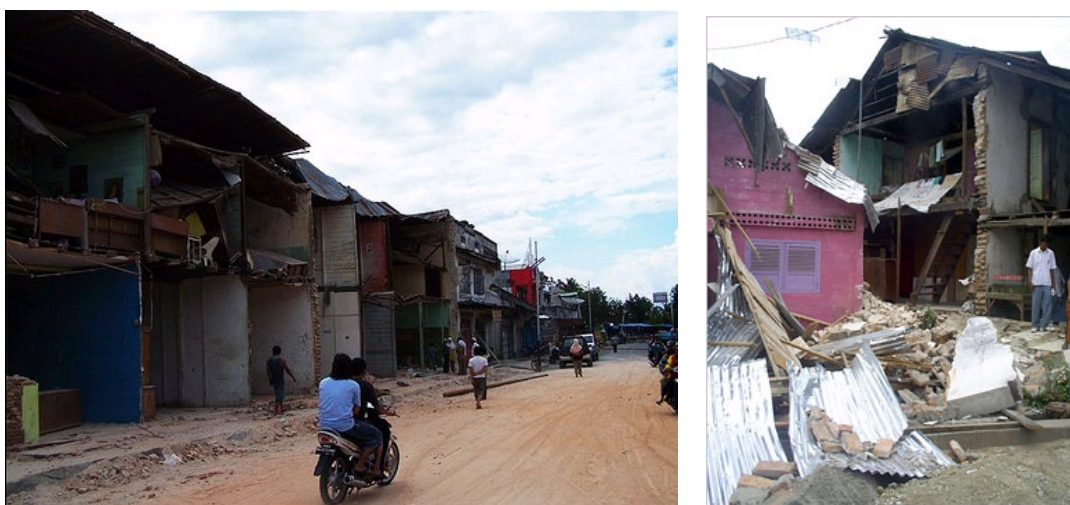
Masonry buildings are generally constructed with bricks and they are either one story or two story buildings. Old masonry buildings has no reinforced concrete lintels and/or columns. Such collapses were observed even in Payakumbuh and Padang, which are relatively far from the epicenter (Figure 5.2) New constructions utilize reinforced concrete slabs and columns. There is no doubt that when such structural elements are integrated with masonry walls they perform better and they prevent the total collapse of the buildings in-spite of some structural damage. The houses or buildings were slightly damaged even they were just on the surface ruptures (Figure 5.3).

Figure 5.2 Collapse of walls of masonry buildings due to out-of-plane loading

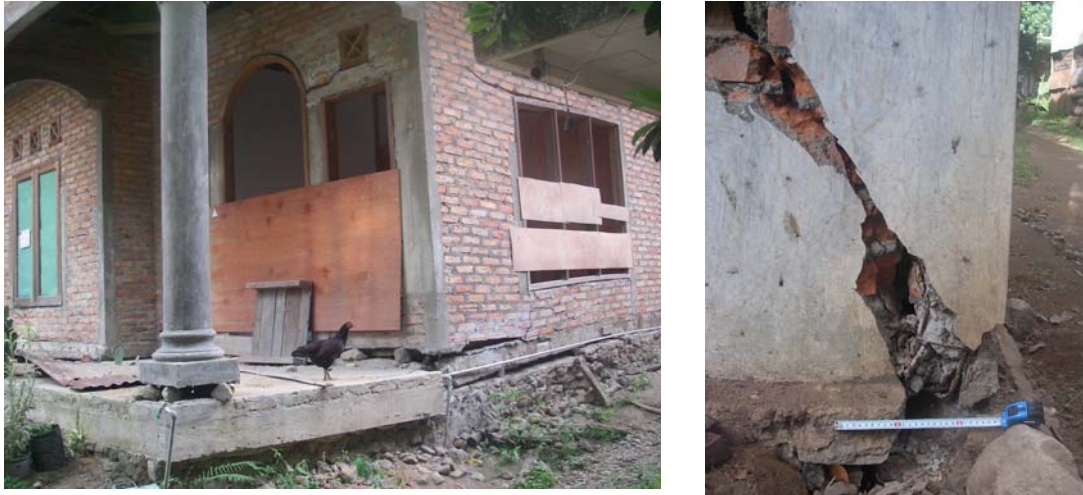
Figure 5.3. Damage induced by surface ruptures to masonry houses with reinforced slabs and columns in Sumpur

- 4) When masonry buildings are constructed with bricks without reinforced concrete slab and columns, they were fragile against ground shaking observed in this earthquake. However, new constructions utilizing reinforced concrete slabs and columns with the integration of masonry walls within the load bearing system performed better and they prevented the total collapse of the buildings in spite of some structural damage.

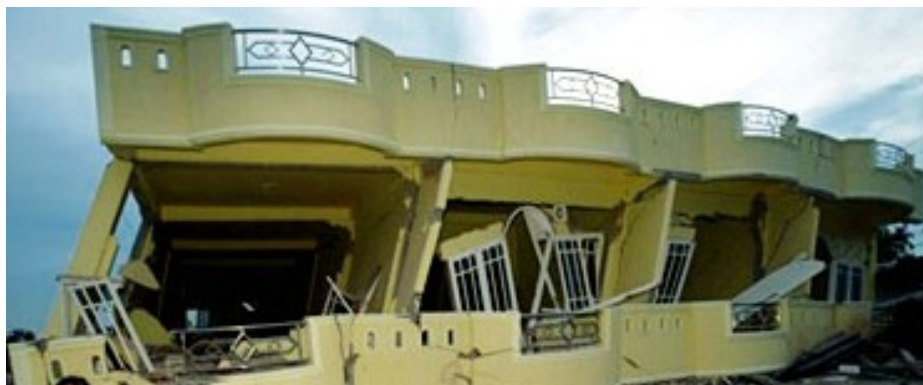
RC buildings with two or three stories suffered heavily from the earthquake. The reinforced concrete structures are framed structures with integrated or non-integrated in-fill walls. The reinforcing bars are generally smooth and infill walls are built with red-burned solid clay bricks using mortar. The floor height in the region ranges between 3 to 4m. The inspections of the reinforced concrete buildings indicated that they are mainly failed in the pancake mode. RC buildings are generally found in cities and large towns. The concrete buildings having 2 or more stories were either collapsed or heavily damaged. The causes of damage to RC buildings are similar to those observed in other recent earthquakes in Indonesia and elsewhere (Figures 5.4 and 5.5). They be re-stated for this earthquake as follows:

- a. Soil liquefaction and lack of the soil bearing capacity (particularly in Solok)
- b. Large ground settlement of embankments nearby river banks
- c. Fragile structural walls and lack of lateral stiffness,
- d. Poor concrete quality and workmanship,
- e. Plastic hinge development at the beam-column joints,
- f. Lack of shear reinforcement and confinement,
- g. Soft story,
- h. Pounding and torsion and
- i. Ground motion characteristics (i.e. multiple shocks etc.).

Figure 5.4 Pancake collapse of reinforced building in Padang (from Reuter)

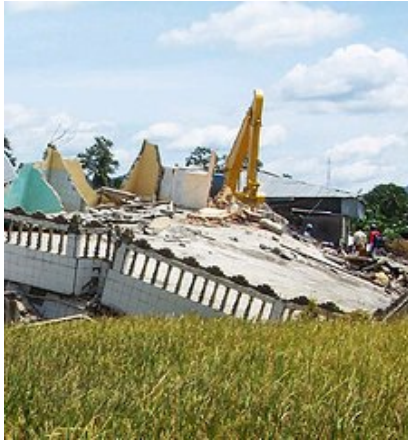
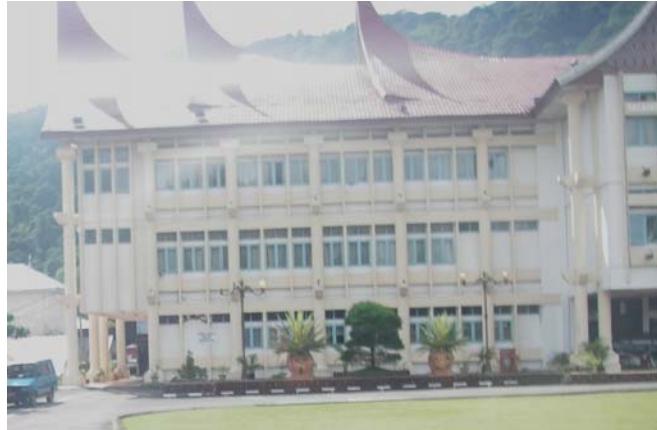
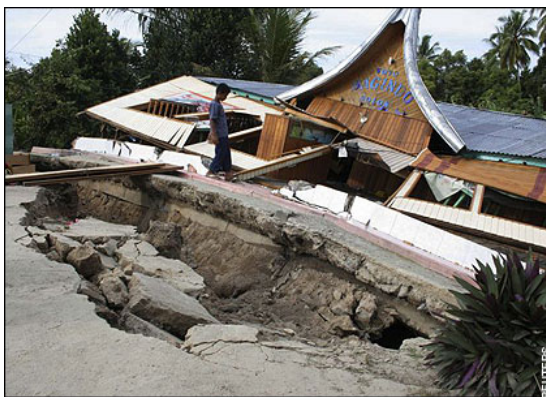
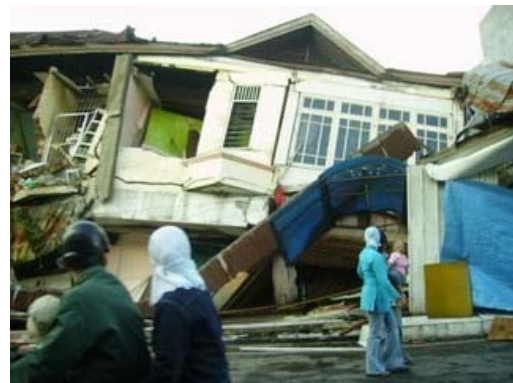
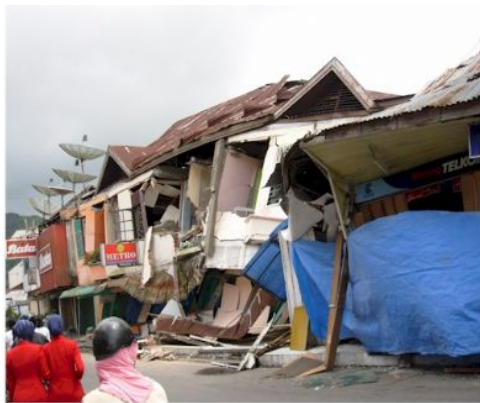
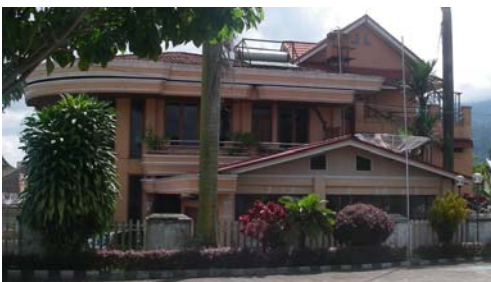
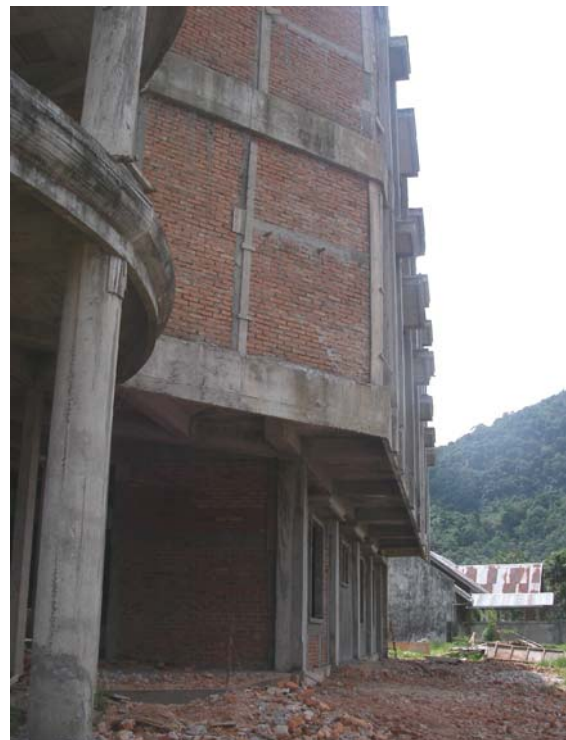
Figure 5.5. Some typical damage to RC buildings

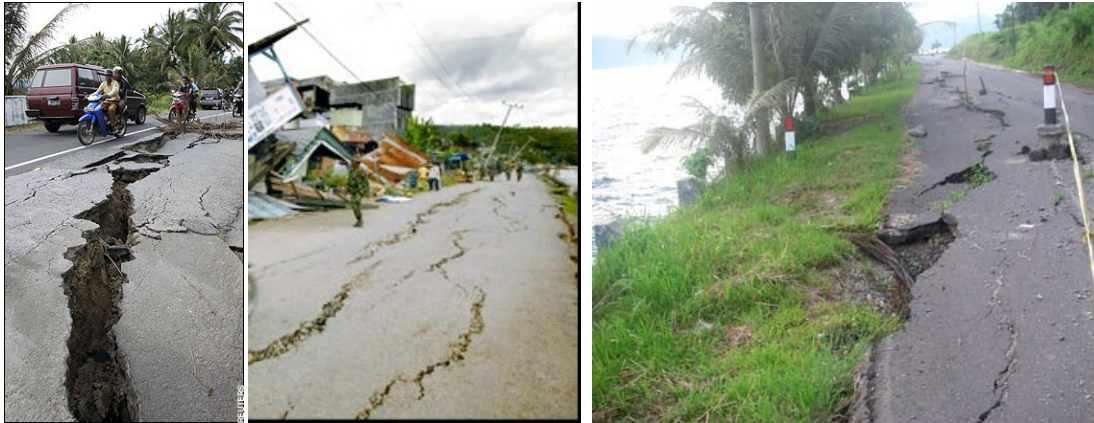
The roads are open to traffic and accessible to affected areas. Damage to roadways were caused at several places due to surface ruptures and embankment failures along the rivers and Singkarak Lake (Figures 4.3 and 6.2). Some of these roadways were re-asphalted while some of them were re-surfaced with soil. The roadway embankment along the shore of Singkarak lake was damaged and there was a repair to the roadway even 6 months passed after the earthquake (Figure 6.2(b)).

Figure 6.2. Damage to roadways due to embankment failures

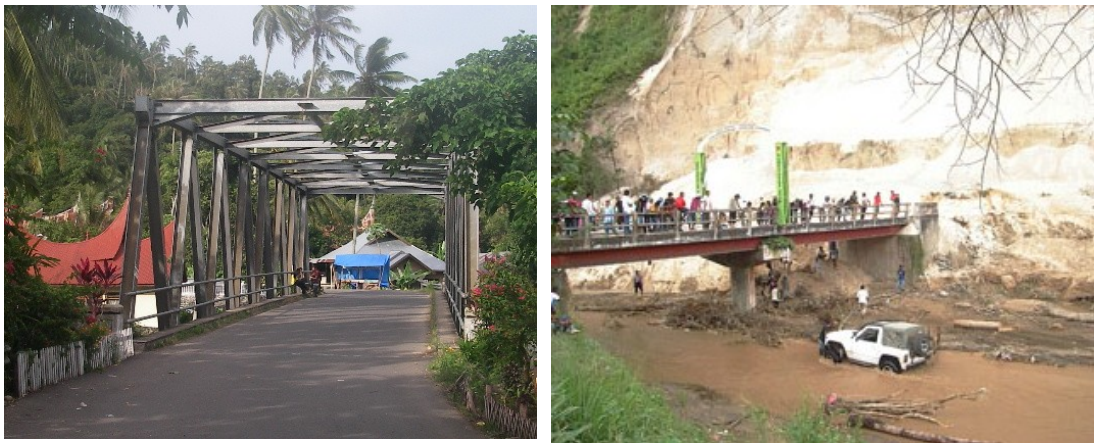
Railway bridges in the epicentral area are truss, arch or simple beam bridges while roadway bridges are of truss or simple beam type. The earthquake shaking did not cause any visible damage to the bridges of railways and roadways even in the

nearest location to the epicenter of the earthquake (Figure 6.3). The debris of slope failure in Sianok Valley obstructed a roadway bridge temporarily.

(a) Truss bridge in Sumpur village

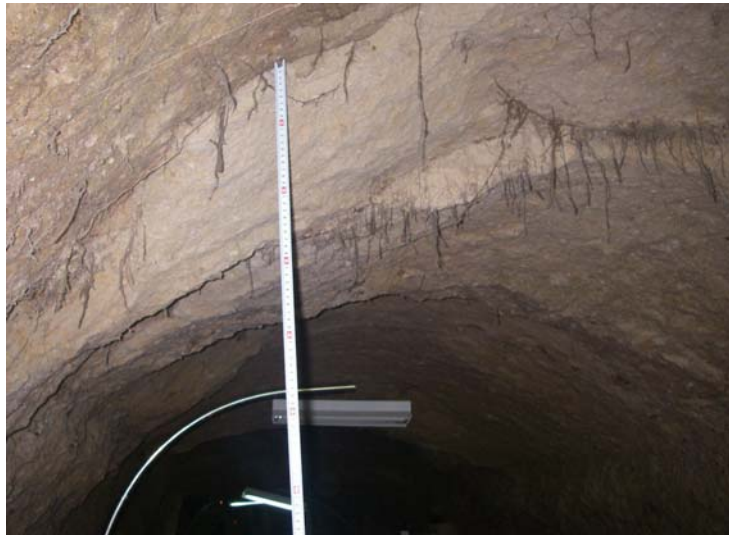
(a) Roof falls

- 7) In spite of such ground motions, the underground shelter excavated in 1942 without any support in weak pyroclastic flow deposit rocks was almost intact after the earthquake. However, there were some slight damage to the underground shelter at three localities. This underground shelter deserves more detailed studies for its superior performance during this earthquake.

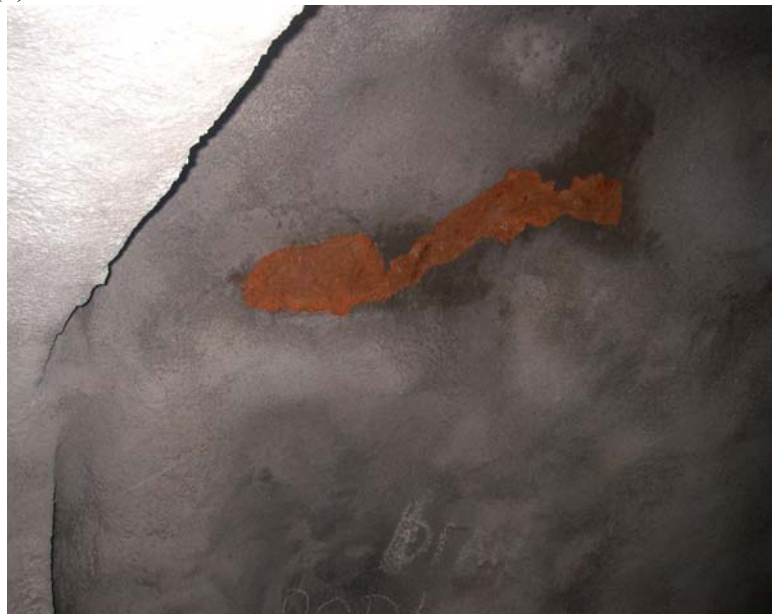
(b) Spalling at Location 3

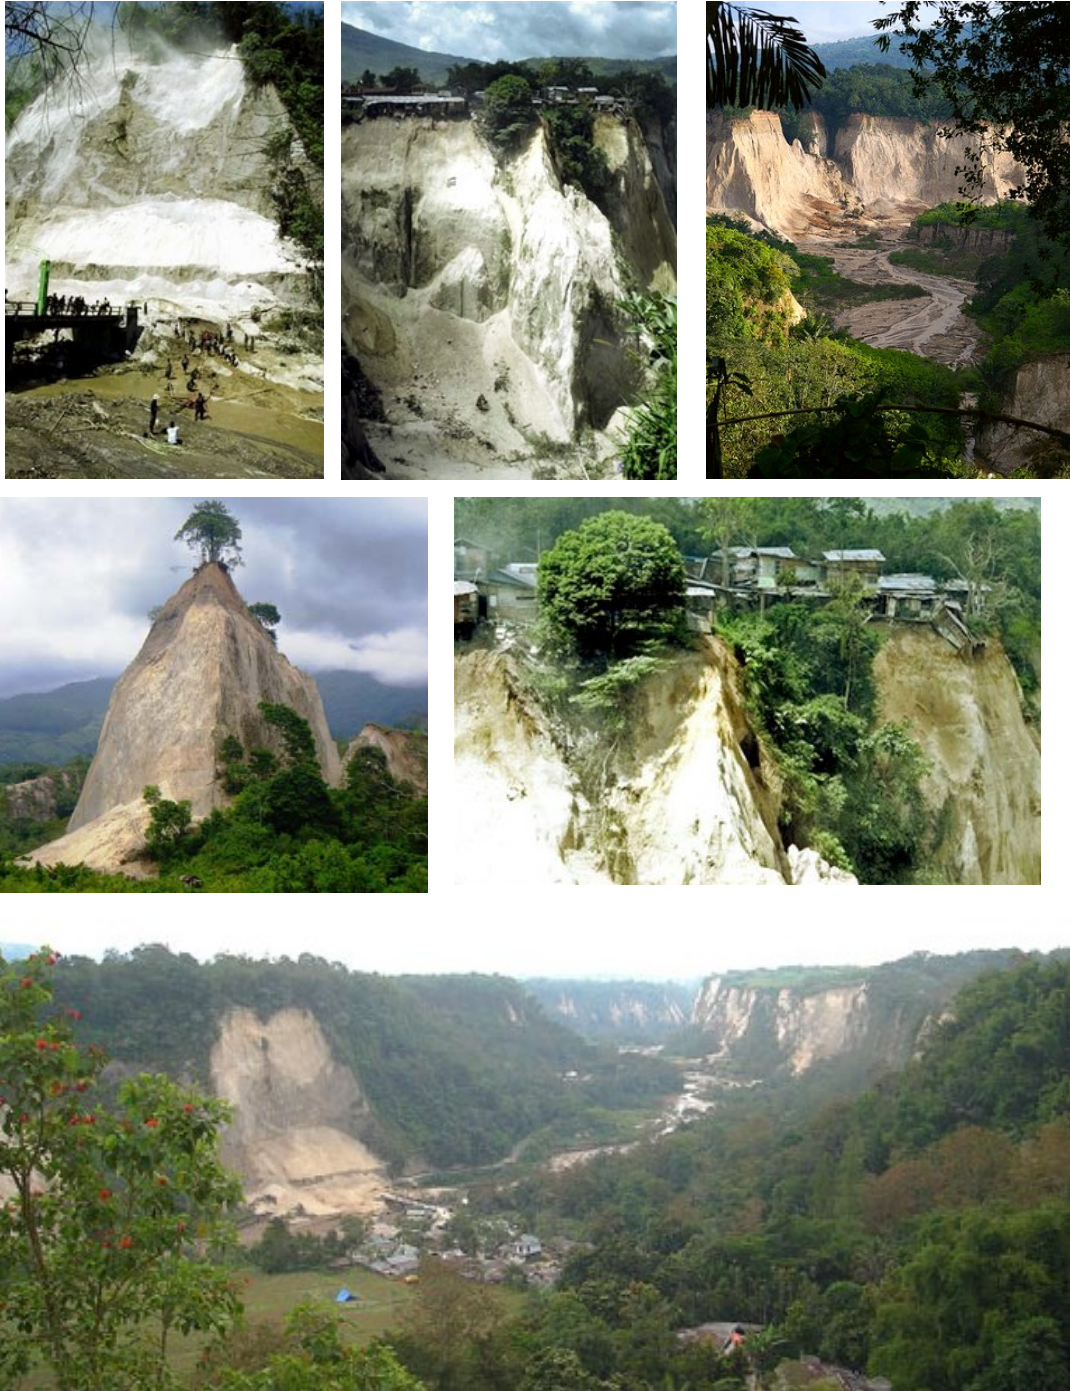
Extensive slope failures observed in Sianok Valley (Figures 8.1 to 8.3). In addition there were also some slope failures and rockfalls in Annai Valley and shore of Singkarark Lake (Figure 8.4). The depth of Sianok Valley is up to 120m and the valley walls are quite steep and the natural slope angles range between  $70-80^{\circ}$ . The ground mainly consists of pyroclastic flow deposits from nearby Volcanoes as also presented in the previous section. The inclination of the failure plane is about  $60^{\circ}$  and it is almost planar. The repose angle of the failed ground is about  $30^{\circ}$ . The material properties of the rock are not well known and it was not measured.

Figure 8.1. Views of slope failures at Sianok Valley in Bukit Tinggi

Using the seismic coefficient method and assuming that the failure is planar, and the friction angle of the ground is  $30^\circ$  and pore water coefficient of 0.5, the relation between slope angle and slope height can be obtained as a function of normalised cohesion to the unit weight of rock for a seismic coefficient of 0.2 as shown in Figure 8.5. In view of the self-standing underground shelter discussed in the previous section and the observed slope heights (80-120m), the most likely normalized cohesion by the unit weight is likely to be about 20 . For this value of the normalized cohesion, the value of seismic coefficient varied between 0.2 to 0.3 by an increment of 0.5 (Figure 8.6). From these parametric computations, the expected

maximum ground acceleration is likely to be around 0.25g. There is no doubt that it will be desirable to carry out detailed geotechnical investigations for determining the properties of ground around Sianok Valley. Nevertheless, the results from these parametric studies would be quite close to the actual values in view of ground conditions in similar type geological and geotechnical environments.

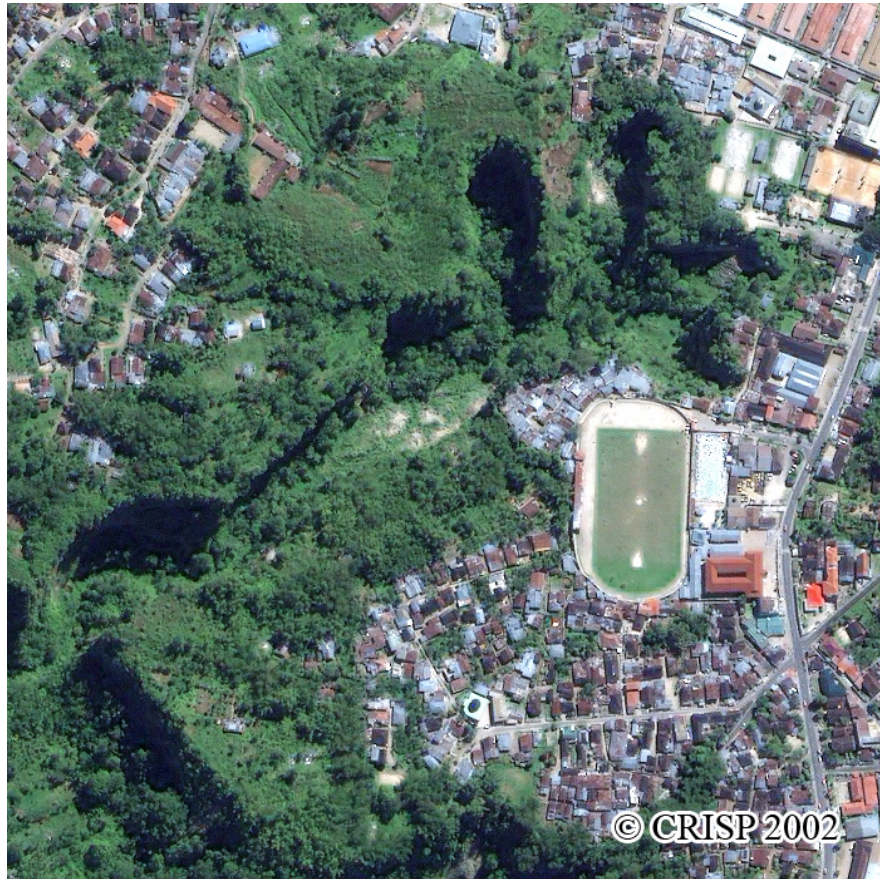
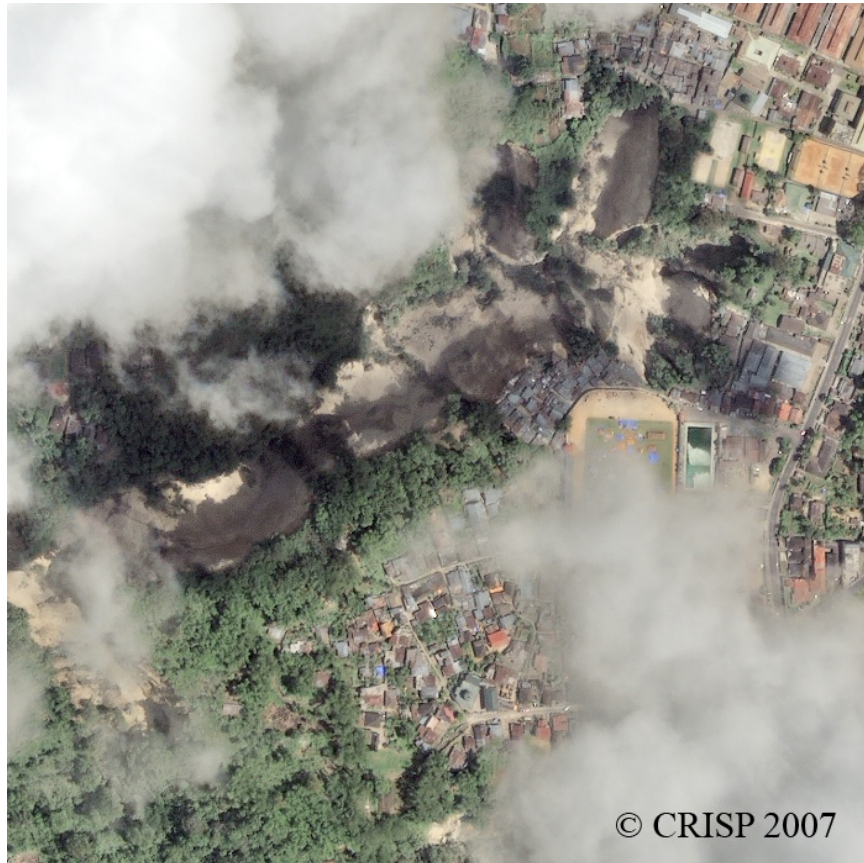
Figure 8.2. Images of Sianok Valley before and after the earthquake

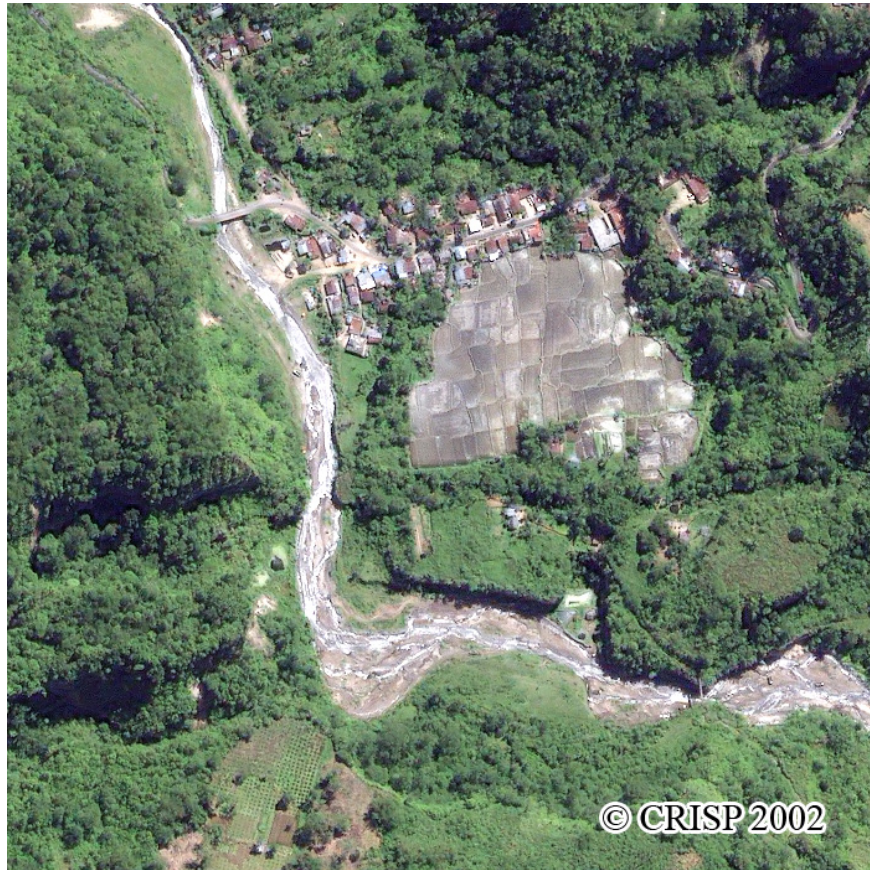
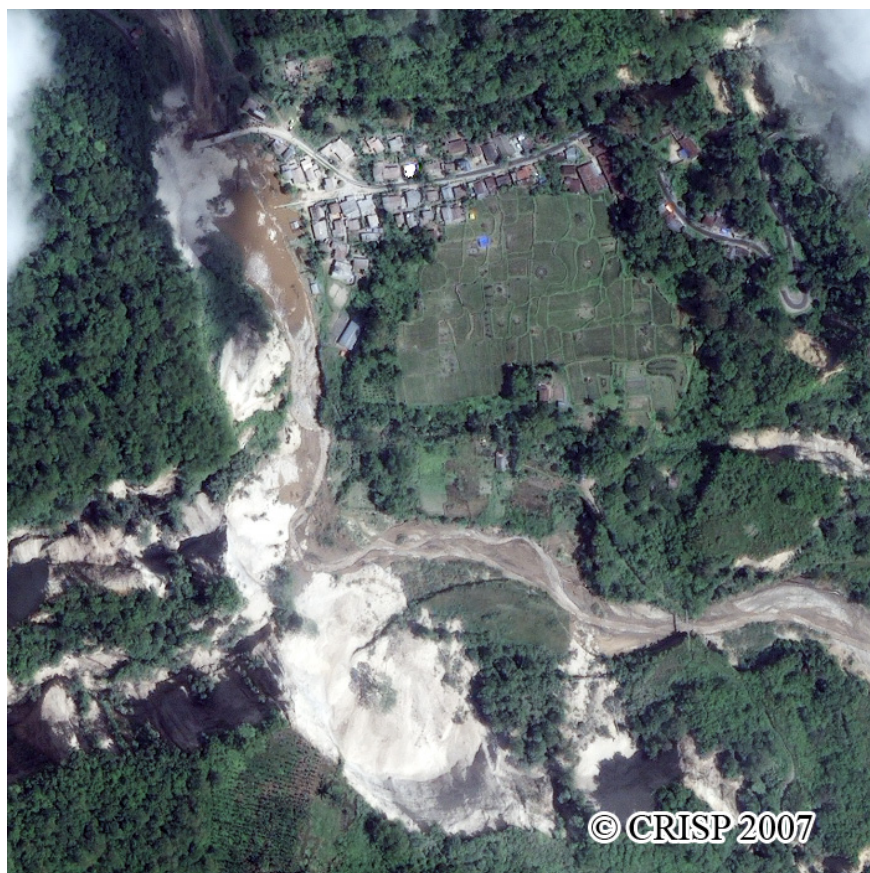
Figure 8.3. Images of Sianok Valley before and after the earthquake

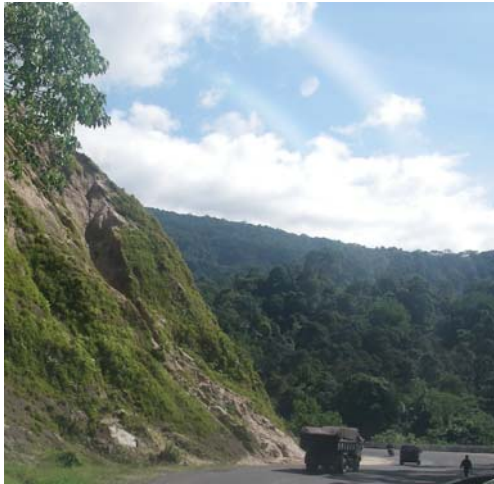
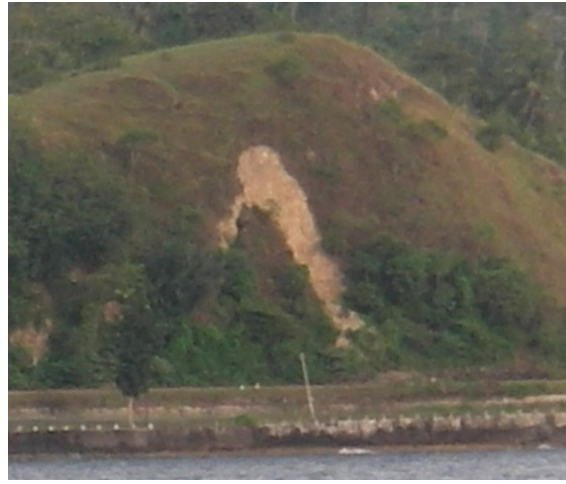
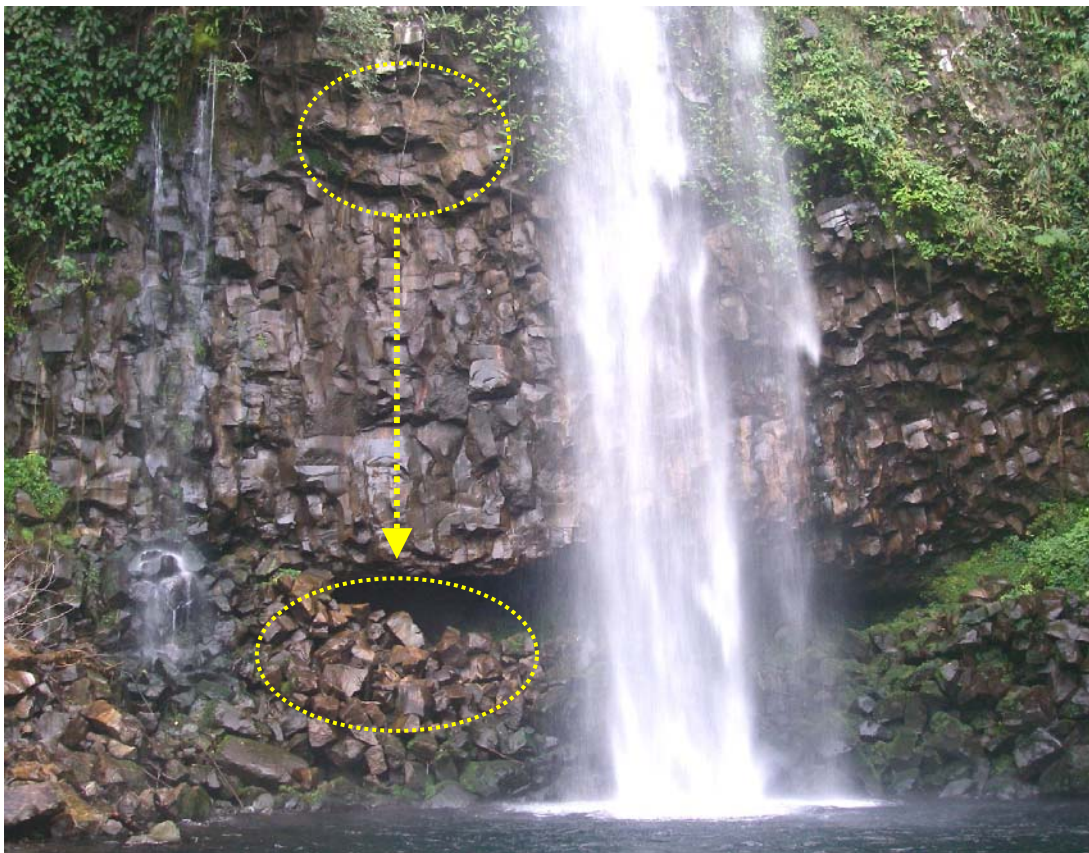
Figure 8.4. Slope failures and rockfalls

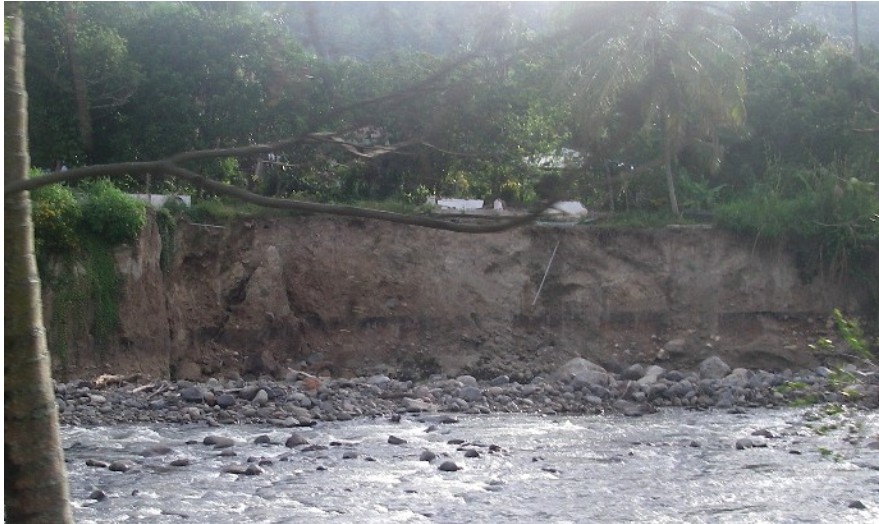
Embankment failures of roadways and rivers were also widespread in the epicentral area (Figures 6.2 and 8.7). The main cause of embankment failures were ground shaking, which resulted in either lateral spreading due to ground liquefaction or curved failure.

(a) Embankment failure at Sumpur Village (the nearest site to the epicenter)

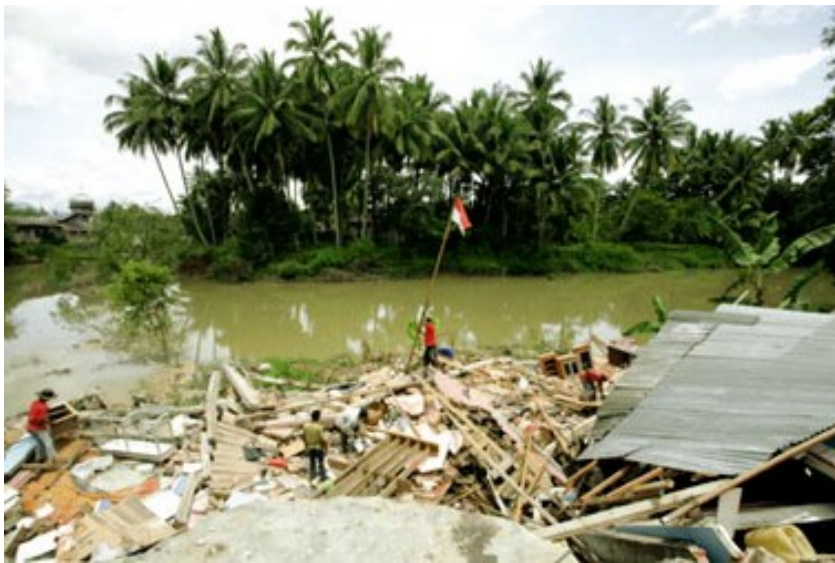
(b) Embankment failure along a river in Solok District  
Figure 8.7. Some views of embankment failures
