液状化に起因する長距離地盤流動により 被災したインフラ施設の復旧と対策

東京大学生産技術研究所 清田 隆

長距離地盤流動の概要

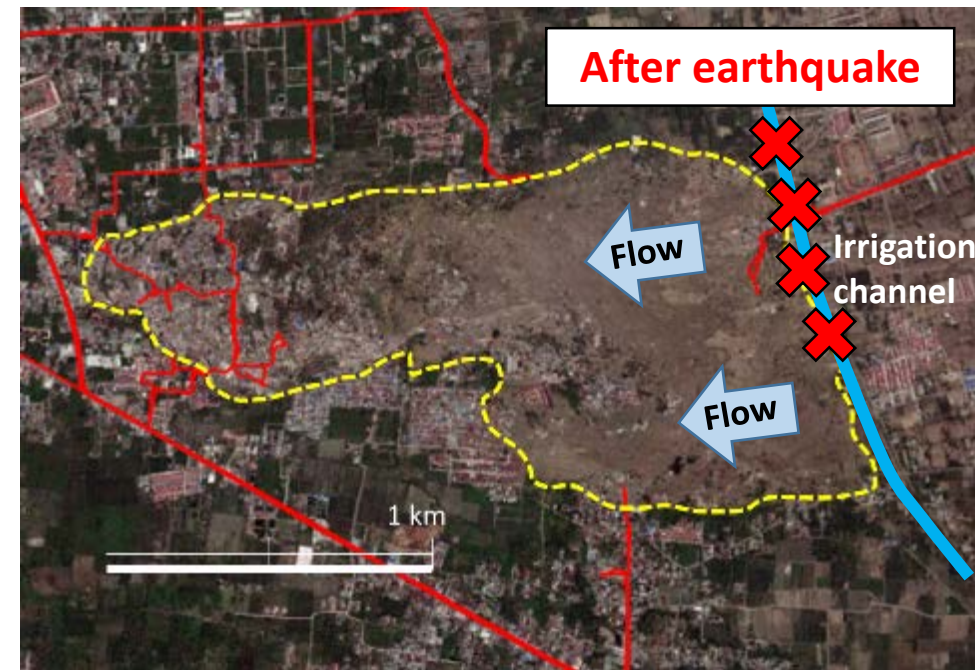
地震前の斜面勾配: 2~3% (1~2 deg), 流動斜面上部に灌漑用水路があり、大きな被害を受けた。

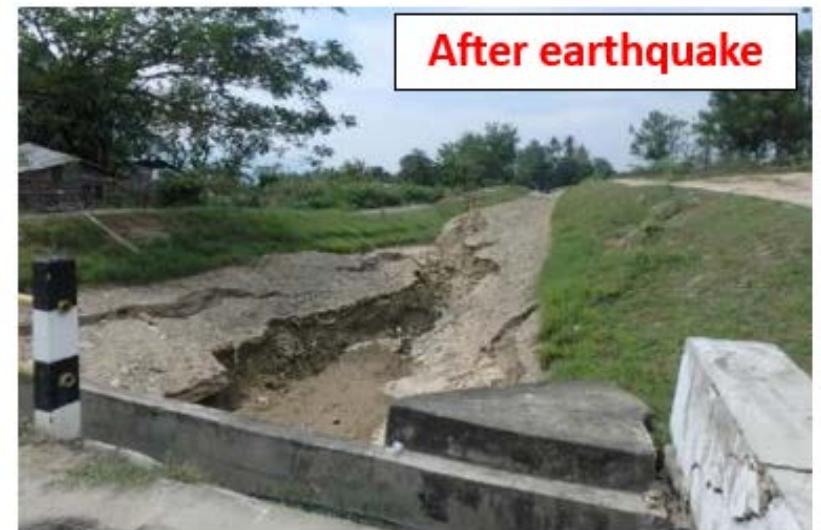
UAV測量を用いた流動前後の地形変化

◆ 灌漑用水路は流動開始後に決壊⇒ 決壊した水が地すべりを引き起こしたのではない

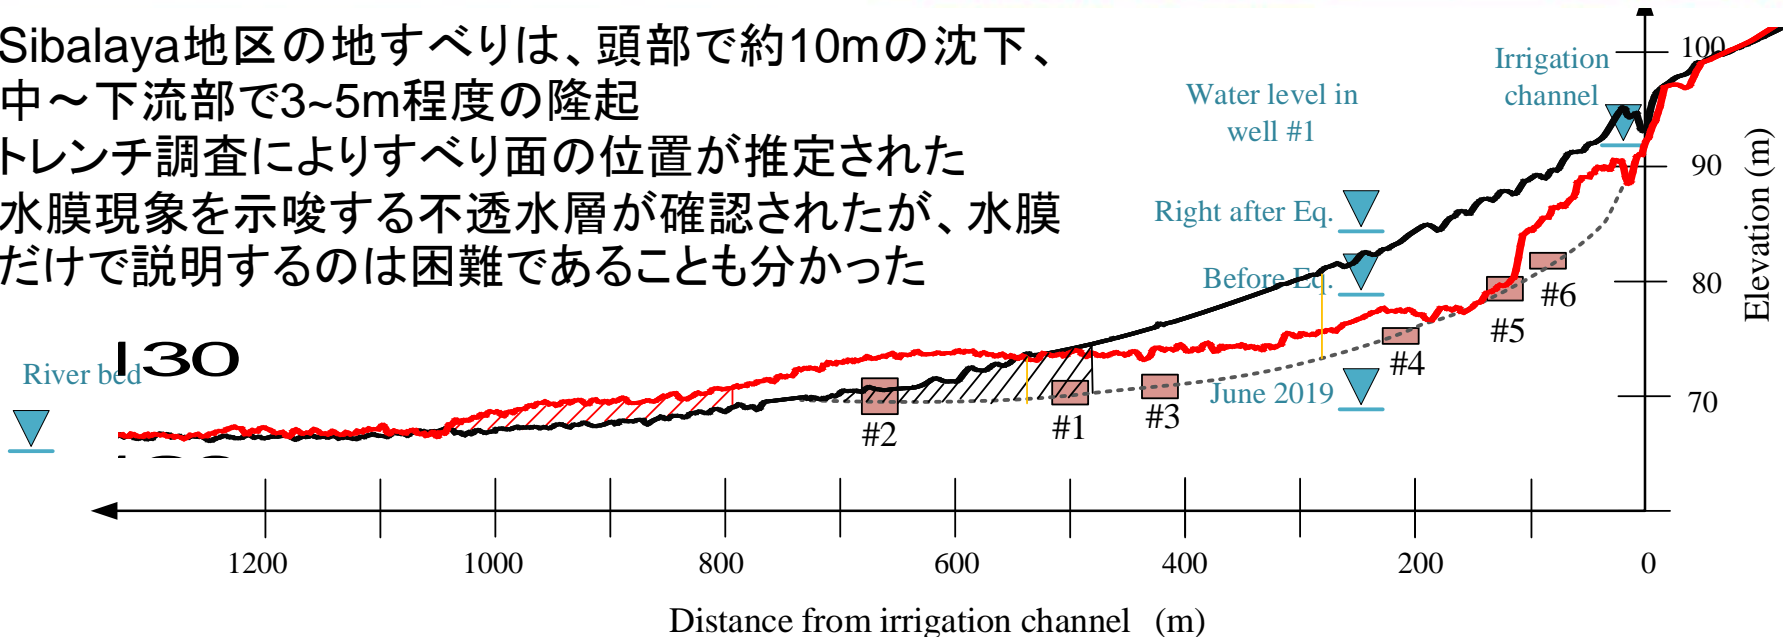
- ◆ Sibalaya地区の地すべりは、頭部で約10mの沈下、中～下流部で3~5m程度の隆起
- ◆ トレンチ調査によりすべり面の位置が推定された
- ◆ 水膜現象を示唆する不透水層が確認されたが、水膜だけで説明するのは困難であることも分かった

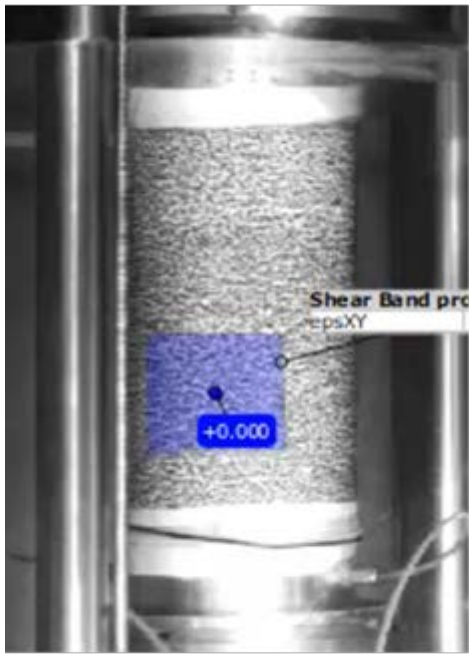
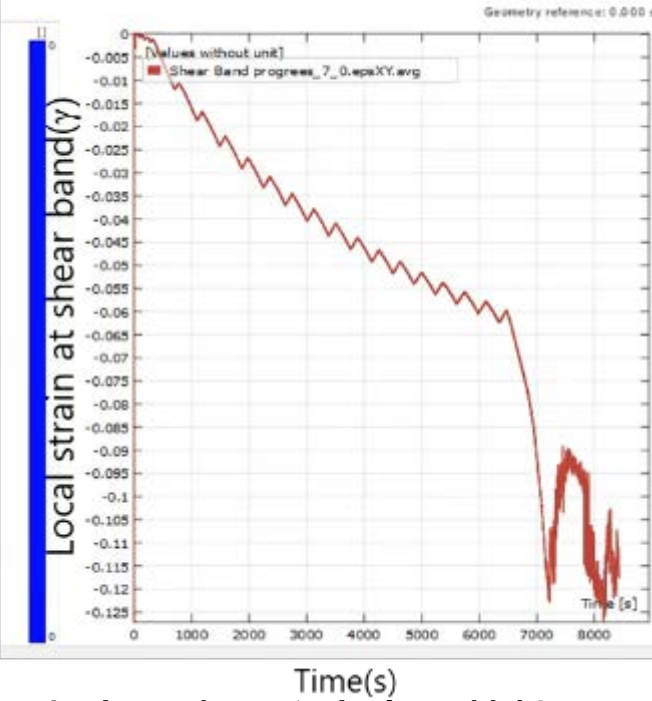
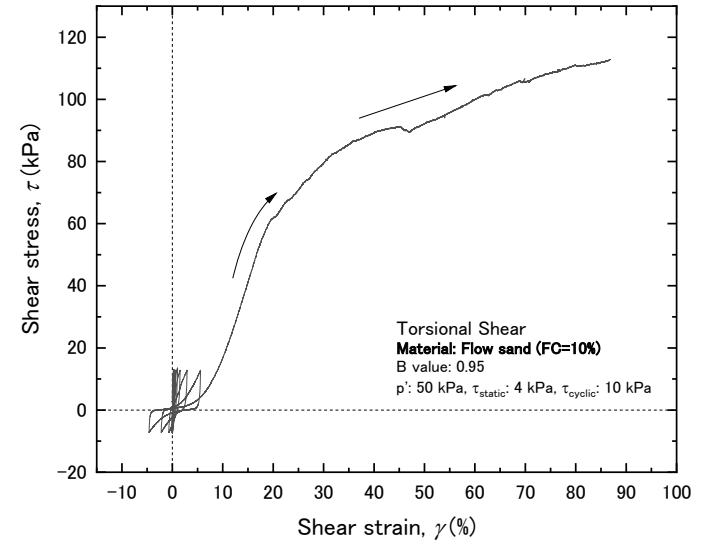
液状化した後の強度変形特性（メカニズム1）

液状化後に顕著なひずみ硬化が発生
⇒ 地盤流動は発生しない

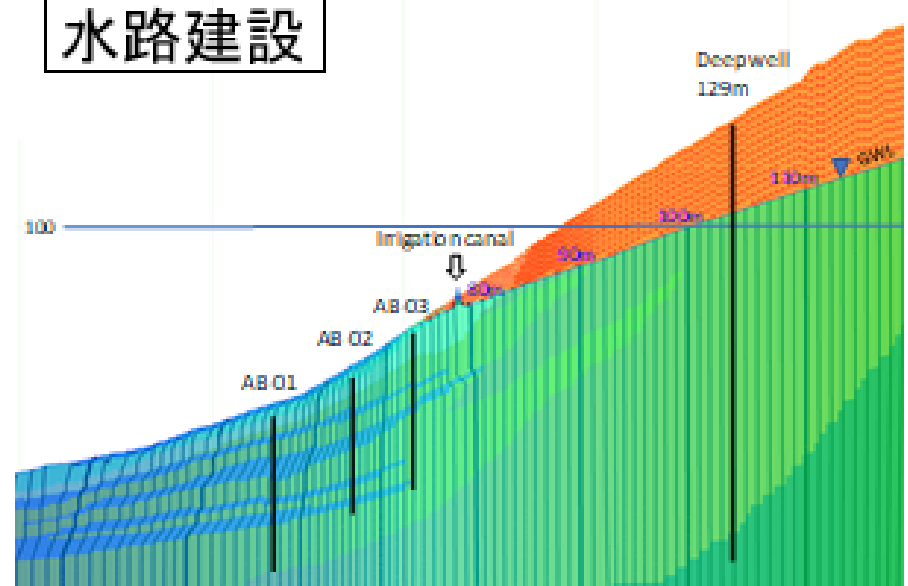
水路建設

灌漑用水路の建設により、用水路の直下では**地下水位が1~3m程度上昇**する。全体の地下水環境に与える影響は大きい
