Infrastructure damage analysis of the April 22, 2019 Pampanga, Philippines earthquake

Key Facts

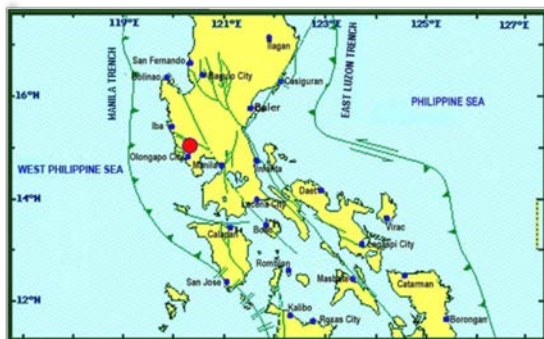
Fig. 2. Epicenter of the earthquake (Source: PHIVOLCS)

This earthquake registered a PEIS (PHIVOLCS Earthquake Intensity Scale) of VII that is characteristic of a destructive earthquake with the presence of liquefaction, lateral spreading and considerably damaged buildings and bridges.

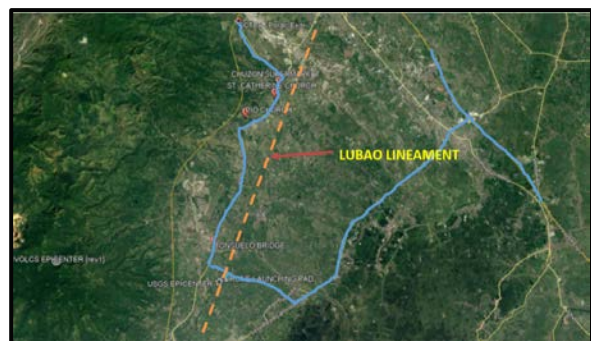
Fig. 6. Location of Lubao Lineament with respect to the Study Team Route colored blue

The earthquake in Pampanga was tectonic in origin. According to an interview with PHIVOLCS through the local news media Philstar, the earthquake that hit Pampanga was caused by a blind or hidden fault, it is yet to be determined⁴. However, the Study Team determined that the probable fault was the Lubao Lineament, which coincides with the reported epicenter of the USGS (see **Fig. 6**).

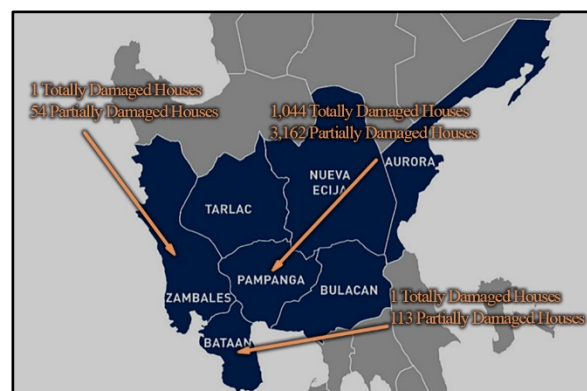
Fig. 7. Summary of damaged houses and locations in Central Luzon

Using 2018 data retrieved from the Philippine Statistics Authority⁵⁾, the number of households for the province of Pampanga is equal to 479,082. The percentage of damaged houses, both partially and totally damaged, in Pampanga with respect to the number of households is equal to 0.88%. Similarly, for the Province of Bataan, with a total number of households equal to 173,212, the percent damaged houses are equal to 0.06%. Lastly, for the Province of Zambales, the percentage of damaged houses to total number of households is equal to 0.04% for all 142,218 households. This is further summarized in **Fig. 7**.

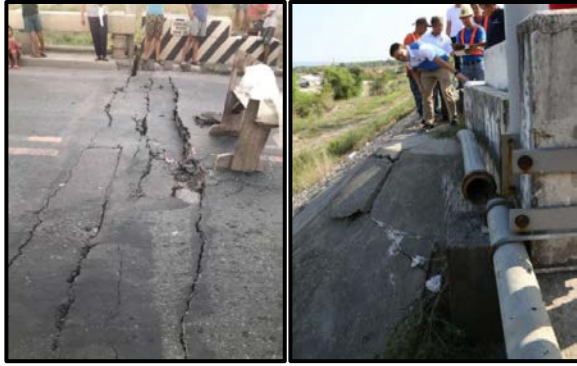
Fig. 8. Damage to Consuela Bridge in Floridablanca, Pampanga (Source: www.bworldonline.com)

One (1) bridge located in Floridablanca, Pampanga was also reported damaged and rendered not passable to vehicles, as seen in **Fig. 8** below. This bridge was reported to have slab deck cracks and depression along one of the approaches before it was repaired.

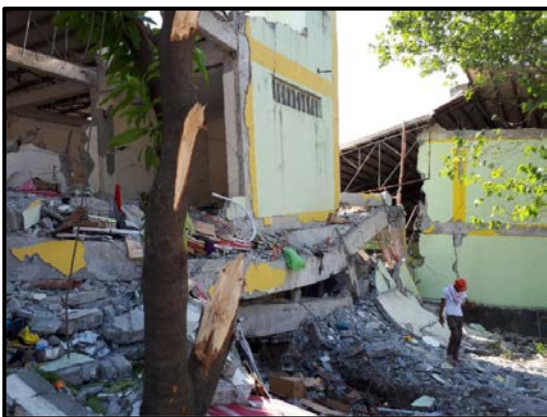
Fig. 9. Damaged exterior of Chuzon Supermarket

In total, 739 structures and buildings were reported damaged due to the earthquake in Regions I, III, and IVA, and the National Capital Region (NCR). This includes the collapse of Chuzon Supermarket, a four-storey supermarket, in Porac, Pampanga and damages to its surrounding structures (see **Fig. 9** and **Fig. 10**). Five of the 18 casualties reported in the province of Pampanga were retrieved from the supermarket collapse, according to Del Rosario from the Philippine News Agency⁶).

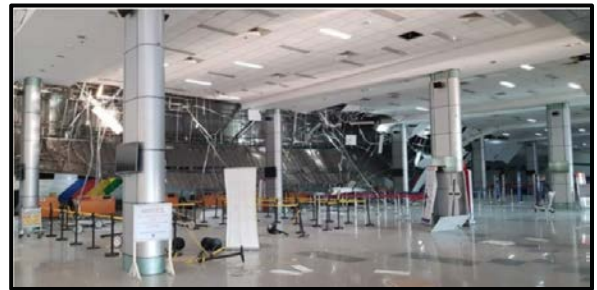
Fig. 11. Damaged ceiling in Clark International Airport

Non-structural damages through a damaged ceiling were observed in the Clark International Airport located in Angeles City, Pampanga (see **Fig. 11**).

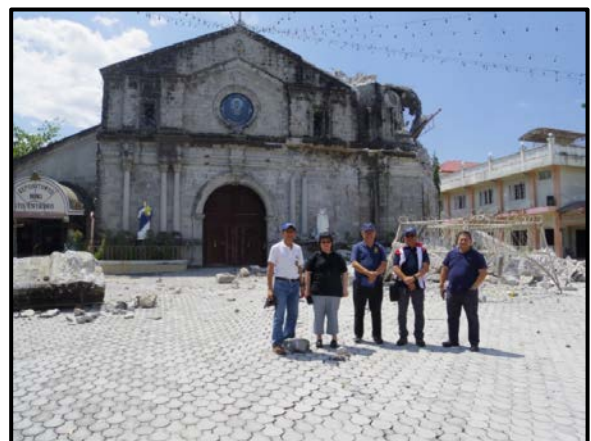
Fig. 12. Bell Tower damage to Santa Catalina Church

Similarly, damaged bell towers of three churches within Pampanga were observed. These churches were namely the Santa Catalina Church (see **Fig. 12**) and Pio Church (see **Fig. 13**) in Porac, and the St. Augustine Church in Lubao (see **Fig. 14**).
