Reconnaissance of the 2017 Central Mexico Earthquake

Key Facts

- Hazard Type: Earthquake
- Date of the disaster: September 19th, 2017
- Location of the survey: Mexico City, Puebla, Morelos
- Date of the field survey: October 15th to 19th, 2017
- Survey tools: Microtremor
- Key findings: site effects, contribution of sinking to the amplification of damage, need for implementation of mandatory retrofitting of old structures and seismic revision of damaged structures

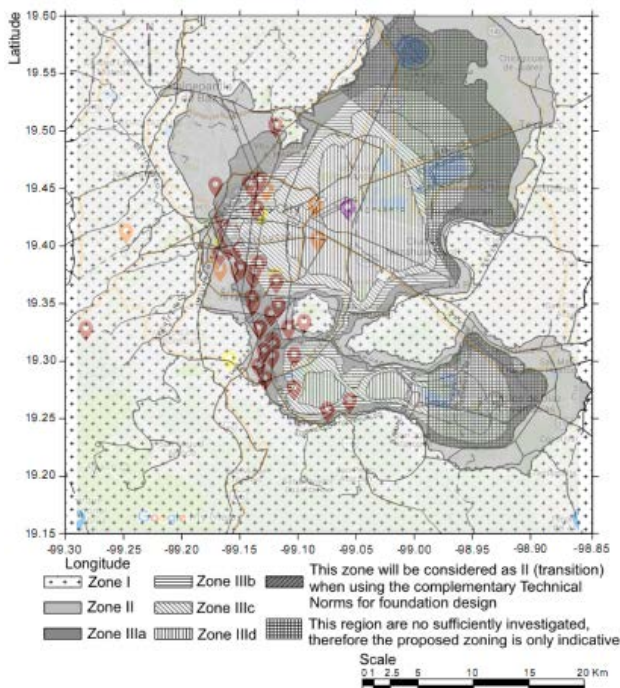
The collapsed buildings are displayed in Figure 20, most of them lying on Zone II and Zone III. Table 3 presents a summary of the buildings observed and the damage level.

and concrete and steel frames. Other relevant characteristics were the location and the stiffness. Corner buildings represented 41% of all the collapsed buildings, while soft-story buildings were 57%¹¹⁾.

Fig.20 Seismic zonation and buildings collapsed

One of the most important observations was that most of the collapsed buildings were built before 1985 and were rehabilitated after minor repairs, for residential or commercial purposes. After the 1985 Michoacan Earthquake, the seismic evaluation of buildings that underwent minor damage was not mandatory, which made these structures more vulnerable during this earthquake.

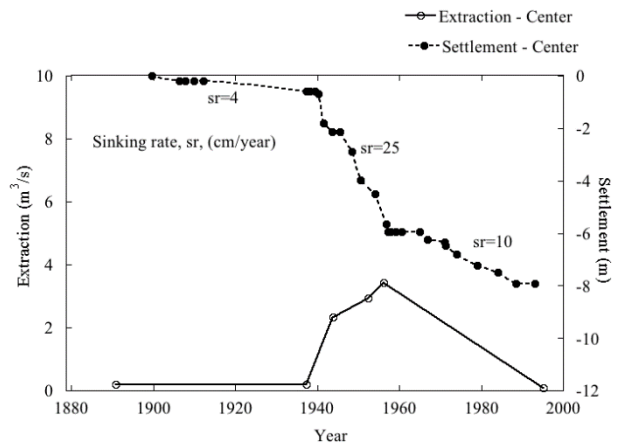
Mexico City has experienced continuous ground subsidence since the last century. In 1890, the government started extracting water for consumption from deep wells located in the center of Mexico City. In 1925, the problem was acknowledged after measuring the settlement of the Cathedral. In 1960, the water extraction stopped in the central part but continued in the south part, in the areas of Xochimilco, Tlahuac and Iztapalapa. However, the subsidence has not ceased in the central area and has also started in the south of the city¹³⁾ (Figures 21 and 22).

This extraction has caused differential settlements and generation of cracks due to the desiccated soils, that have affected buildings, roads and historical remains. Particularly, the counties of Tlahuac and Xochimilco, that are characterized for being located in the old area of lakes and are the places where deep

Fig.21 Subsidence in the center of Mexico City¹³⁾

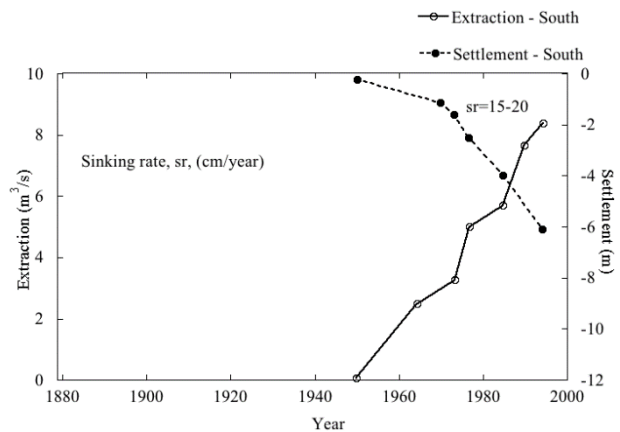
Fig.22 Subsidence in the south of Mexico City¹³⁾

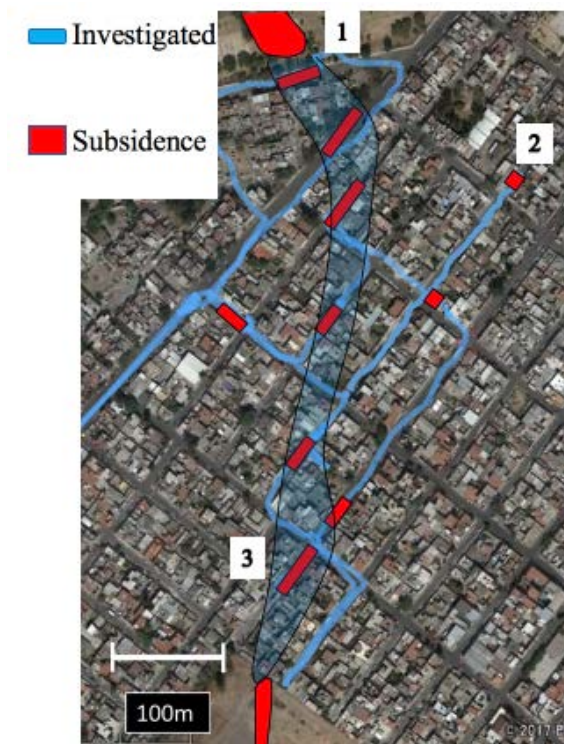
Fig.23 Area surveyed in Colonia del Mar

Site 1, in Fig. 23, is a park on the border between Tlahuac and Iztapalapa counties (Figure 24). In this area, the local government had previously built a subsidence monitoring station, that can be seen in the back, because the park had been settled for a while. However, a settlement of around 1 m was observed on the running track immediately after the earthquake, and on the date of the survey, the maximum settlement was 1.3 m.
