# Preliminary Report of the Damage by the 2021 Off Fukushima Prefecture Earthquake Mj7.3, Japan

- Hazard Type : Earthquake
- Date of the disaster : February 13<sup>th</sup>, 2021
- Location of the survey : Fukushima and Miyagi prefectures, Japan
- Date of the field survey : February 15<sup>th</sup> and 16<sup>th</sup>, 2021
- Survey tools : Digital Camera
- Key findings:
  - (1) Minor damage due to soil liquefaction and ground deformation were found in Yamamoto Town and Soma Port.
  - (2) Damage, such as road pavement cracks, cracks around abutment and suspected liquefaction in Soma Overpass Bridge and Soma East Bridge are reported.
  - (3) Cracks and spalling due to shear deformation in horizontal beams of the frame piers of the Shinkansen viaduct near to Shiroishi Zao station were found.
  - (4) Damage to buildings was not severe compared to the measured strong ground motions.

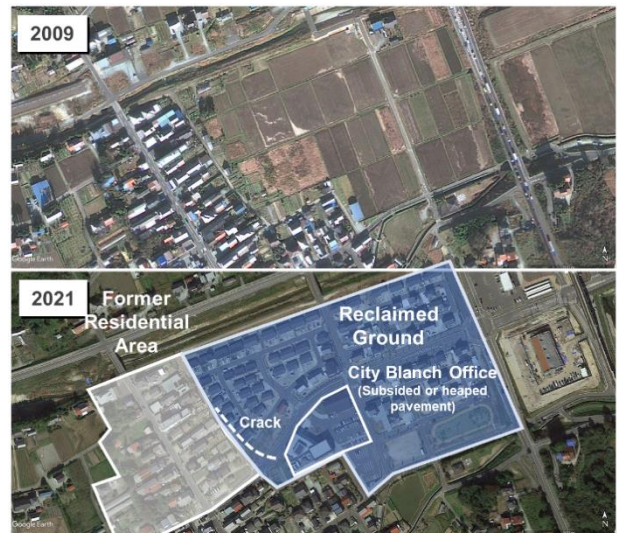
The 2021 earthquake caused minor geotechnical damage in a residential area in Yamamoto Town, Miyagi Prefecture. After the tsunami in the 2011 Tohoku earthquake, new residential houses and Sakamoto Branch Office of Yamamoto Town were constructed on the reclaimed land that was once paddy fields. Photo 1 shows aerial photos of the affected area taken in 2009 and 2021, respectively. Photos 2 (1) shows the damage observed around the Sakamoto

**Photo 1** Sakamoto residential area before and after the reclamation (Satellite Image : Google, ©2021 Maxar Technologies)
