Geotechnical Preliminary Report of The M_j 7.3 Fukushima Earthquake on March 16, 2022

Key Facts

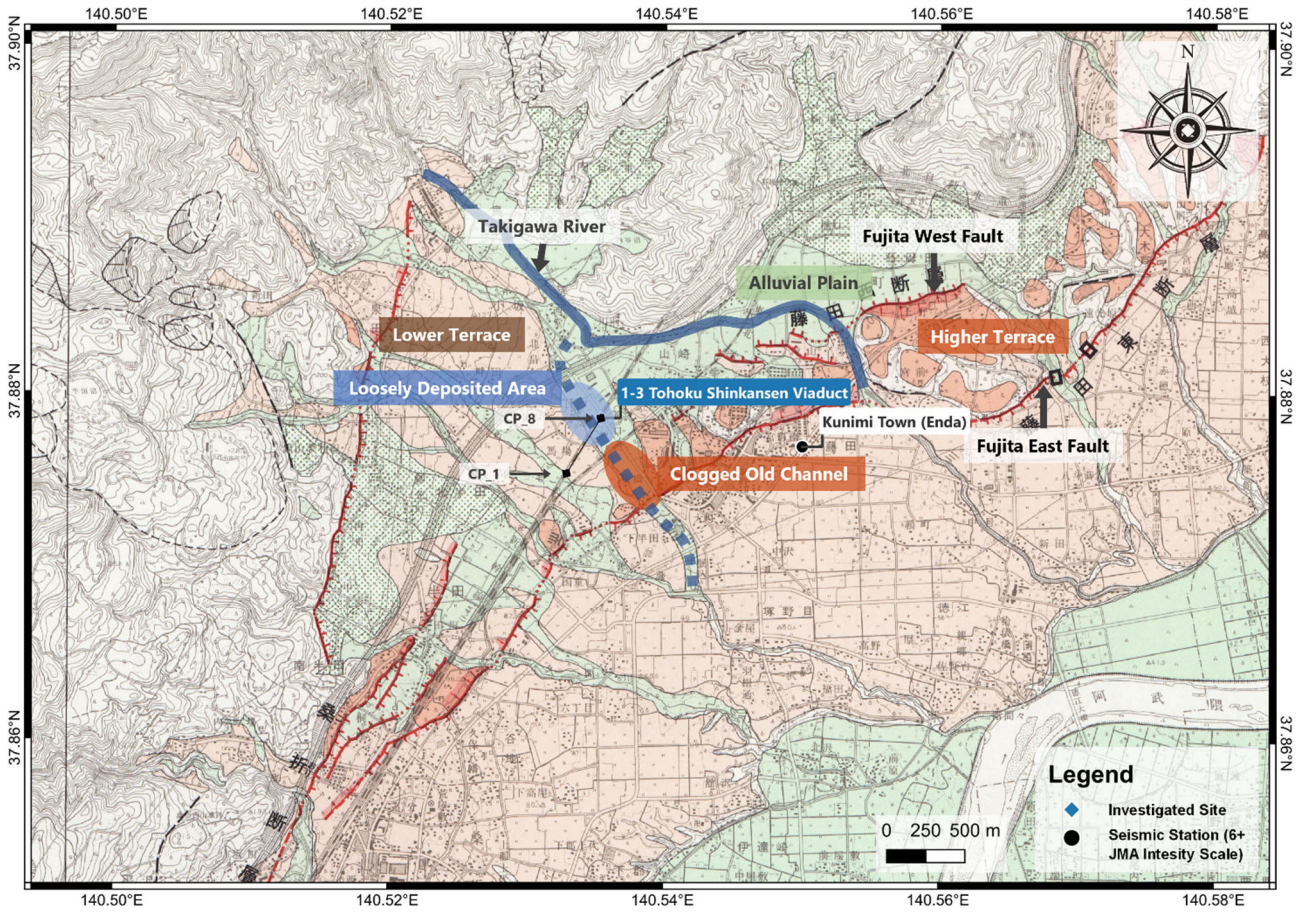
Fig.5 Local topography map around the damaged viaduct in Kunimi Town based on the Active Fault Map⁸⁾

The Active Fault Map from the Geospatial Information Authority of Japan (GSI)⁸⁾ shows the damaged pier locates on the alluvial plain of the Takigawa River, neighboring a higher terrace in the southeast (**Fig.5**). The higher terrace on the downstream of the Takigawa River has been lifted up because of two reversal faults called Fujita East Fault and Fujita West Fault. These liftings could change the flow direction of the Takigawa River and might result in depositing a loose and soft sedimentary layer around the affected site.
