**A RECONNAISSANCE REPORT  
ON  
THE 2007 SINGKARAK LAKE (SOLOK) EARTHQUAKE  
WITH  
AN EMPHASIS ON THE SEISMIC ACTIVITY OF SUMATRA FAULT  
FOLLOWING 2004 and 2005 GREAT OFF-SUMATRA EARTHQUAKES**

**Ömer AYDAN**

**Earthquake Disaster Investigation Sub-Committee  
Japan Society of Civil Engineers  
(Tokai University, Department of Marine Civil Engineering, Shizuoka)**

**August 2007**

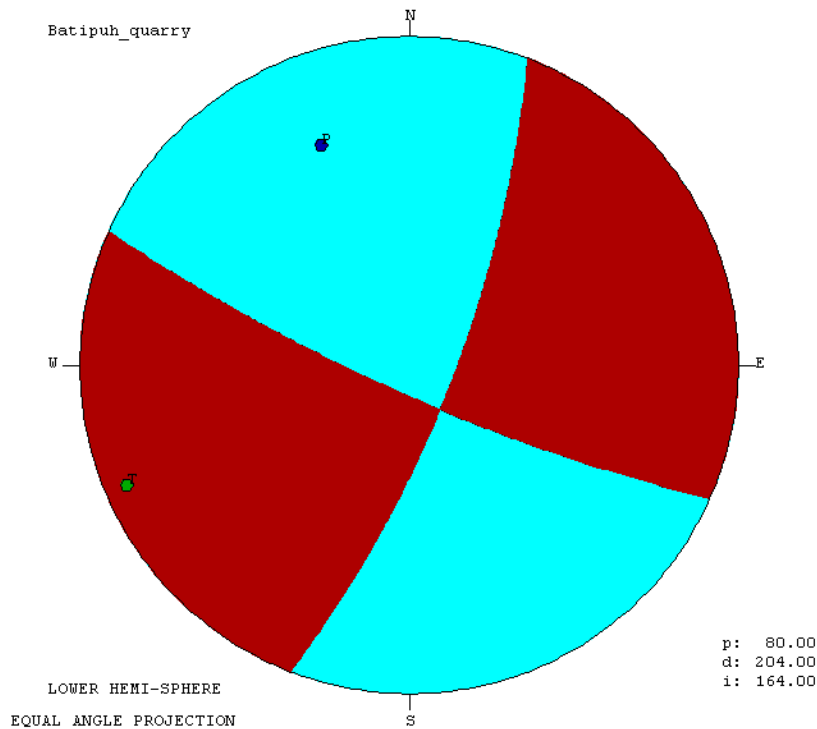
Figure 3.4. Inferred focal mechanism solution for the striations in Batipuh quarry.

The author did some observations in a quarry just north of Singkarak Lake. Figure 3.3 shows views of the fractures in a quarry and a fault surface with striations. The fractures are almost steeply inclined. However, their dipping direction is about 85°SW. The striations are almost horizontal. Nevertheless, they have slight normal component. In other words, the sense of deformation implies slight trans-tension type movements. Figure 3.4 shows the inferred focal mechanism solution for the striations in the quarry proposed by Aydan (Aydan and Kim, 2002, Aydan 2007b). The strike of the fractures is slightly different from the general trend of the SFZ.

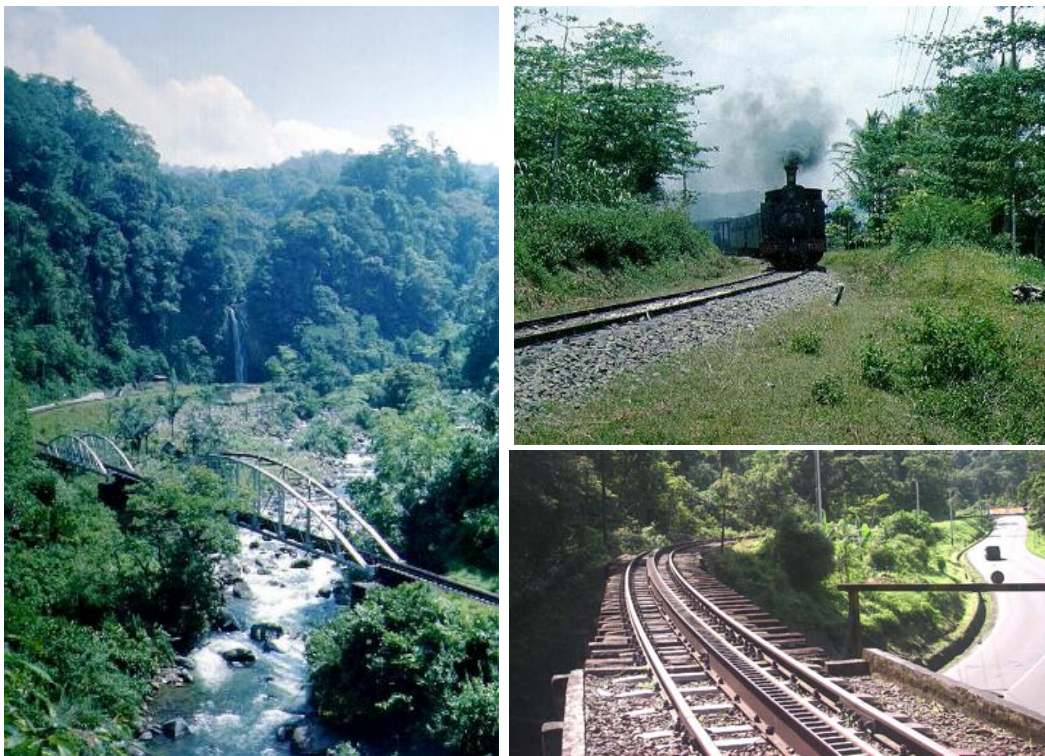
Figure 6.1. Views of railway lines in the epicentral area

There is a railway line which starts from Teluk Bayar port of Padang pass through Anai Valley to Padang Panjang where it joins the line from Lima through Bukit Tinggi and the line from the east coast of Sumatra Island via mining town Sawahlunto and Solok. The construction of the line was associated with the colonial Dutch period, during which Ombilin underground coal field was started to be exploited in 1891. The gradient of a 43km long section of the line between Kayutanam and Batu Tabal is quite steep and it was constructed as rack line. The visual inspection of the railway line near the famous Anai water-fall and Padanglawas near the epicenter revealed that there was no damage to the railway line (Figure 6.1).

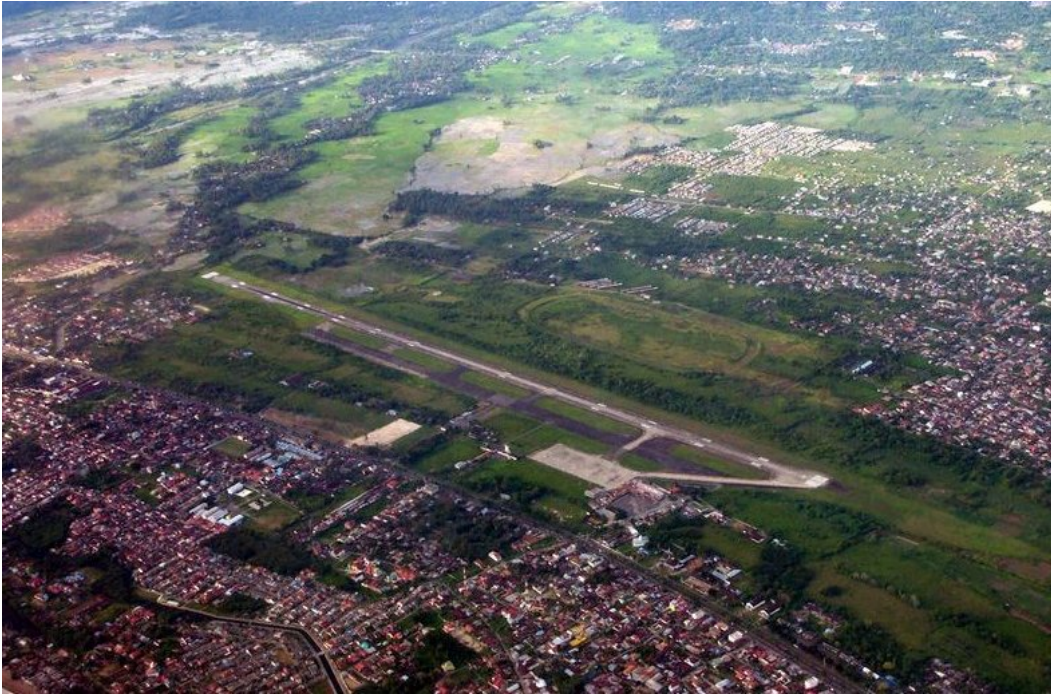
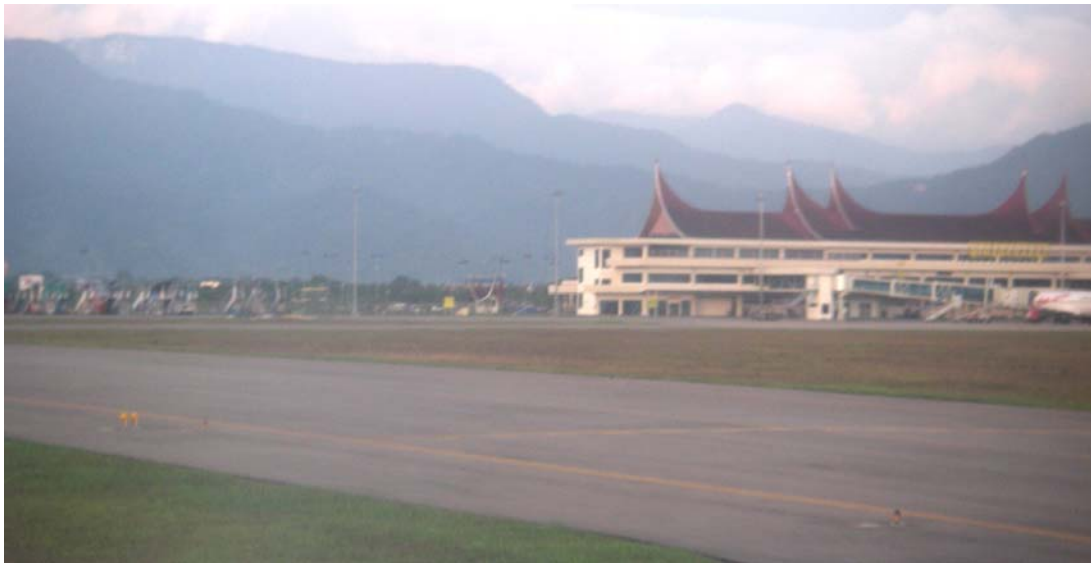
Figure 6.4. Views of airports in earthquake affected area

The airports in the earthquake affected area are Tabing air-force airport and Minangkabau civil airport (Figure 6.4). Minangkabau airport is newly re-built in 2001 by Shimizu Corporation and PT Adhi Karya through a softloan from Japan International Corporation Bank (JICB) (90%) and APBN (10%). The runway is 2750m long and its elevation is about 5m. The ground condition in the vicinity area is sandy soil. The earthquake did not cause any damage to its runway and terminal building. Furthermore, the airport traffic was not suspended following the earthquake.

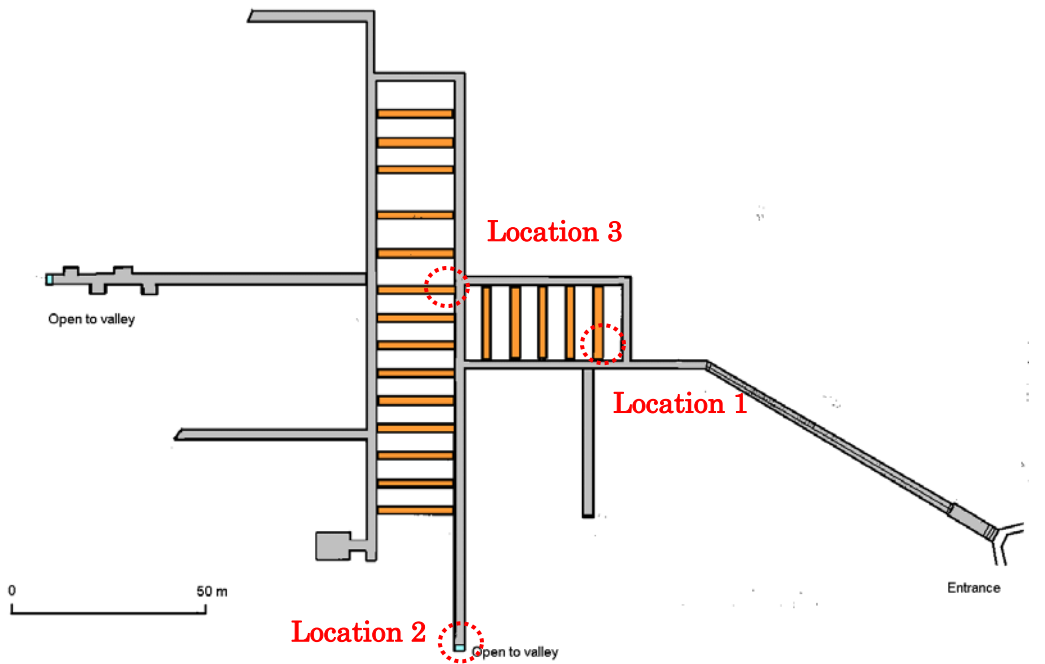
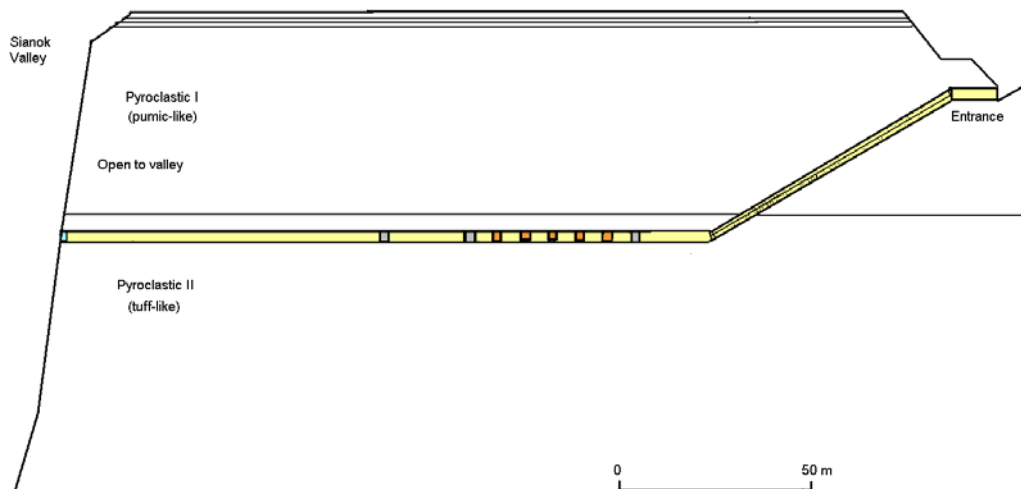
Figure 7.2. Plan and cross sectional views of the underground shelter

acceleration to cause the slope failures was estimated to be more than 0.2g. The other estimations yielded similar values (see Sub-section 4.5). In spite of such high ground motions, the weak rock conditions and extensive slope failures, the underground shelter was almost intact after the earthquake. The author found three locations where some damaging effects of the earthquake on the underground shelter were observed (Figure 7.5). The first location was at the first room with a base width of 3.8m near the bottom of the inclined shaft and a 10-20cm thick slab of rock was fallen from the roof for a length of 5m. The rock layer belongs to the pyroclastic flow deposit layer 1. The second location was at the ventilation adit next to slope. A 40-50cm thick rock slab was fallen from the roof for a length of 2m and semi-ruptured roof material could be observed. A 100cm long and 5cm wide spalling occurred at a room with base width of 3.8m was observed. Except these three locations there was no visible damage to the underground shelter.

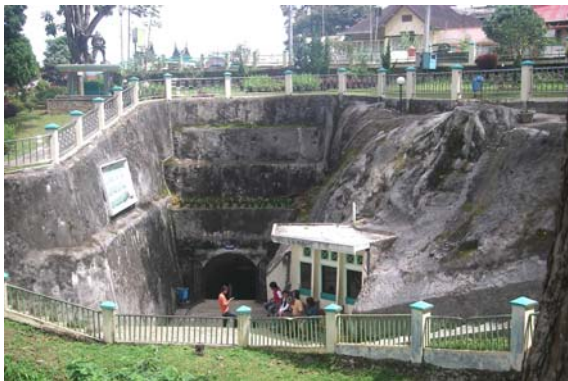
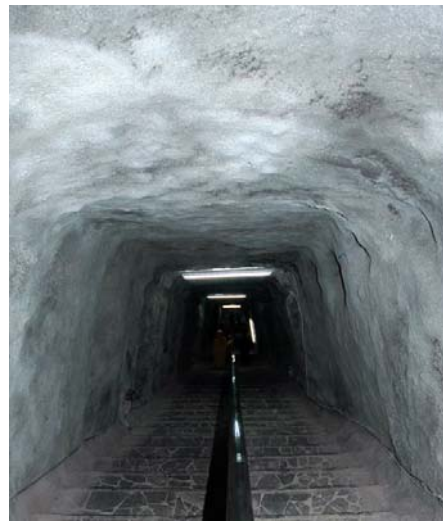
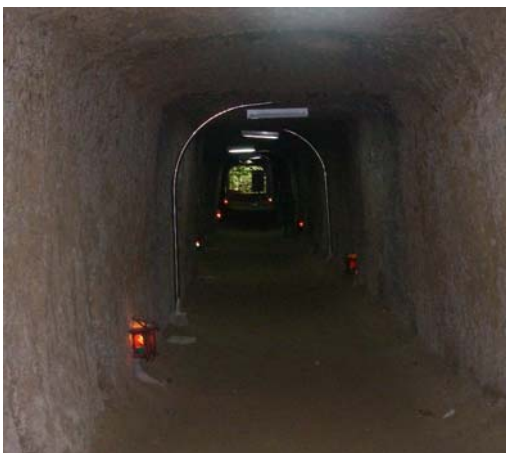
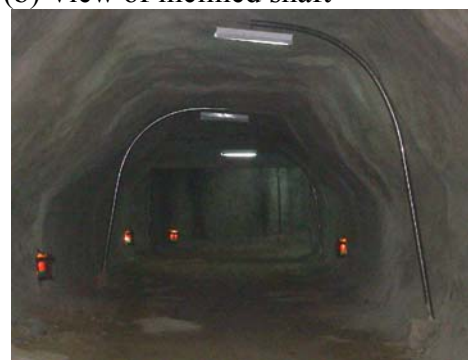
Figure 7.4. Some views of the inclined shaft and adits and rooms in the shelter

The configuration of adits changes from location to location and their functions. The inclined shaft has arched roof and it is 2.4m high and 3.0m wide (Figure 7.4). The main adits has a trapez shape with a height ranging between 1.8 to 2.1m and its base width ranges 2.4 to 2.6m. The rooms between adits are larger and their width is about 4m with a height of 2m.

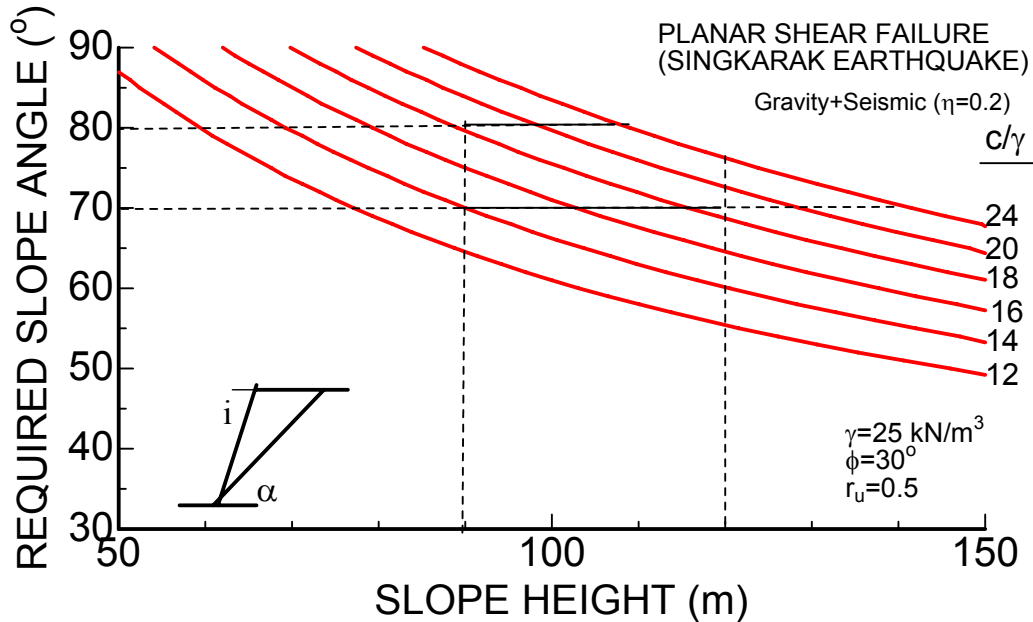
Figure 8.5. The relation between slope angle and slope height as a function of normalized cohesion by unit weight

Using the seismic coefficient method and assuming that the failure is planar, and the friction angle of the ground is  $30^\circ$  and pore water coefficient of 0.5, the relation between slope angle and slope height can be obtained as a function of normalised cohesion to the unit weight of rock for a seismic coefficient of 0.2 as shown in Figure 8.5. In view of the self-standing underground shelter discussed in the previous section and the observed slope heights (80-120m), the most likely normalized cohesion by the unit weight is likely to be about 20 . For this value of the normalized cohesion, the value of seismic coefficient varied between 0.2 to 0.3 by an increment of 0.5 (Figure 8.6). From these parametric computations, the expected

maximum ground acceleration is likely to be around 0.25g. There is no doubt that it will be desirable to carry out detailed geotechnical investigations for determining the properties of ground around Sianok Valley. Nevertheless, the results from these parametric studies would be quite close to the actual values in view of ground conditions in similar type geological and geotechnical environments.

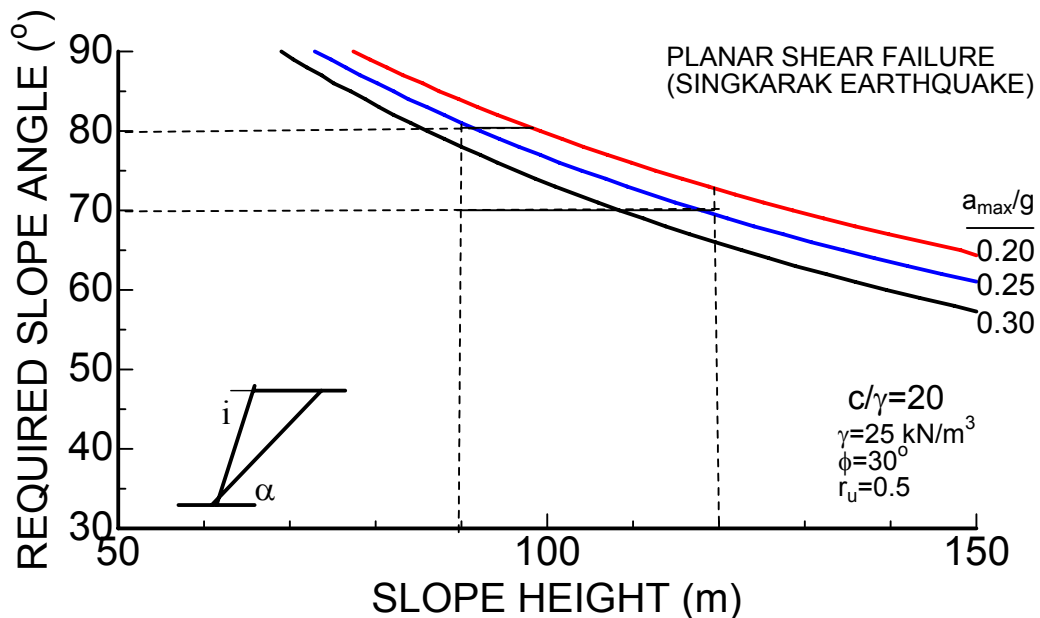
Figure 8.6. The relation between slope angle and slope height as a function of seismic coefficient

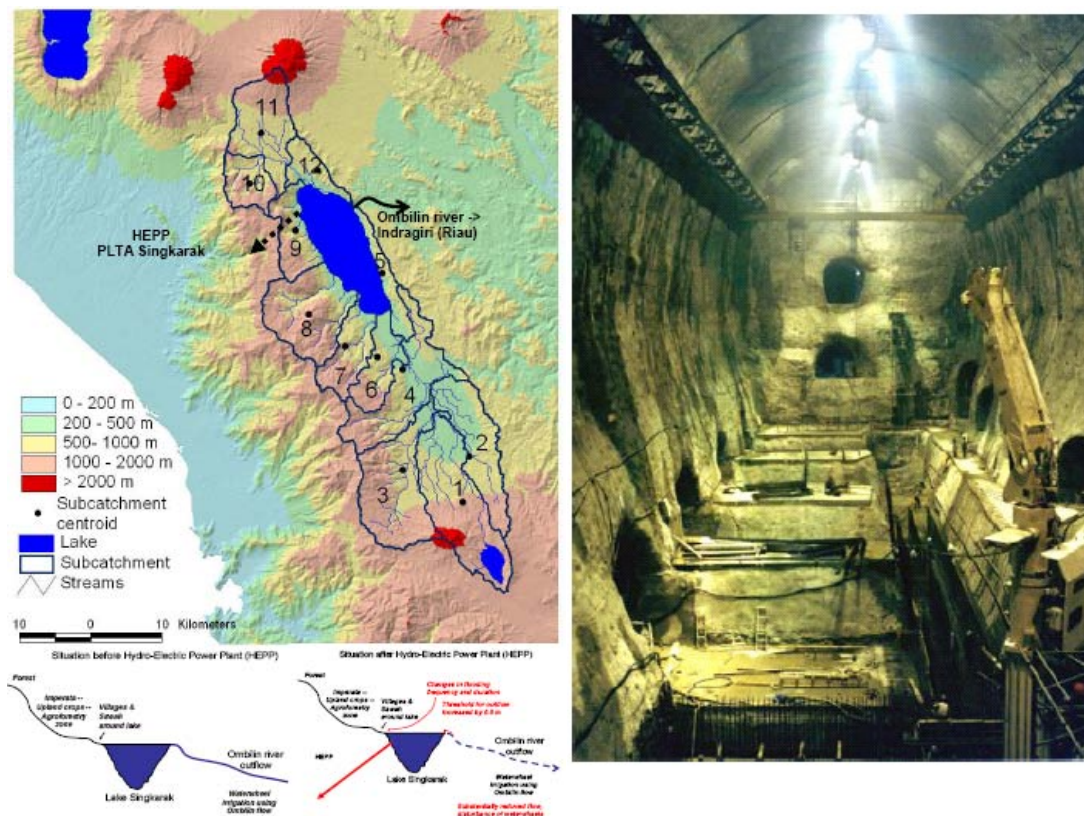
(a) Layout and location of HEPP

(b) Underground power house

There was no damage to the Singkarak hydro-electric power plant by the earthquake. The electricity production was back after an automatic shut-down of the plant due to ground shaking.

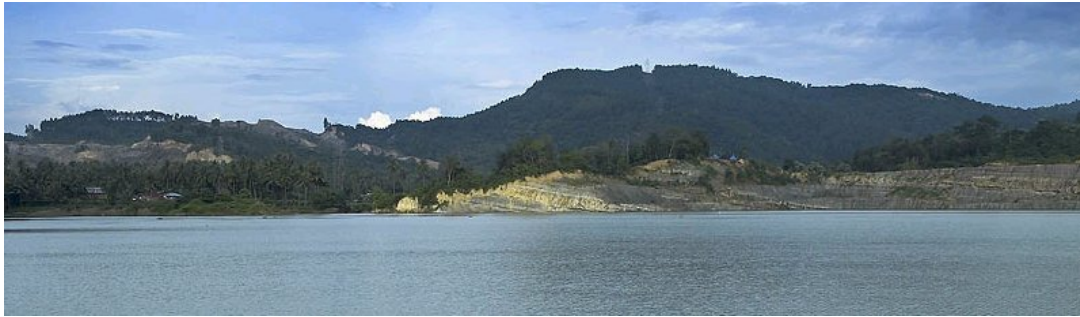
Figure 10.3 Kandi lake created by the flooding of the abandoned coal open-pit

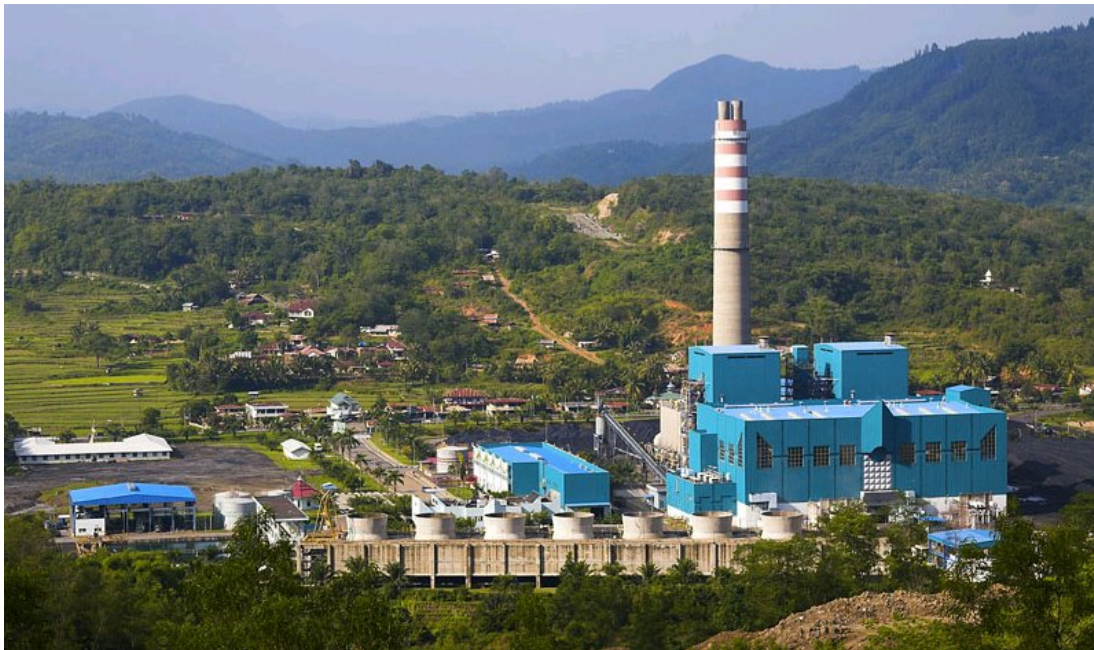
Another major power plant in the epicentral area is Kandi Thermo-electric Power Plant near Sawahluhung (Figure 10.4). The coal to this plant was supplied from underground mine at Sawahluhung and it was shut down with the closure of the mine. There was no report of damage to this shut-down thermo-electric power plant by the earthquake.

Figure 10.4. A view of Kandi Thermo-electric Power Plant

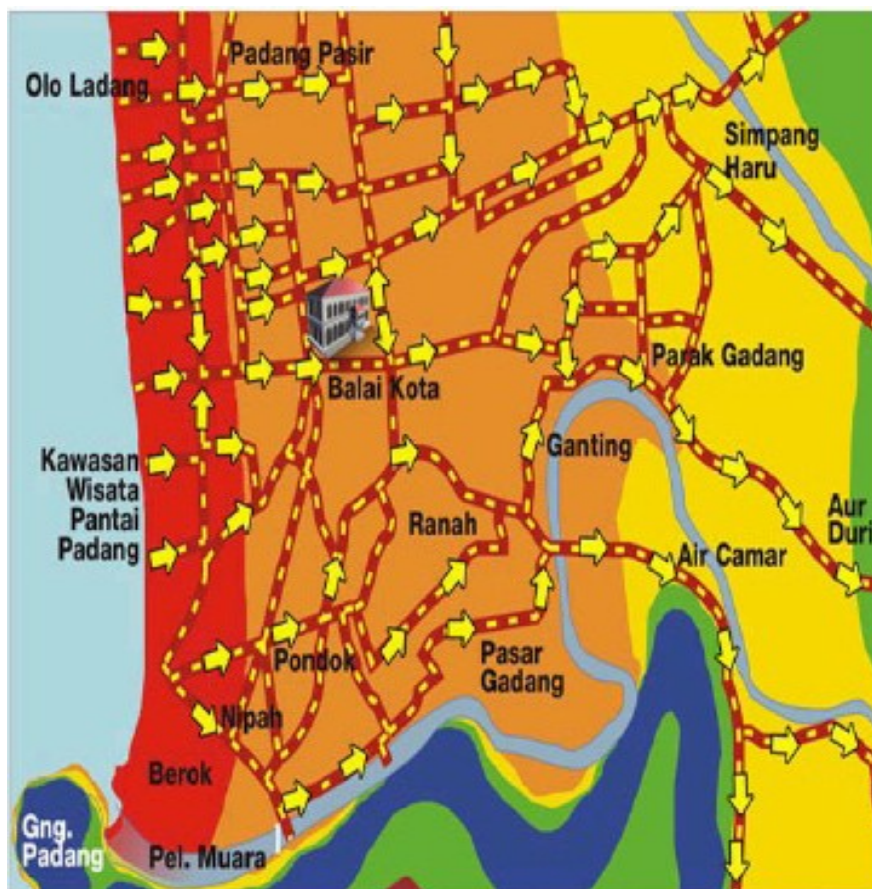
Figure 11.1. Horizontal Tsunami evacuation routes for Padang City

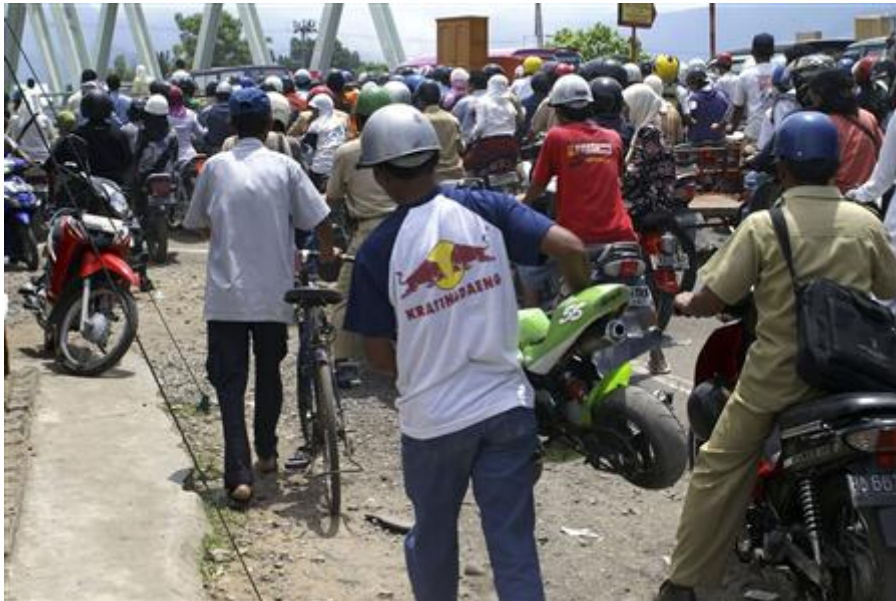
The second important issue is the release of the accurate information to the public as soon as earthquakes occur. Meteorology and Geophysics Agency (BMG) of Indonesia is responsible for releasing such information. However, this agency failed to release such information in most recent earthquakes of 2004 Aceh, 2005 Nias, and 2006 South Java as well as 2007 Singkarak (Solok) earthquake. The information must be provided to public at most in 5 minutes time. The system must be capable of if earthquake has the potential for causing tsunami. If so, it should provide information on expected arrival time and tsunami height. The system used in Japan is probably the most effective one so far in the world. There was a huge panic in Padang city since people did not get information about the location, magnitude and its potential for causing tsunami in due time by Meteorology and Geophysics Agency (BMG) of Indonesia. In spite of drills, the people tended to use vehicles, motorbikes, bicycles causing traffic jams (Figure 11.2).

Figure 11.2. Panic in Padang city following 2007 Singkarak Lake earthquake
